Ground damage caused by 2007 Niigataken Chuetsu-oki Earthquake

Rolando P. Orense
Faculty of Engineering, University of Auckland, NZ

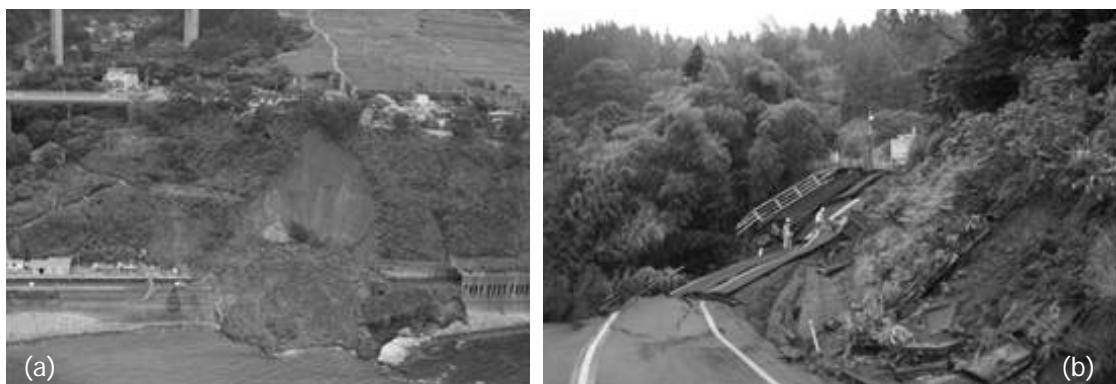
One major landslide occurred in the vicinity of JR Shin-etsu Mainline's Omigawa station (see Figure 3a) where the debris covered part of the railway line. Fortunately, no one was injured due to the landslide. The slope was fairly steep and the slide involved a volume of soil about 100m high, 50m wide and 10m deep. The resulting scar had almost vertical face. Because of the steep hills in the vicinity of the station, other landslides were observed in the area as well. Note from the figure the presence of railway tunnel protection structure immediately to the right of the landslide, indicating slope instability problems in the area.

Figure 3: Examples of slope failures during the earthquake: (a) near JR Omigawa station (photo by Kokusai Kogyo Co. Ltd); and (b) along National Route No. 8 in Senbon, Nagaoka City (photo by Prof. Inoue).

Another large-scale landslide occurred along National Route No. 8, which connects Kashiwazaki to Nagaoka. The landslide, which occurred in the foothills of Senbon (east of Kashiwazaki), started at about 60m above the road pavement (see Figure 3b). The slide pushed the highway into the Kurokawa River which runs parallel to the road (on the left lower portion of the photo). The debris covered about 80m section of the road, causing the suspension of traffic operation along this major road.

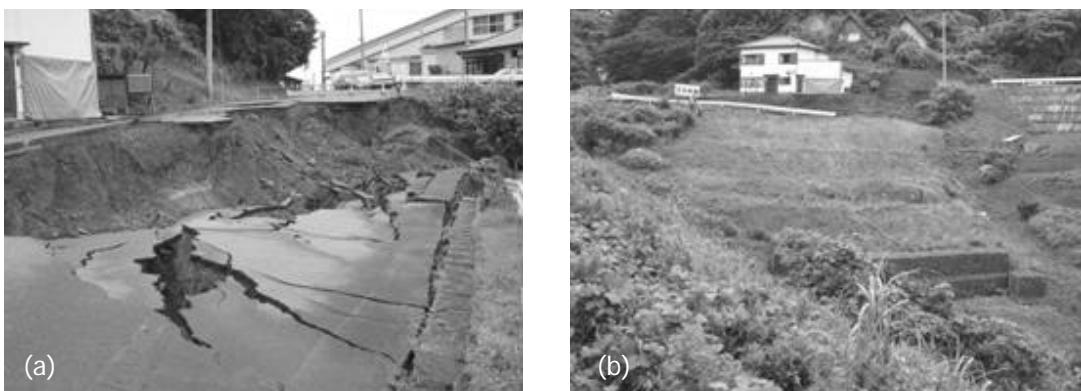
Several embankment failures were observed in road fills along the coast. In Kasashima off Route No. 8, a 60m-portion of an embankment underwent more than 1m of vertical displacement, resulting in road closure (see Figure 4a). The slope appeared to have undergone previous stabilization using slope grading and gabion baskets to support the toe, as shown in Figure 4b.

Figure 4: Collapse of man-made embankment in Kasashima.

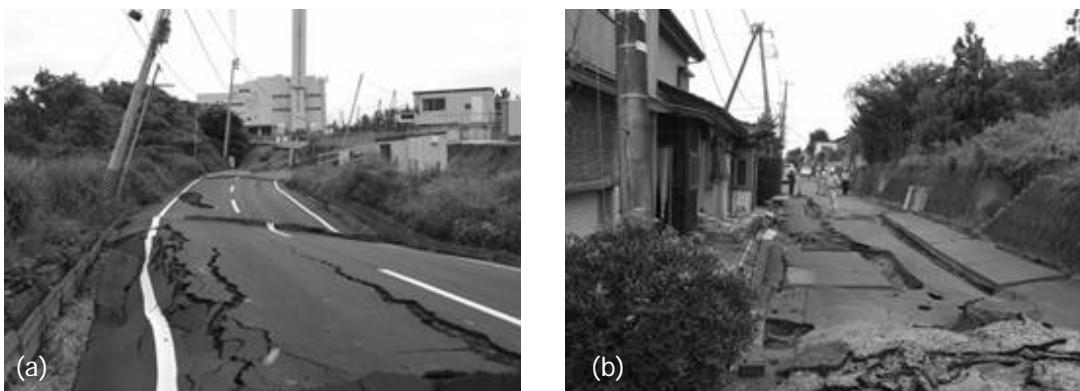
The road parallel to the Sabaishi River which leads to the Kashiwazaki City's Garbage Incinerator Plant underwent extensive liquefaction. The road spread laterally towards the river, resulting in massive embankment failure (See Figure 5a). The vertical displacement of the head

Figure 5: Liquefaction-induced ground deformations: (a) Road leading to Kashiwazaki Incinerator Plant; (b) at Yamamoto Danchi, Yamamoto Town

scarp was about 3m (maximum), with the lateral spread movement occurring from the sand quarry area towards the river. Sand boils were also observed near the river. This site may have been a former river channel of the Sabaishi River which was buried when the road was constructed. Also seen in the background of the photo is the damaged exhaust chimney of the plant. The reinforced concrete chimney, measuring 58m high by 4.6m wide, was broken at the lapped reinforcing joint slightly below the centre of the chimney.

Another area of extensive damage was observed in Yamamoto Danchi, Yamamoto Town adjacent to the incinerator plant (Figure 5b). Cracked pavements, uplifted manholes, lateral spreading and uneven settlements were observed in many parts of the area. Considerable liquefaction was also observed at the Suidobashi Park in Nishimoto, Kashiwazaki City (Figure 6a). This area has been transformed into a park when flood mitigation efforts were implemented in 1984 at the time the Ugawa River system was straightened. Sand boils and ground cracks were also observed in Sabaishigawa Park (Figure 6b).

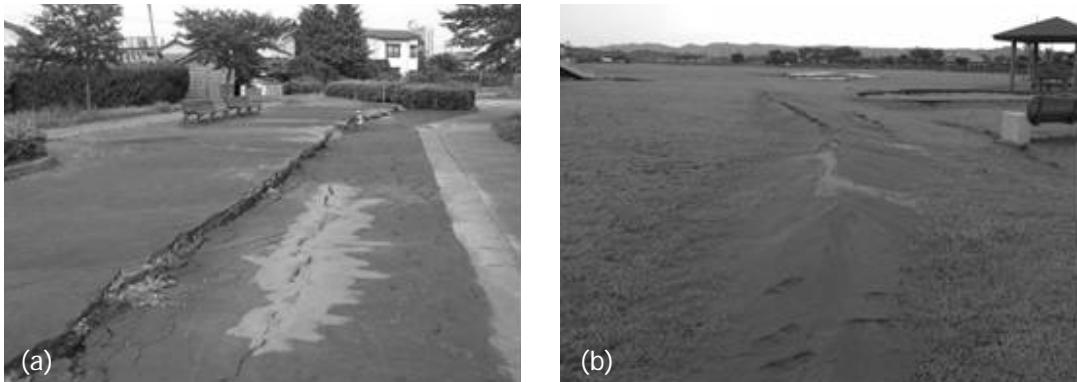
Figure 6: Sand boils induced by soil liquefaction: (a) Suidobashi Park; and (b) Sabaishigawa Park

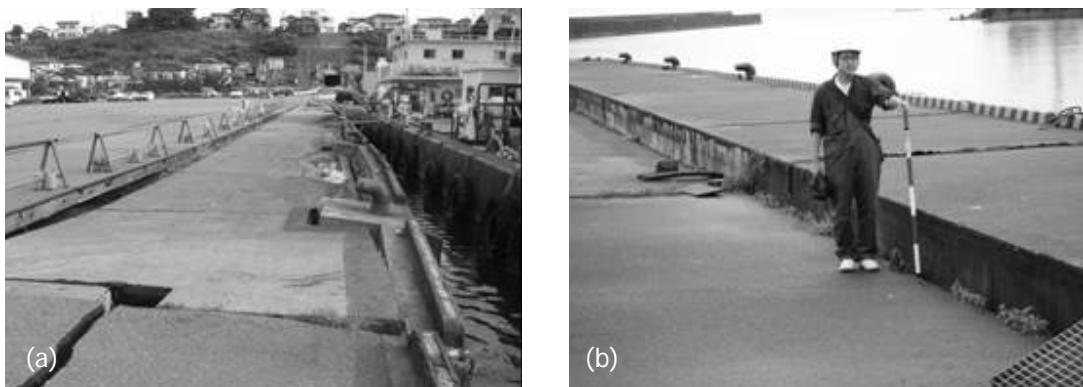
The earthquake affected several coastal structures in Niigata Prefecture. Among these, the Kashiwazaki Port, the largest facility in the affected region with approximately 1.25km of waterfront berths, suffered extensive damage due to liquefaction-induced ground deformations. At the West Wharf, settlement and displacement of the quay walls opened joints in the aprons and deformed the ground in the yard area (see Figure 7a). At the Fishing Port, the apron settled

Figure 7: Damage to port and harbour facilities: (a) lateral spreading; and (b) apron settlement in Kashiwazaki Port.

by as much as 20 cm due to the lateral displacement of the quay wall toward the sea (see Figure 7b). Similar types of damage were observed at the Central Wharf, where cracked pavements, deformed quay walls and uneven surfaces were noted. In addition, the remains of blown-out sands caused by liquefaction were observed in many places around the harbour. The Eastern Berth, which was being used by the Japan Coast Guard and Japan Self-Defence Forces as a staging area for recovery and rebuilding efforts, suffered minor liquefaction effects, with lateral displacements in the order of <5cm and apron settlements ranging from 2-7cm.

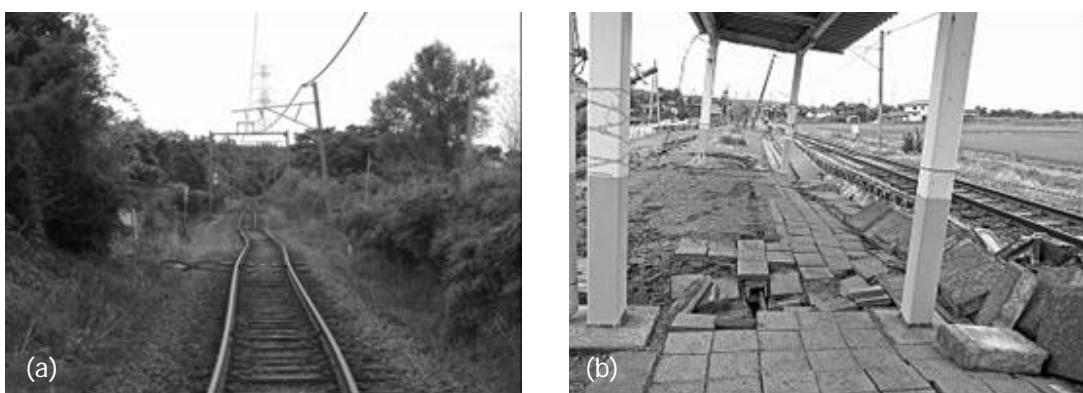
Damage to railway lines were also evident, although highly localized. Between Arahama Station and Nishiyama Station on the JR Echigo Line, the rail track buckled at locations where the railway embankment moved laterally during the earthquake (Figure 8a). Moreover, the Arahama Station platform was completely damaged, together with the powerlines and signalling equipment, as a result of liquefaction-induced settlement and lateral spreading (Figure 8b).

Figure 8: Damage to railway facilities: (a) buckled railway track; and (b) damaged platform of Arahama train station.
