# Slope failures, scour and infrastructure damage: - Tairāwhiti road network response to multiple severe weather events

*D. L. Fellows & N. Barker*

GHD Ltd, New Zealand Auckland, & Palmerston North.

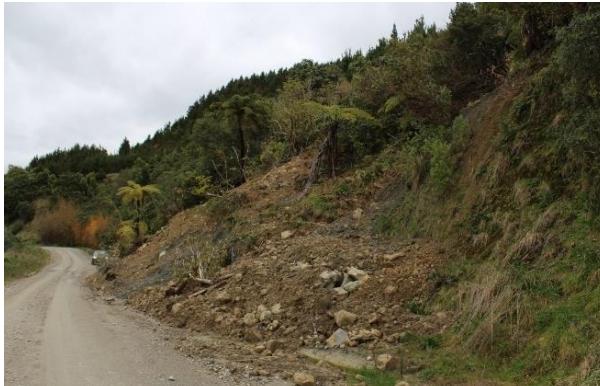
Over slip at Waimata Valley Road, Gisborne

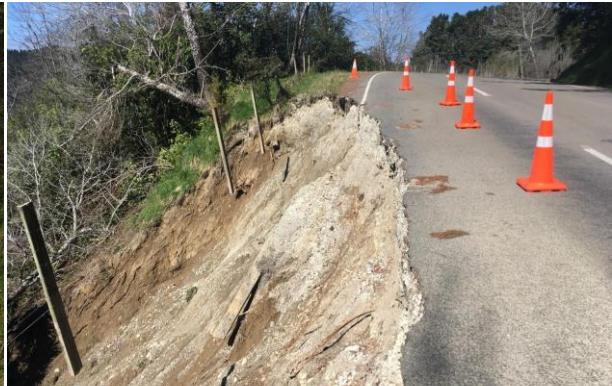
Under slip at Armstrong Road, Whatatutu

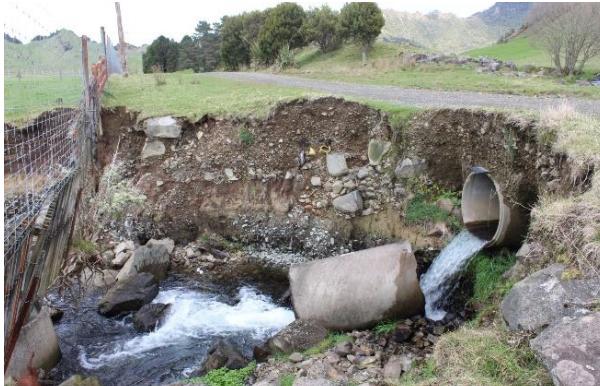
Culvert outlet scour at Moutohora Road, Motu

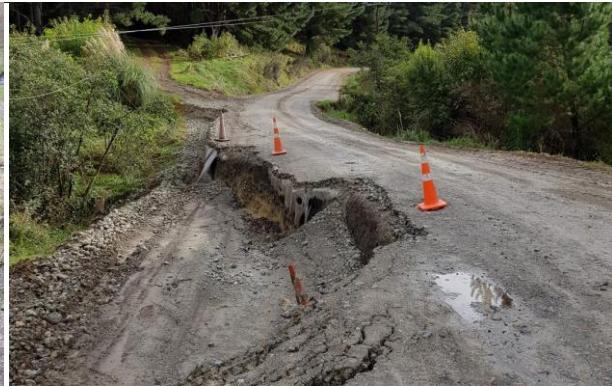
Under slip at Tarndale Road, Whatatutu

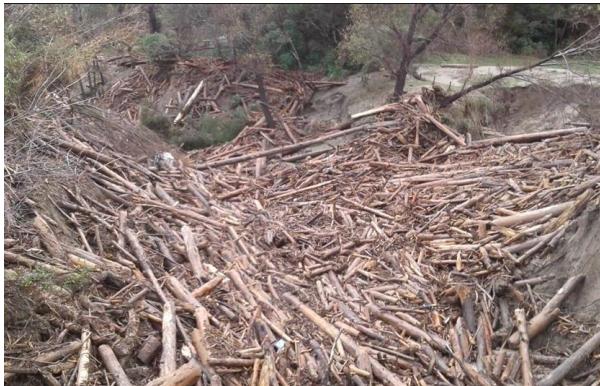
Forestry scrag damage at Paroa Road, Tolaga

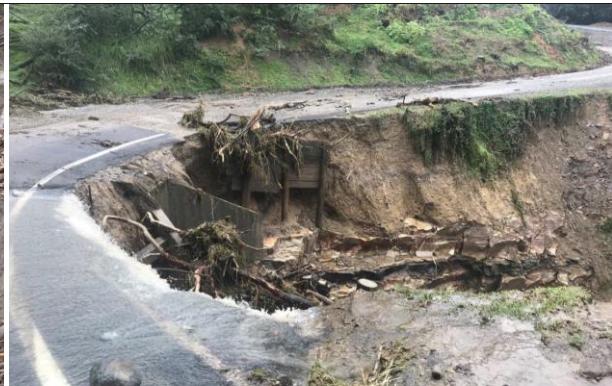
Scour due to culvert blockage and storm water runoff at Arakihi Road, Tolaga

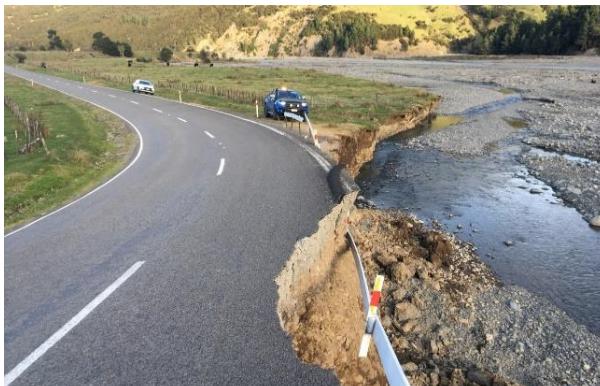
River bank scour at Tapuaoeroa Road, Ruatoria

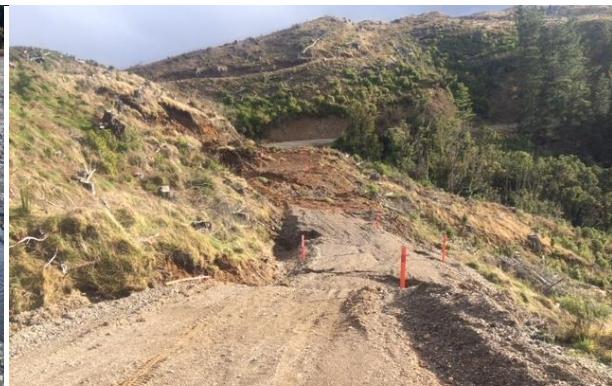
Hillside failure at Waitahaia Road, Te Puia Springs
