Seismically induced displacement of land affecting multiple residential properties in the Port Hills, Christchurch, New Zealand, following the 2010/2011 earthquake sequence

R P Hunter

Tonkin & Taylor, Environmental and Engineering Consultants, NZ.

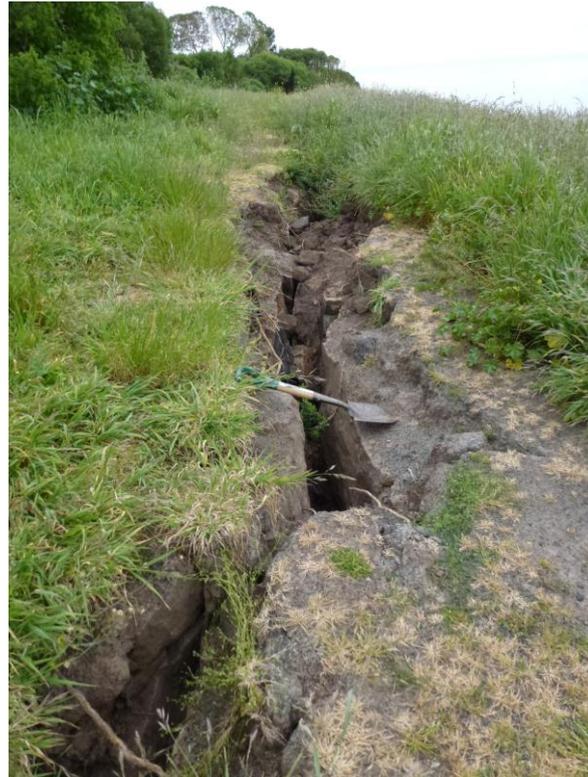
Ground deformation is characterised by persistent tension cracks that trace generally parallel to cliff edges (Figure 1), and the formation of head scarps. These tension cracks opened further in subsequent aftershocks, particularly in the M6.4 earthquake on 13th June 2011, where some tension cracks that formed as a result of the 22nd February earthquake, became the location of the new cliff edge. Factors that have affected the individual site response include topographic amplification, seismic wave directionality, and the local geology.

Figure 1: Tension crack traverses parallel to cliff edge along Whitewash Head showing the opening of the fractured volcanic lava and the overlying soil

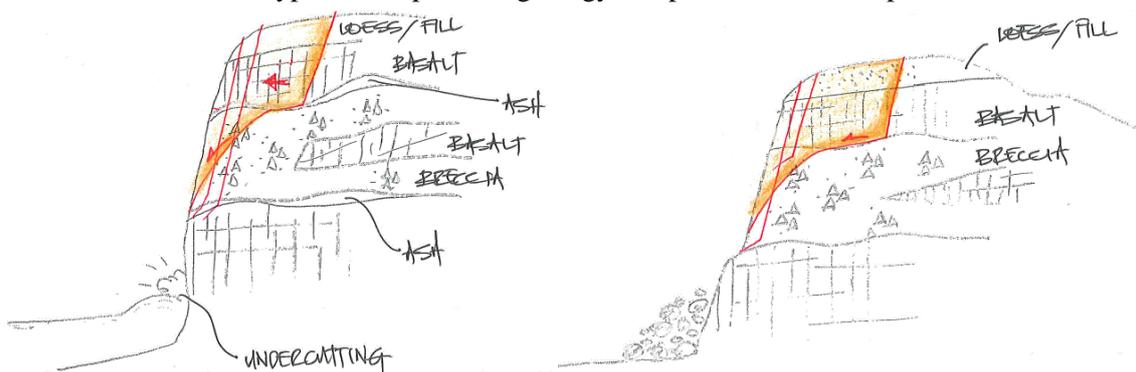
It is thought that the toppling and sliding would have occurred on largely pre-existing fractures in the rock mass, with the likelihood that additional tension cracks also opened up back from the cliff as the rock mass dilated when shaken. There is evidence that amplification of seismic acceleration, of the order of 2 to 4 times that recorded locally, occurred on ridge crests. The relatively weathered state of the volcanic units on the outer cliff faces, where zones of cavernous weathering and marine undercutting were apparent, is likely to have facilitated tension crack development and subsequent failure under seismic loading. Figure 2 shows schematic sketches of typical cliff profiles, geology and possible cliff collapse mechanisms.

Figure 2: Schematic diagrams to show the failure mechanisms of cliff collapse

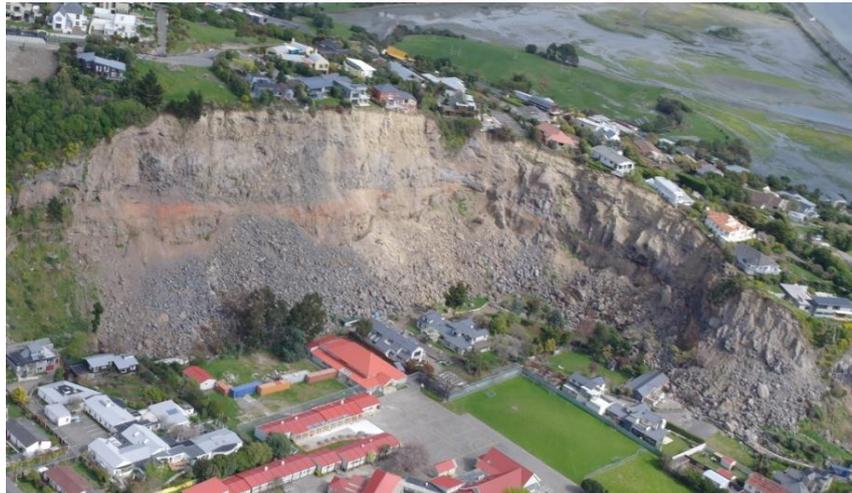
Cliff collapse has affected a number of residential properties, public, private and commercial land, with the loss of land at the top of the cliff, and deposition of fallen rock and soil debris at the base (Figure 3). Some structures have been affected as the retreating cliff edge has caused the dwelling foundations to be undermined, resulting in the partial collapse and loss of building structures over the edge of the cliff face (Figure 4), and the evacuation of private accessways, as shown in Figure 5. At the bottom of cliff faces, some buildings have also been damaged as a result of the fallen rock and soil material (Figure 6).

Figure 3: Cliff collapse at Redcliffs showing the large amount of rockfall material at the base of the cliff

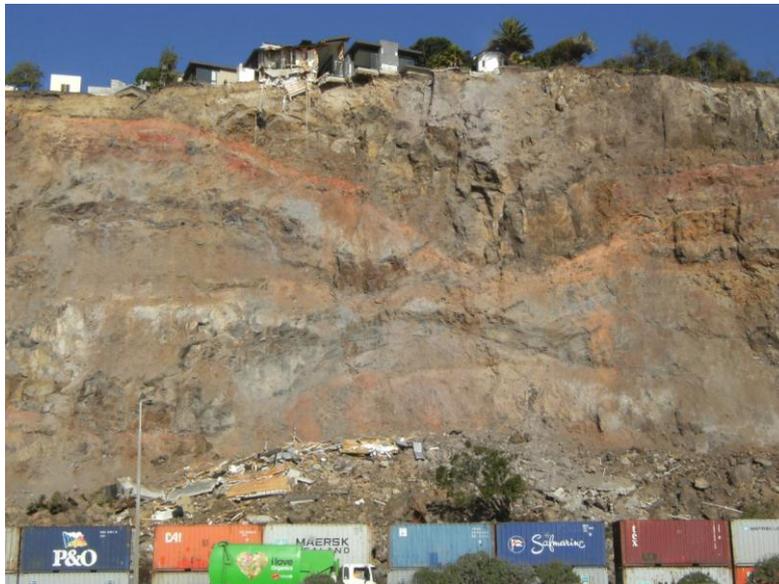
Figure 4: A property above Peacocks Gallop (Main Road, Sumner) that has lost land and foundation support as a result of cliff collapse

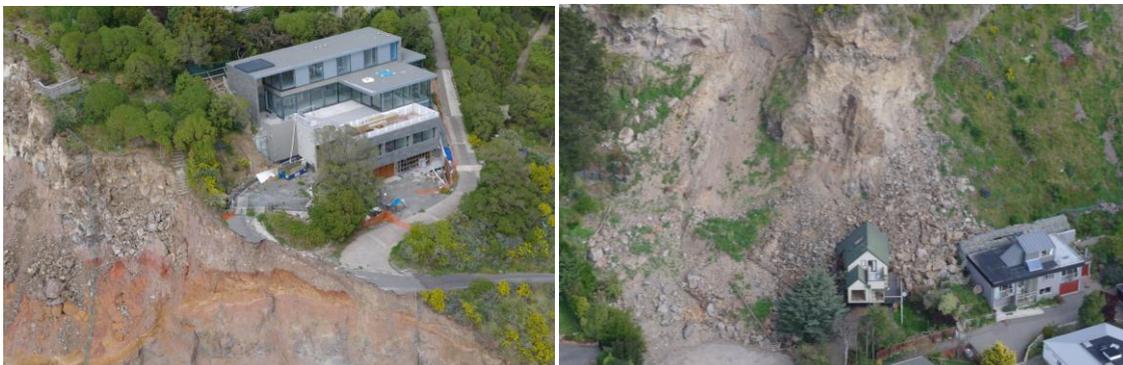
Figure 5 (left): Cliff collapse resulting in the loss of access way to a dwelling on Whitewash Head

Figure 6 (right): Dwellings at the bottom of a failed cliff that were damaged by fallen rock debris

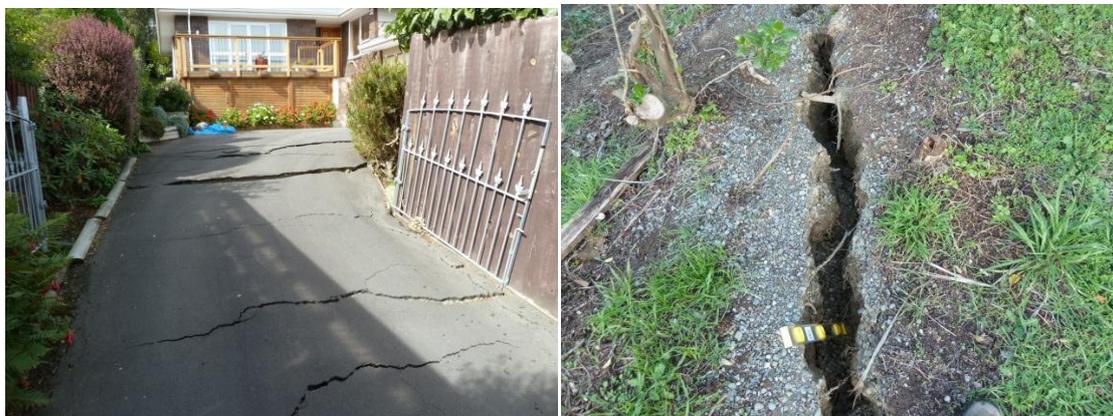
Land displacement initially occurred in the M6.2 earthquake event of 22nd February 2011. Ground deformation observed is characterised by semi-continuous, stepped and en-echelon tension cracks (Figure 7 and Figure 8), either narrowly focussed or in a broader zone. These features are generally present at elevations ranging between relative level (RL) 10 m and RL 25 m and slope angles between 4 and 24° at the toe of the Port Hills. Down slope displacements from all seismic events were up to 670 mm, with lateral extents extending up to 850 m in any one area. Some AWAA's also exhibit compression features aligned in the same orientation as the tension cracks and located at the edge of the valley floor. A schematic sketch of the geology and potential failure surface is shown in Figure 9.

Figure 7 (left): Tension cracking across a driveway on Vernon Terrace

Figure 8 (right): Typical tension crack in the lower colluvial wedge slope area near Ramahana Road

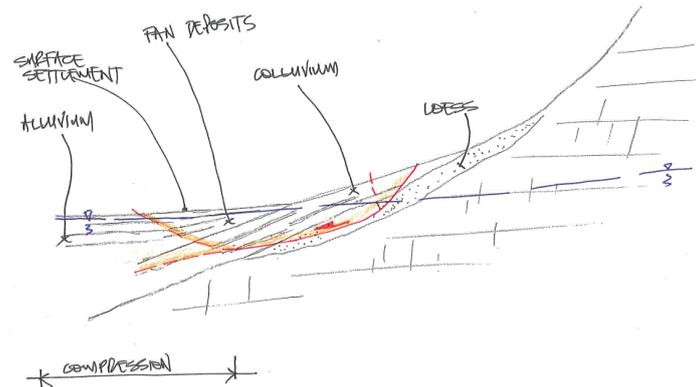
A liquefaction analysis based on Cone Penetration Tests (CPTs) in valley floors, identified layers of soil that have the potential to liquefy in earthquake events. The driving mechanism for these colluvial wedge failures may be partially driven by a softening of liquefiable layers in the toe region of these slopes, resulting in a reduction in the resisting force, allowing the slope to be more easily displaced during seismic accelerations. Newmark slope stability modelling showed that the high seismic acceleration, especially the vertical acceleration, was the most sensitive parameter imposed on the slope to exceed the cohesive and frictional resistance resulting in slope displacement.

Figure 9: Schematic diagram to show the possible colluvial wedge failure mechanism.

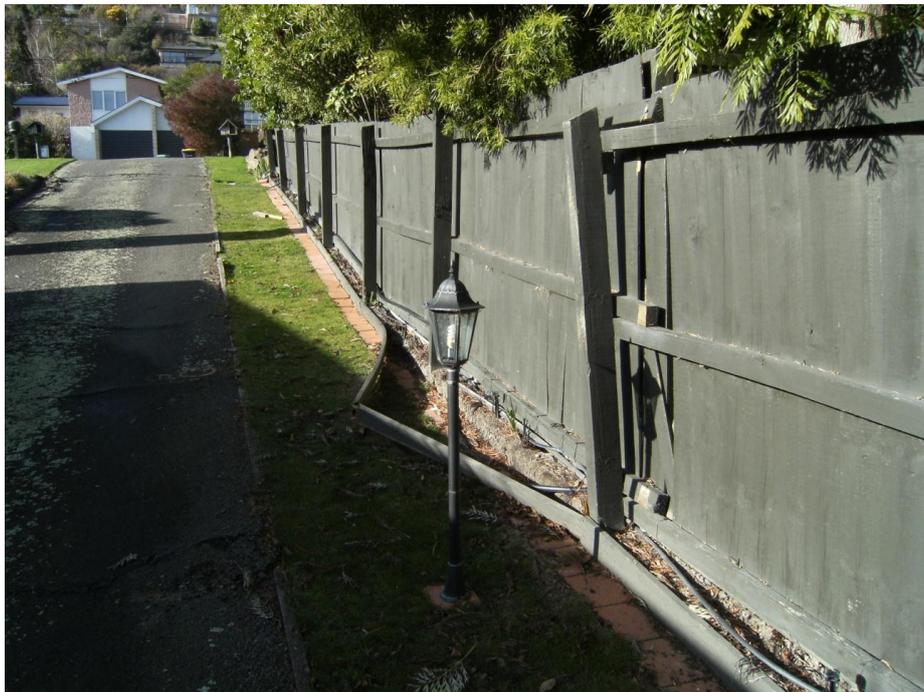
As a majority of the Port Hills is characterised by colluvial wedge like geology at the toe of slopes, this type of land deformation is widely observed, with generally decreasing displacements away from the 22nd February and 13th June earthquake epicentres. For the many dwellings that straddled the cracks in the land, stretching of foundations and structures has occurred, while dwellings above and below the cracks have sustained significantly less structural damage, most of which can be predominantly attributed to the strong seismic accelerations. Some structures in the zones of compression have experienced foundation and structural damage as a result of these compressive forces (Figure 10).

Figure 10: Compression expressed in the fence and driveway of a property on Vernon Terrace.

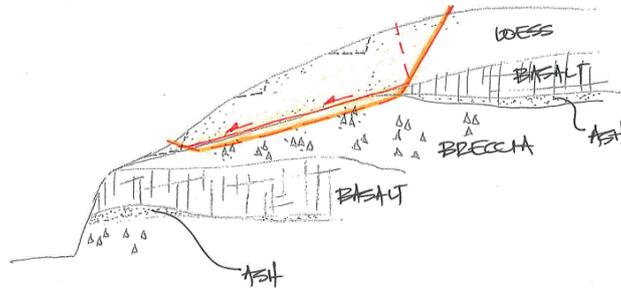
Slope displacements resulted from the high vertical and horizontal accelerations originally during the 22nd February earthquake, and again during the 13th June earthquake. There is also evidence that smaller, harder to measure displacements have occurred as a result of other significant seismic events. Failure mechanisms may be attributed to separation and shearing near the loess-rock interface, combined with some internal deformation within the loess. As this paper is prepared, it is not yet clear whether any of this deformation can be attributed to dilation within the underlying rock mass. Seismic amplification, seismic wave directionality and contrasting seismic wave velocities between the bedrock and loess may have had a significant role in initiating this mechanism. Figure 11 shows a schematic cross section

Figure 11: Schematic diagram to show a possible slope mantle deformation failure mechanism.

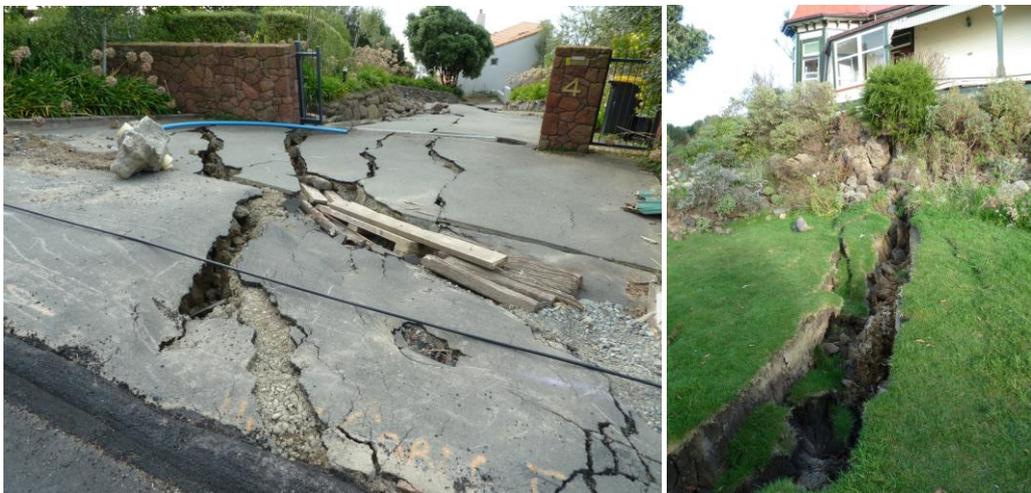
Land displacement in the slope mantle (loess and loess colluvium on mid to upper Port Hill slopes) initially occurred in the M6.2 Christchurch Earthquake of 22nd February 2011. Ground deformation is characterised by persistent tension cracks and formation of a head scarp (Figure 12) with some lateral scarp shear displacement. This damage was also characterised by a minimal visible compression zone or toe breakout of the slope displacement. As a result, dwellings straddling land cracks have been stretched, making some unsafe and/or not practicable to occupy.

Total down slope displacements accumulated across multiple seismic events typically range from 50mm to 200mm, with the exception being Kinsey Terrace which has experienced up to 1100mm of displacement (Figure 13 and Figure 14).

Figure 12: Head scarp region of a slope mantle displacement – direction of movement towards right side of page.

Figure 13: Head scarp crack tracking through a dwelling, pulling it apart.

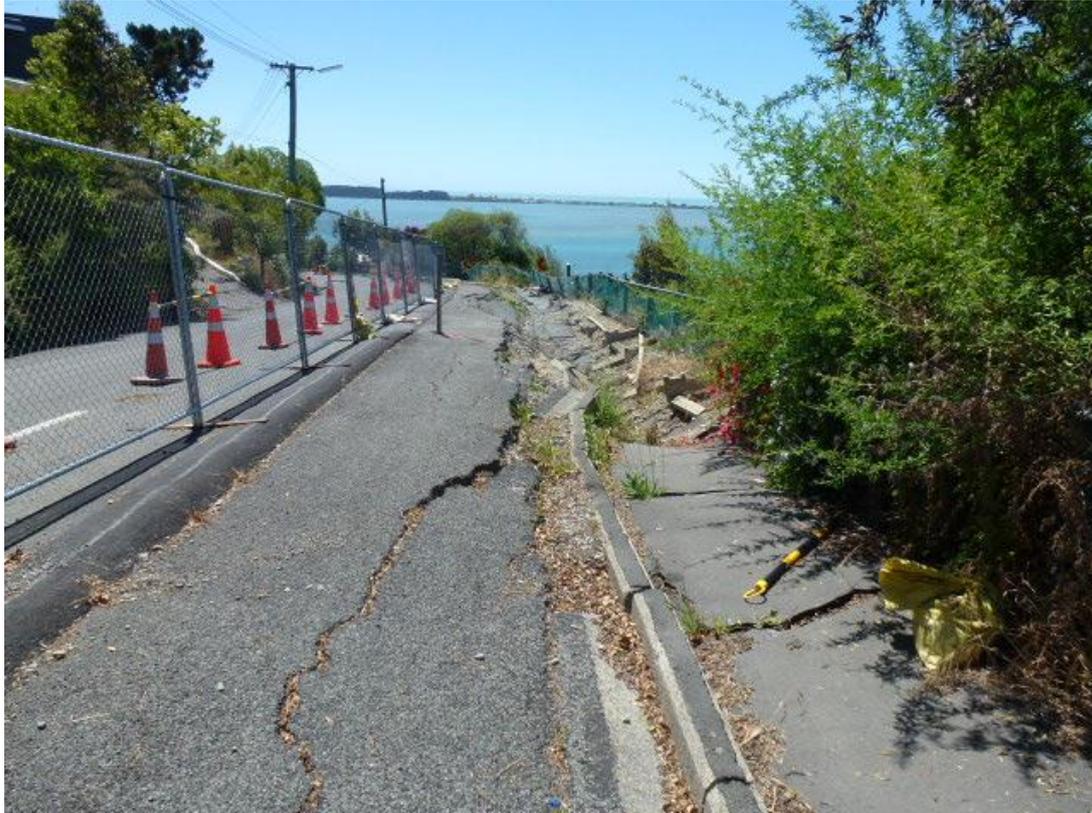
There are thousands of damaged retaining walls across the Port Hills, many of which are un-engineered rock facings that have a purpose more closely aligned to erosion protection. However, there are also many examples of yielded engineered timber pole walls, timber and concrete crib walls, concrete in-situ walls and concrete block walls that have also experienced some damage as a result of the earthquakes. In some locations, generally along road cuts, there are laterally continuous sections of retaining structures that have all experienced some deformation. As a result, retained soils have also deformed and caused cracking at the land surface across multiple properties. An example of this is shown in Figure 14, where a concrete crib retaining wall extending over a 500m length deformed and resulted in the relaxation and settlement of the retained fill, which manifested in cracks that extend for the length of the

retaining structure. As a result, the footpath and road have been compromised, with foot and road traffic being diverted.

Figure 14: Deformation behind a concrete crib retaining wall, affecting approximately 500m of footpath and roadway along Mt. Pleasant Road.
