Response and initial risk management of landslide dams caused by the 14 November 2016 Kaikoura earthquake, South Island, New Zealand

Keywords: Kaikoura, earthquake, landslide, dams, risk, management

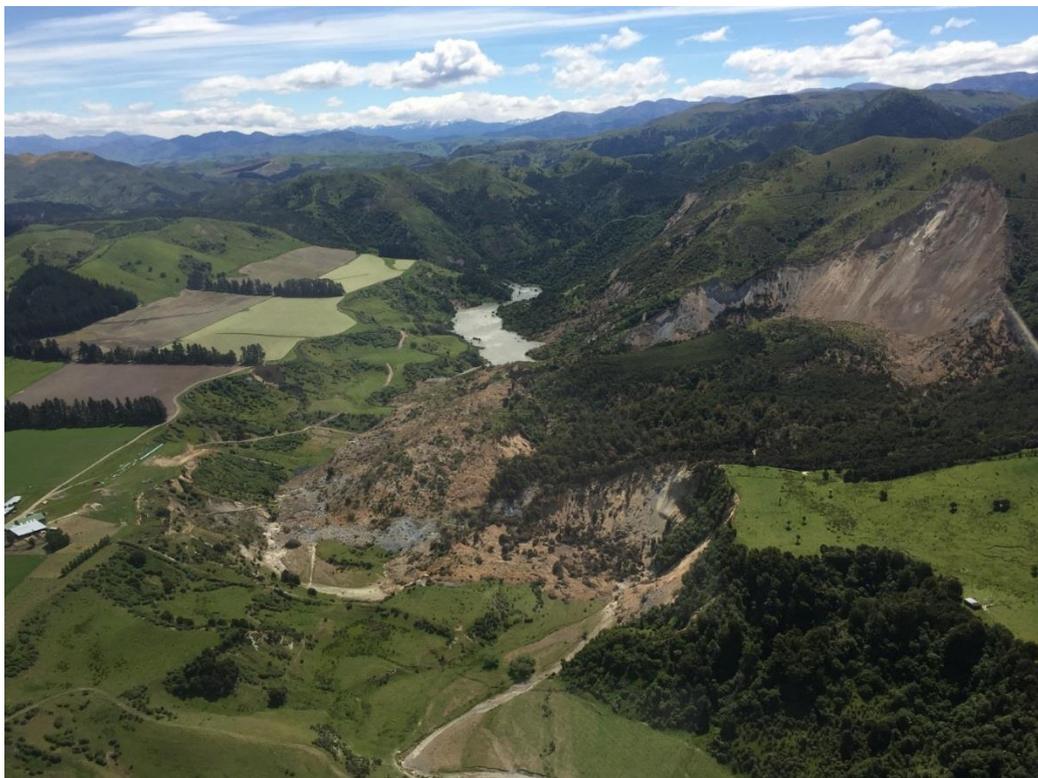
How these two very different styles of landslide dam perform over the coming months and years is of interest as it will inform landslide dam assessment after future earthquakes. As of the 12th July 2017 only one of the large, strong source rock dams remain (on the Hapuku), the others having breached during annual flood flows generated by heavy rainfall in early April 2017. The large weak rock dams on the Stanton and Leader rivers are either still intact (Stanton River) or partially intact (Leader River).

Figure 2: Landslide dam on the Leader River shortly after the earthquake. The landslide is a slump/block slide in a siltstone and is typical of the large landslides in weak Neogene rocks. The dam overtopped and partially breached in February 2017 (Photo credit: Environment Canterbury).

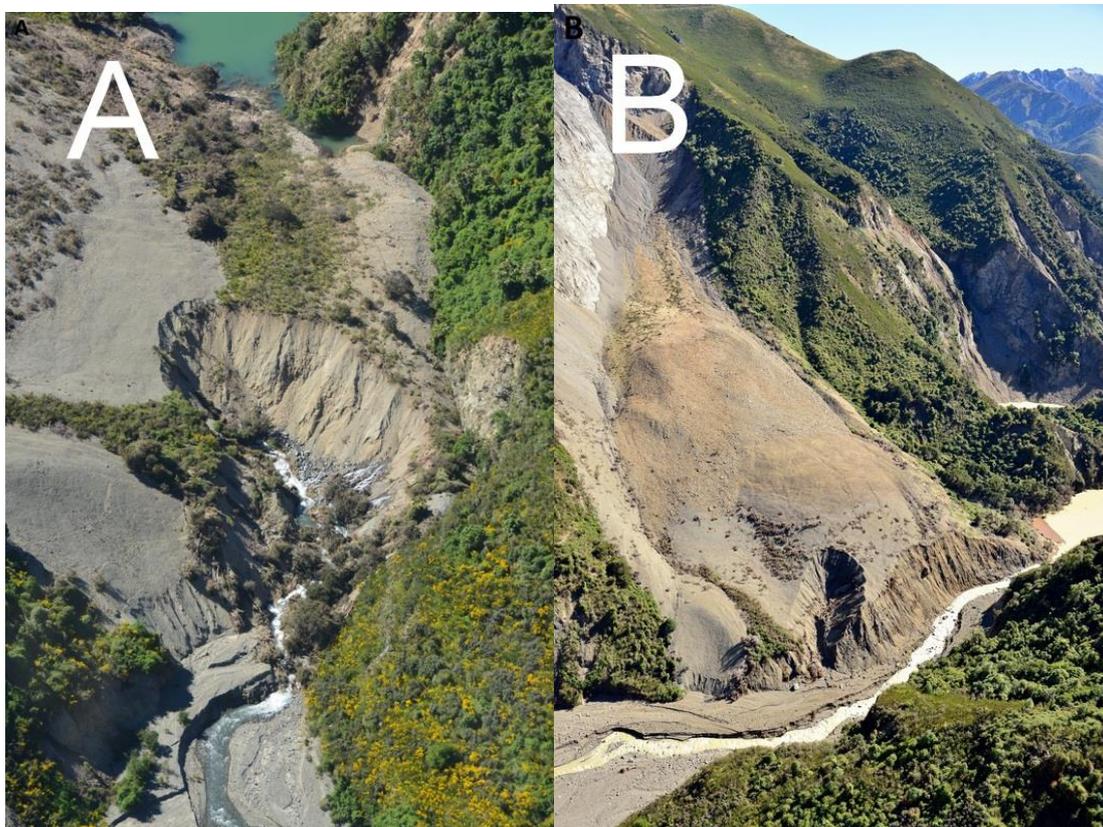
Two types of landslide dams are recognised based on the geological source material as mapped by Rattenbury et al (2006), namely: weak (5-20 MPa) Neogene sedimentary rocks (sandstones and siltstones), and moderately strong to very strong (20-100 MPa) Carboniferous to Cretaceous Torlesse 'basement' greywacke (sandstone) and argillite (mudstone) rock, but also includes some Neogene limestones. The most frequently occurring landslide types, adopting the scheme of Hungr et al. (2014), correlate to these materials, where reactivated rock planar and rotational slides tend to be the dominant landslide type in the Neogene sedimentary rocks. First time rock and debris avalanches with strong structural geological controls, were the dominant landslide type in the basement materials. This led to two quite distinct types of landslide dam. The weak rocks failed as large block slides and slumps and, compared to the strong rock dams, were relatively impervious (Figure 2). In contrast, the landslide dams formed from strong source rocks were effectively piles of porous angular gravels where piping of water flows through the dam is readily

apparent (Figure 3). The source material for these landslides is Torlesse Greywacke which typically forms disrupted rock slides because of the closely jointed and fractured nature of the source rock mass. The resulting debris can be described as an angular gravel and is highly permeable. As a result, the large greywacke-derived landslide dams developed flows through the permeable material forming the dam under normal flow conditions. On the 6 April 2017, ex-Tropical Cyclone Debbie passed over the area dumping 100-150 mm of rain in 24-hours for the first time since the earthquake. As a consequence of this rainfall several of the greywacke dams finally overtopped and breached, effectively removing the landslide barrier and potential hazard.

Figure 3: The greywacke-derived landslide dam in the upper reaches of the Conway River in the Seaward Kaikoura Ranges. This large dam developed flows through the permeable material of the dam under normal flow conditions (Photo 3A: J. Mitchell, 22/11/2016). On the 6 April 2017, 100-150 mm of rain fell in 24-hours and as a consequence this dam overtopped and breached, removing the landslide barrier and potential hazard. (Photo 3B: D. Townsend, 7/4/2017).

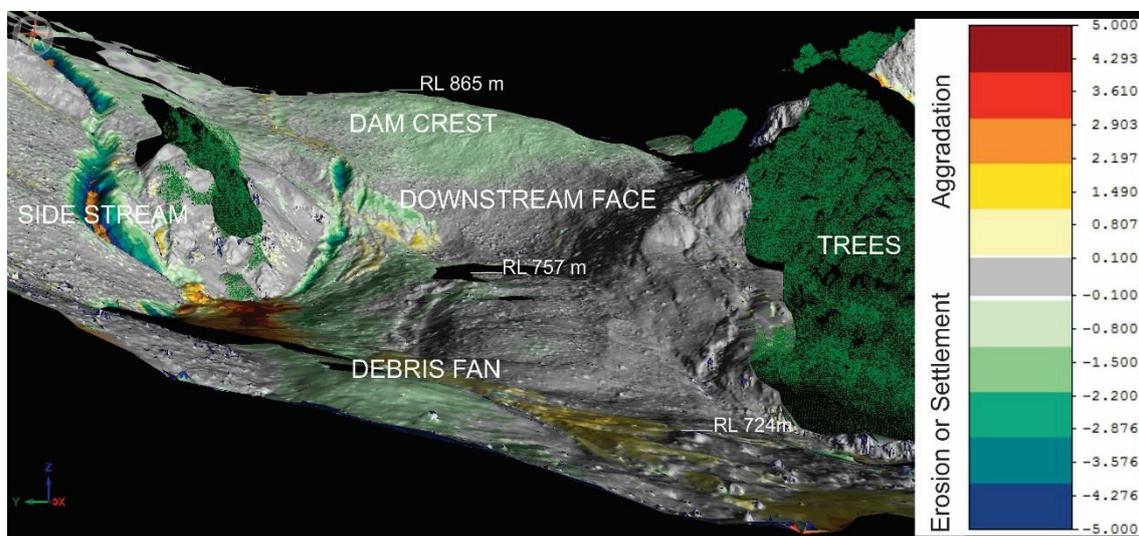
In one case, the landslide dam in the upper reaches of the Hapuku River, the terrestrial laser scanning process has been repeated three times. The change model was derived from two scans, the first taken on 15 December 2016 and the second on 28 March 2017 (Figure 4) and shows the landslide dam was slowly deforming. The crest of the dam was lowered by a nearly one metre over a period of nearly four months, and the front of the dam shows erosion and scour from piping flows with deposition downslope. Subsequent to the second scan, the dam overtopped on 6 April 2017 with the formation of an overflow channel and further erosion of the downstream face.

Figure 4: A change model of the downstream face of the Hapuku landslide dam. It shows cool colours in areas of settlement and erosion (greens and blues) and warm colours (oranges and yellows) in areas of aggradation. Dark green is woody vegetation. (Image processing carried out by Garth Archibald, GNS Science).
