## Practical aspects of construction decisions for large wind turbine foundations

Don Tate  
Riley Consultants Ltd, Auckland, New Zealand

Keywords: wind turbine, greywacke, foundation stiffness, Clegg hammer

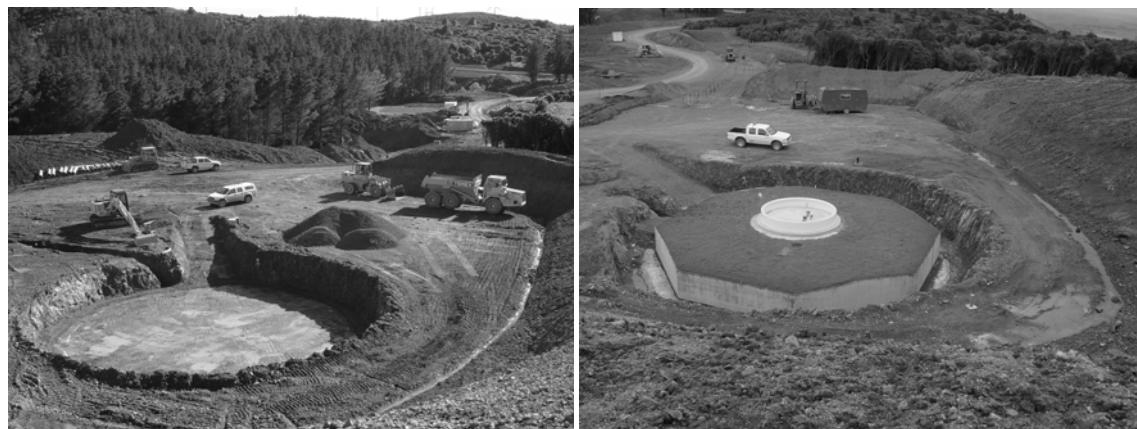
In 2007 TrustPower Ltd (TrustPower), a private power generation company commissioned the Stage 3 expansion of the Tararua wind farm. The civil works, involving construction of the access roads, hardstand platforms and turbine foundations, was undertaken through 2006 and continued through the winter. The existing wind farm, comprising the original two stages of construction has 103 turbines, each with a capacity of 0.66MW. The Stage 3 expansion included 31 new 3.0MW capacity turbines. The new machines are thus significantly larger than the first two stages, and are supported on a mass concrete foundation. The pads are octagonal in shape, 15m diameter and approximately 2m thick. Figure 1 shows the hardstand and foundation excavation stage and then the mass concrete pad at a later stage.

Figure 1: Stages of foundation construction

The general methodology at each site involved excavation to the general hardstand level. This was followed by a further 2m deep excavation for the turbine foundation. Foundation verification inspections were carried out at several stages and, where considered necessary, detailed geological mapping of defects and geological structure was carried out. The ground conditions were the responsibility of RILEY, with the structural designers inspecting the steelwork. Some of the key issues encountered are discussed in the following sections.

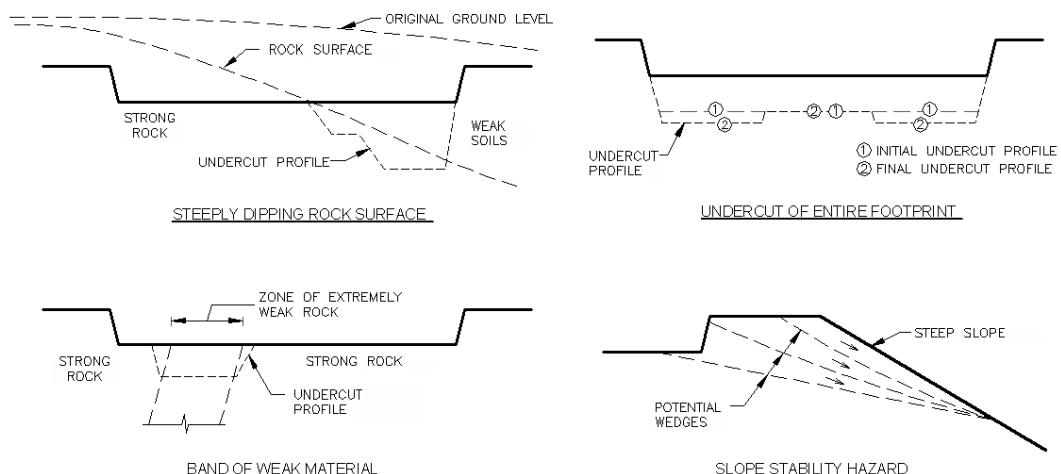
- a steeply dipping competent rock surface with unsuitable (soil strength) material above;
- marginal strength over the entire footprint; and
- weak zones in bands within a more competent rock mass (sometimes several areas).

These scenarios are shown in Figure 2. In addition to considerations of foundation stiffness and uniformity of support, a focus of geological mapping was identifying potential wedge-type ground movement mechanisms daylighting on adjacent steep slopes. Stability analyses were carried out where considered necessary to confirm acceptable margins on slope stability.

Figure 2: Foundation scenarios

Where marginal foundation materials existed the material was undercut to a more suitable level, and backfilled with an imported high quality hardfill. Due to the size of the foundation pad extensive excavation and backfilling volumes were undesirable, from both timing and cost considerations. Table 1 below shows how each of the various scenarios were addressed during construction.

Scenario	Solution
1. Steeply dipping rock surface	Material meets acceptance criteria at undercut level Acceptable
	Material does not meet criteria at undercut level Consider rafting effect of hardfill
2. Unsuitable over entire footprint or weak material in a band	Material meets acceptance criteria at undercut level Acceptable without further analysis
	Material does not meet criteria at undercut level Consider rafting effect of hardfill
