SECOND ANZ YOUNG GEOTECHNICAL PROFESSIONALS CONFERENCE

PROCEEDINGS OF THE SECOND AUSTRALIA-NEW ZEALAND YOUNG GEOTECHNICAL PROFESSIONALS CONFERENCE

DECEMBER 1995

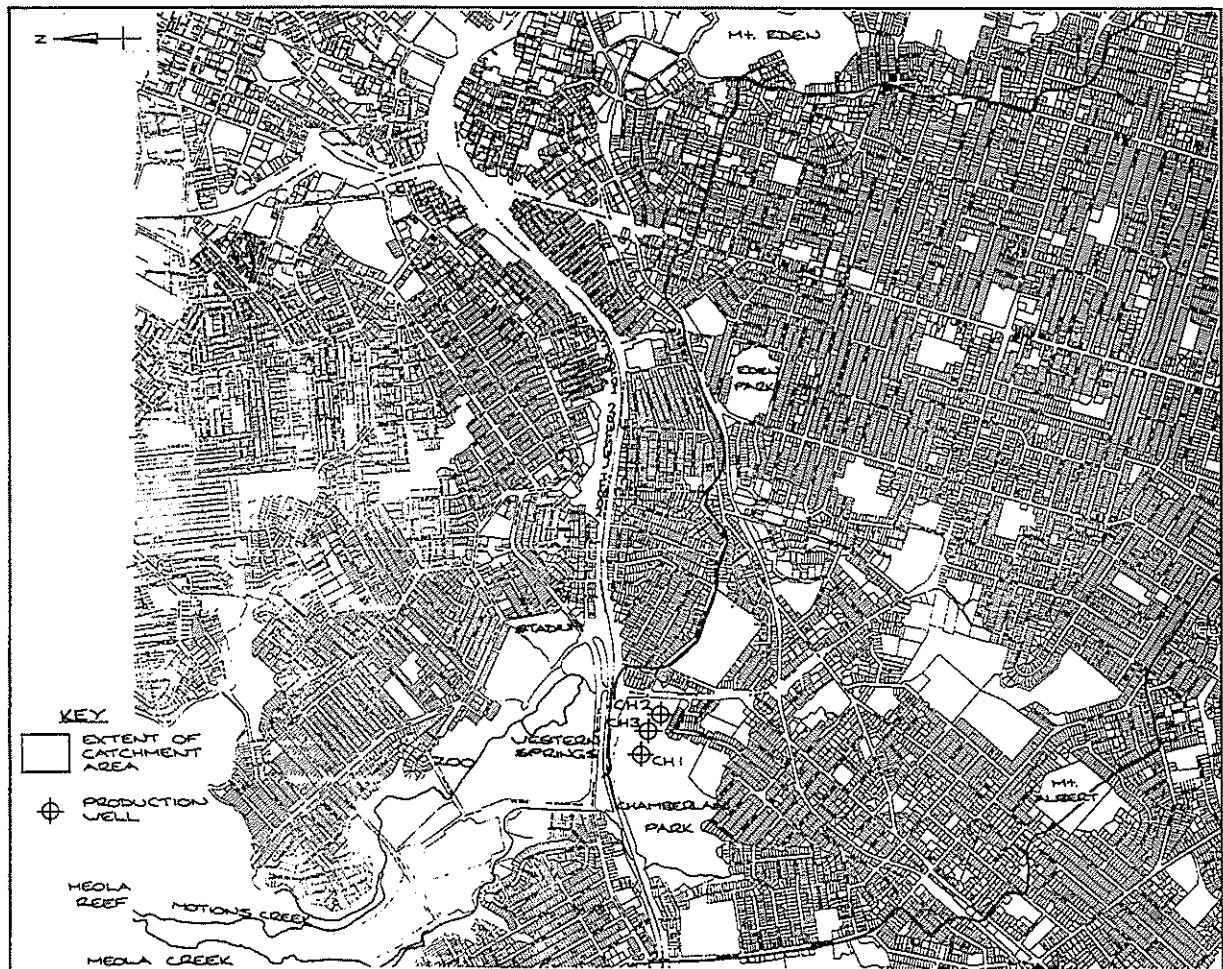
Figure 3. Plan of Western Springs scheme area.

It was determined that abstraction rates of 5000 m³/day to 7000 m³/day were feasible from both technical and environmental viewpoints. A decision was made by the ACC to apply for 5000 m³/day for municipal supply as this would allow all three schemes to use the same water purification works design as well as being a long term economically viable rate. Riley Consultants Ltd. [3] report on the proposed scheme contains details of the investigation and modelling.
