# Roading Geotechnics '98

NEW ZEALAND  
GEOTECHNICAL SOCIETY  
SYMPOSIUM

**AUCKLAND, JULY 1998**

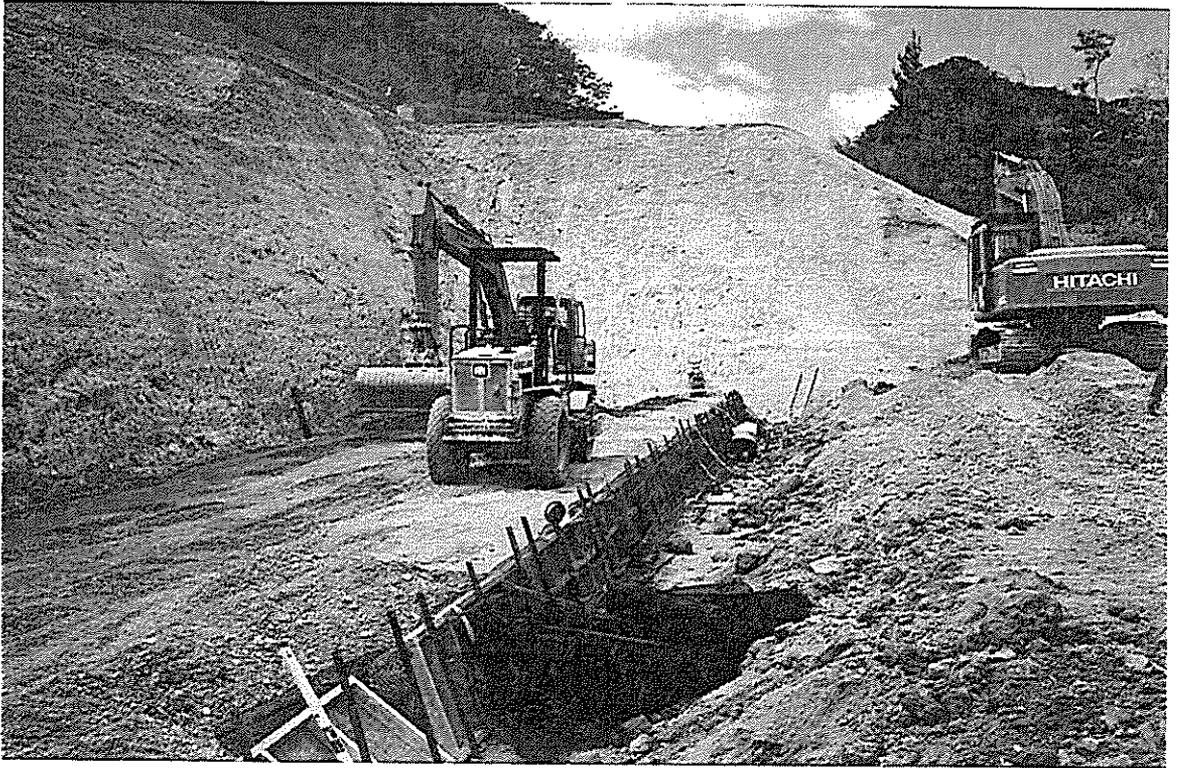
Photograph 1: Mohaka Hill, lower excavation and beginning reinforced slope
