NZ GEOMECHANICS NEWS

Newsletter of the New Zealand Geotechnical Society Inc. ISSN 0111-6851

DECEMBER 2009, ISSUE 78

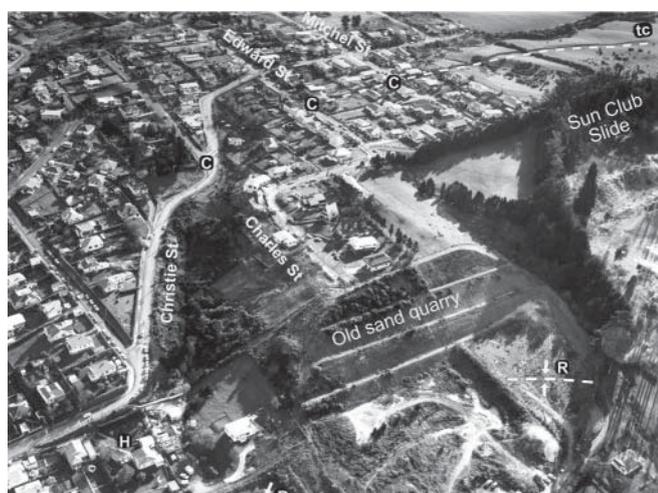
Figure 3: Aerial photo of the Abbotsford landslide area before the final movement on 8 August 1979. It shows the developing compression ridges (R) in the old sand quarry, tension cracks (tc) crossing farmland, and part of the Sun Club Slide. In the toe area, the Patterson house (H), which was later destroyed by the landslide, may have been affected by initial creep slide movement as early as 1972, or possibly 1968. Breakage of water mains caused by the developing ground cracks (C) became apparent in 1978 (Photo by courtesy of Aeropix, Dunedin).

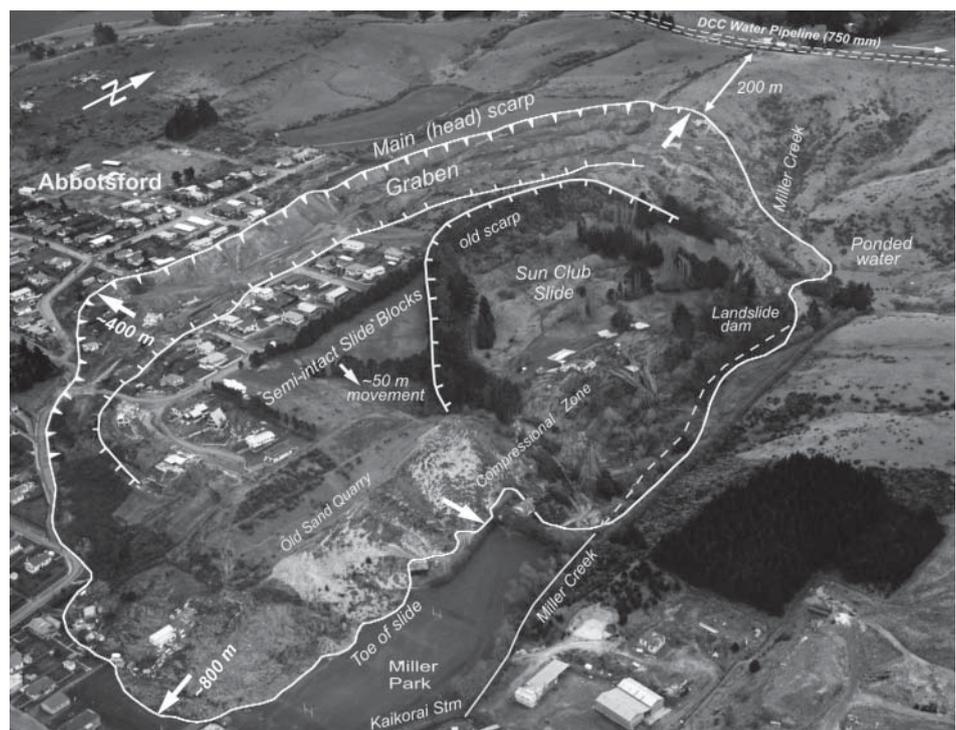
Figure 7: Aerial photo of the Abbotsford Landslide on 9 August, showing its main geomorphic features, which include: the head scarp, graben, houses on the sliding block, and the compression zone, landslide dam and ponded water at the slide toe. Other features shown that may have contributed to the failure include the old sand quarry at the toe and leaking DCC water pipeline 200 m to the north. The old Sun Club Slide on the west side of Miller Creek shows the inherent instability of the area (GNS Science Photo CT947).

The final rapid movement of the landslide lasted up to 50 minutes. A large block of land containing 28 houses slid southeast towards Miller Creek. The sliding mass left behind a large chasm (graben) up to 30 m deep, into which 15 houses collapsed and were destroyed (see Figures 7 to 10).

The main landslide mass moved 50 m downslope towards Miller Creek over ~30 minutes, forming a graben 70–150 m wide and 15–30 m deep at the slide head. Much of the sliding block remained intact. Miller Creek was temporarily blocked by landslide debris, which included remnants of the relict Sun Club Slide (Figures 9 and 10). A trench was quickly dug to drain the ponded water and prevent a dam-break flood. Because the movement was relatively slow, and people had been evacuated from areas of greatest damage (in the graben and slide toe), no lives were lost and no one was injured by the slope failure. The landslide resulted in 69 houses being either destroyed or rendered inaccessible by the graben (Figures 8 and 9). Many houses on the sliding block survived the landslide

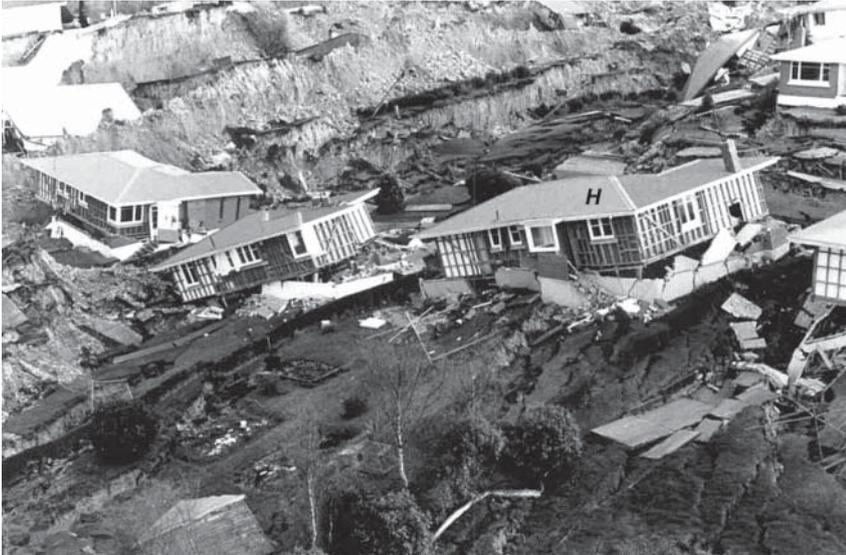
Figure 8: Photo of the landslide disaster scene on the morning of 9 August showing the chaotic ground subsidence and some of the houses destroyed in the graben when it opened. The tilted and damaged house (H) moved about 50 m southeast and down about 12 m by the collapse (photo by Don Bird, EQC).

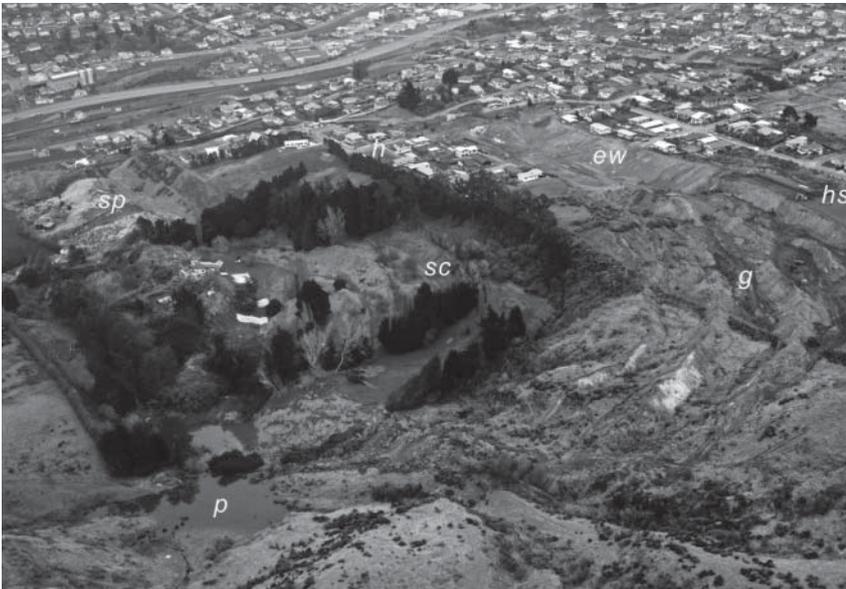
Figure 9: Aerial view of the Abbotsford Landslide looking south and showing the water ponded (p) in Miller Creek by slide debris, the graben (g) with its extensive concentric ridges and deep rents, earthworks (ew) to regrade the head scarp (hs) and protect nearby houses, the former sand pit (sp), Sun Club Slide (sc), and largely undamaged houses (h) on the slide blocks (GNS Science Photo CT948).

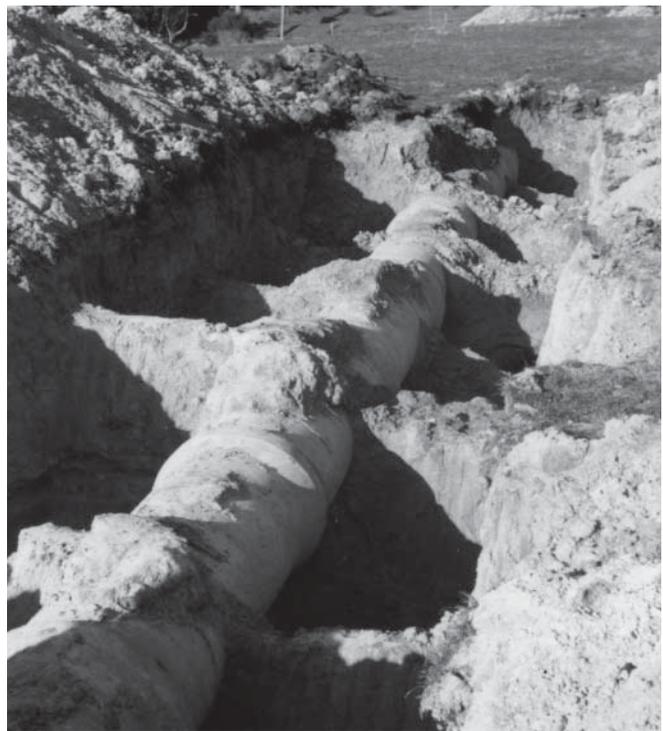
Figure 19: Dunedin City Council 750 mm water pipeline under repair (Pit W7) 200 m north of the landslide area (Fig.11) on 13 August 1979. (photo by courtesy of ER Garden and Partners).

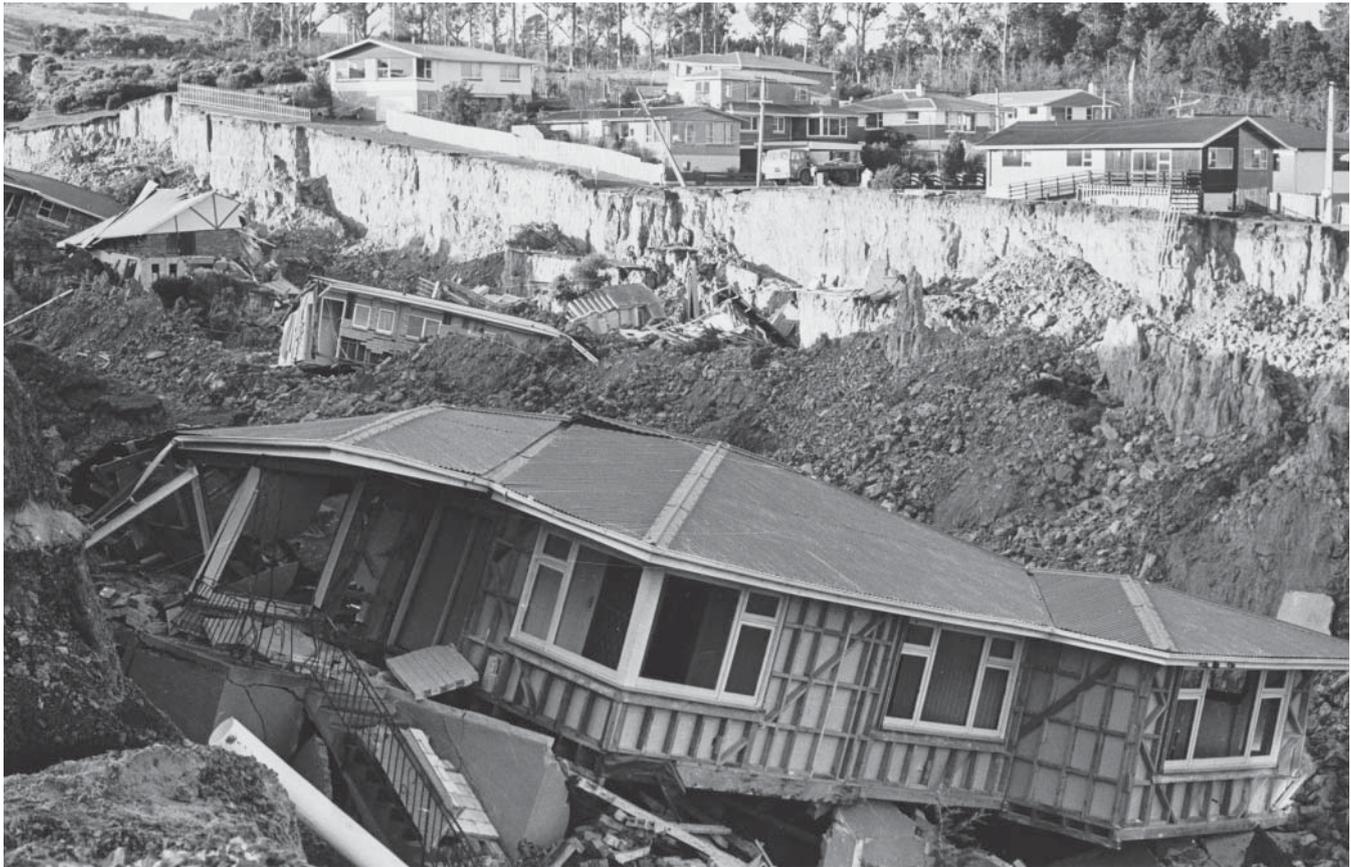
Above: Houses in the landslide graben. Photo courtesy of The Otago Daily Times

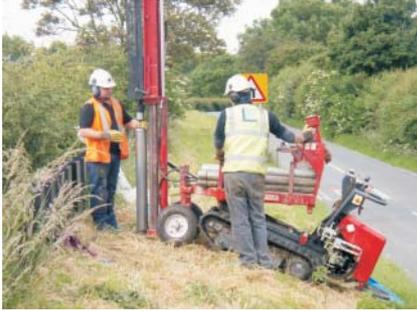
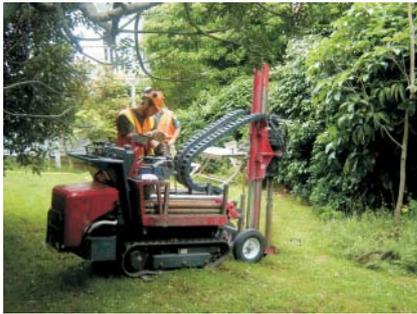
TERRIER MINI-RIG

- Compact manoeuvrable track mounted rig
- Suitable for limited access sites (rig is only 800mm wide with low mast height)
- Obtains good quality core samples to depths of 10m+
- Samples soils up to SPT N=50
- Dynamic probing capability (DPSH) to 30m depth
- Conventional SPT testing
- Excellent for environmental sampling (good sample recovery, no cross-contamination, no excess spoil)
- Great for installing piezometers/wells
- Rotary attachment for triple tube barrel coring of rock
- Down-the-hole hammer drilling for soakage testing in basalt

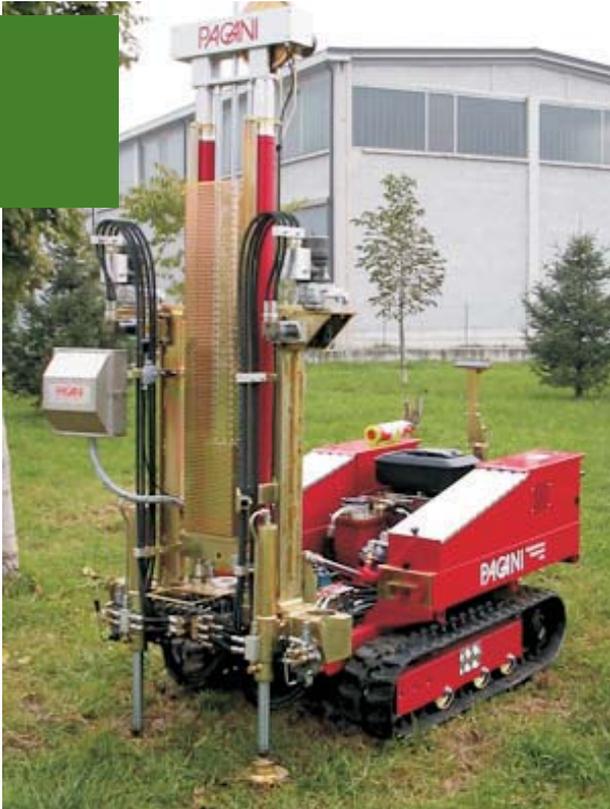
CPT AND DMT RIG

- Compact maneuverable track mounted rig
- Easily established and setup on site
- Quick automatic anchoring system
- Capable of 20 tons push (dependant on anchoring conditions)
- Electronic piezocone (CPTu)
- New seismic flat plate dilatometer (sDMT)
- Provides all the soil parameters needed for finite element analysis with high level of confidence

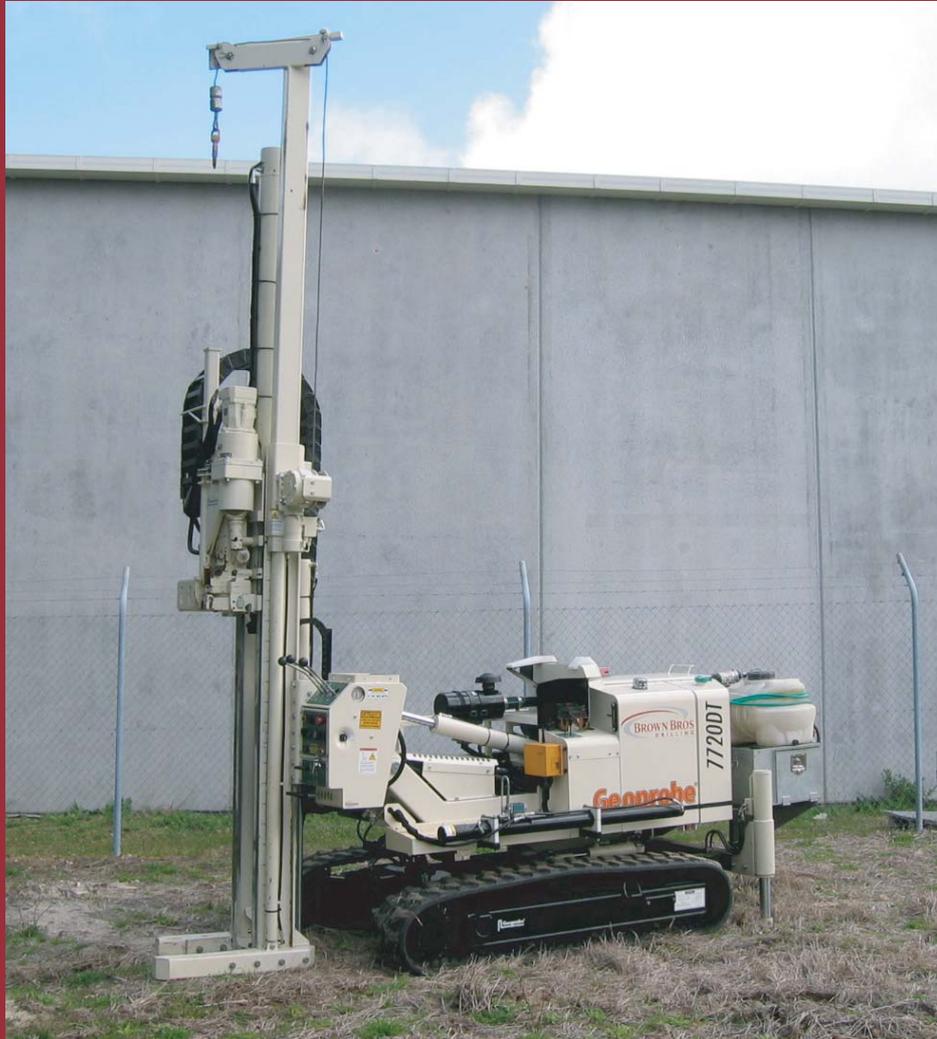
GEOPROBE MODEL 7720DT

High capacity multi purpose direct push machine, long stroke mast.

With CPT and MIP options

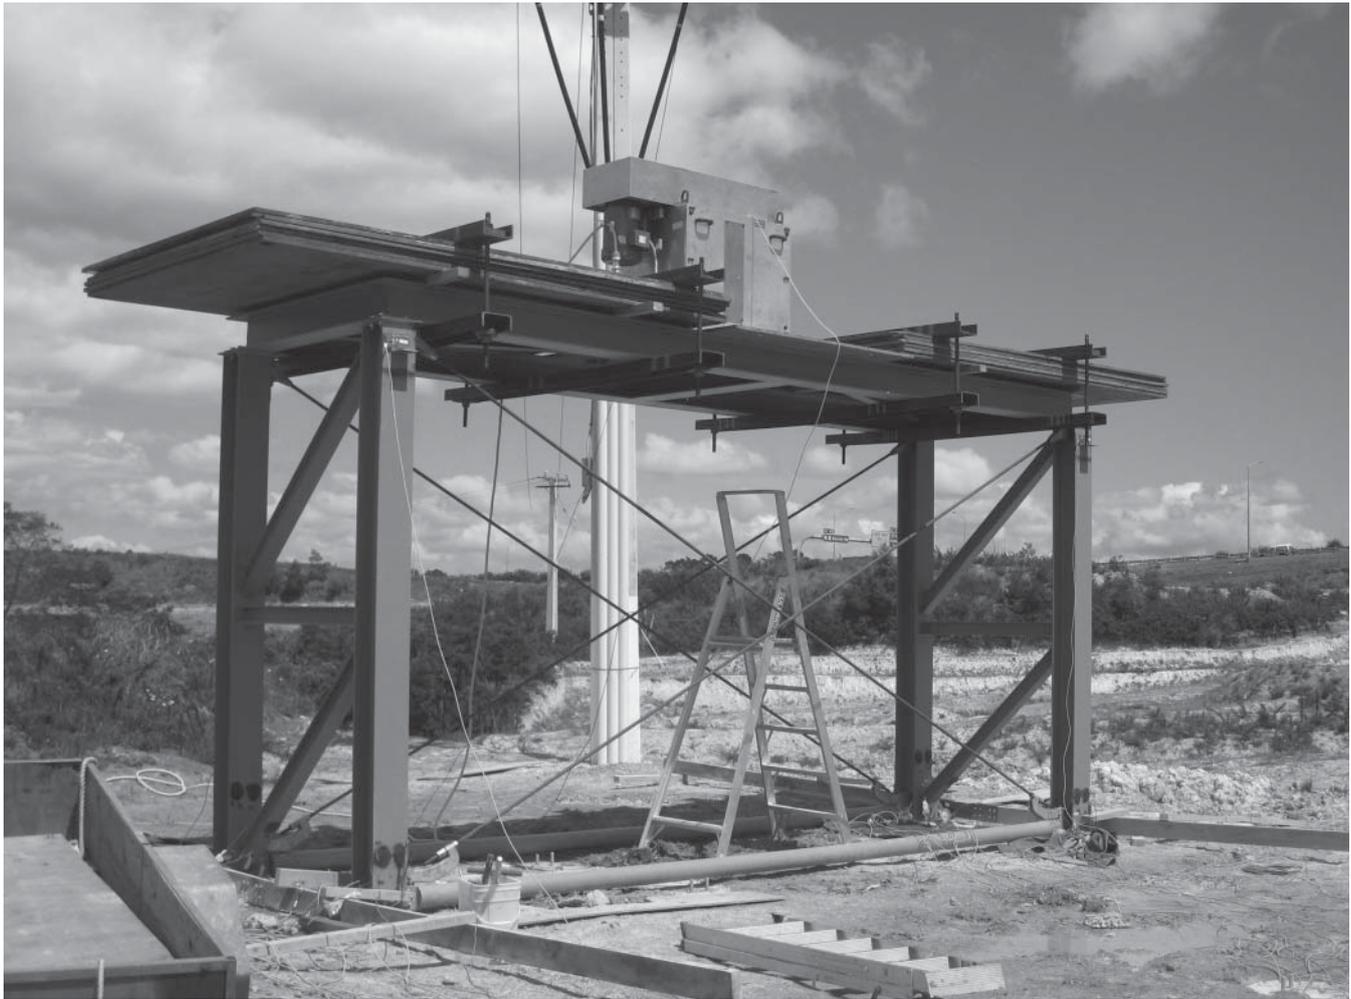
Figure 2: The test setup

All three models were compared with centrifuge experiments that were performed at the University of California, Davis. These experiments were of rocking shear walls sitting on San Francisco Bay mud (clay). All

three models showed roughly comparable results and all these values compare well with the centrifuge results. The OpenSees model produced results most comparable with the centrifuge data. However further development is still needed, as the sliding capacity of this model was insufficient.

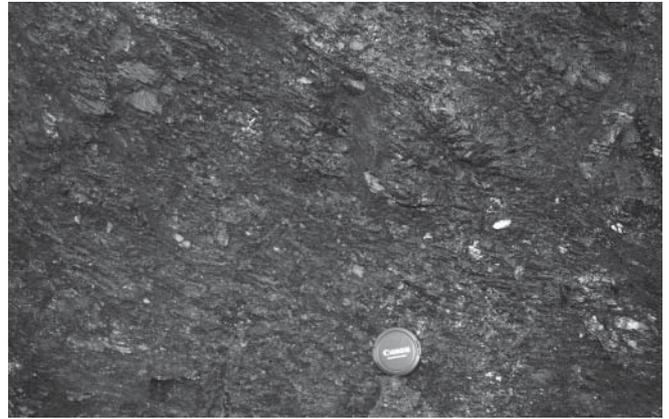
Figure 2: The weak, sheared nature of the coal seam

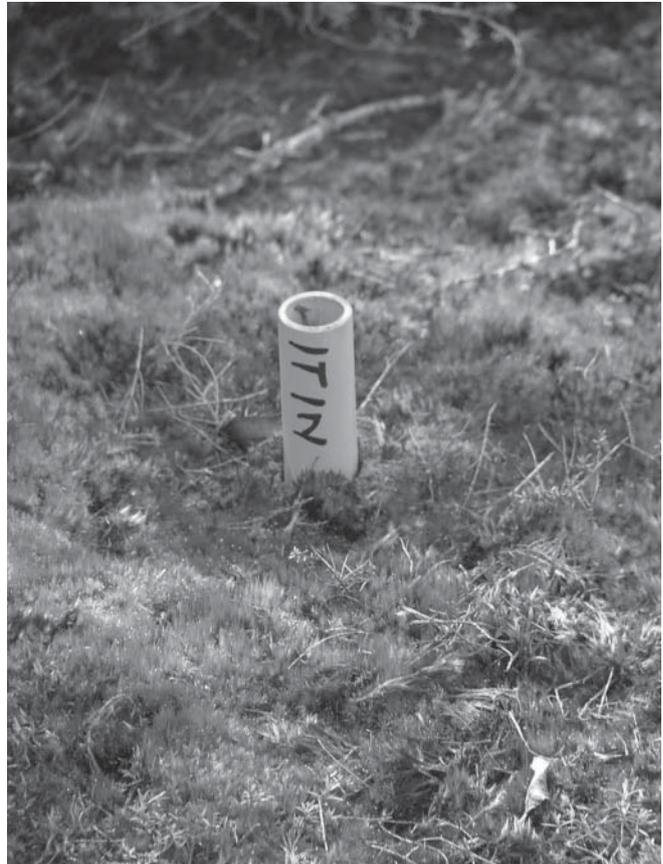
Figure 2: GeoNet in association with Central Surveys Ltd have installed a series of survey marks to monitor the stability of the ground above the Hipaua thermal area. Nineteen galvanised tubes have been placed along the scarp above the true left bank of the Waimatai stream as close to the cliff edge as possible in areas with acceptable sky visibility. These marks together with LINZ marks outside the area of interest form the Waihi landslide monitoring network.

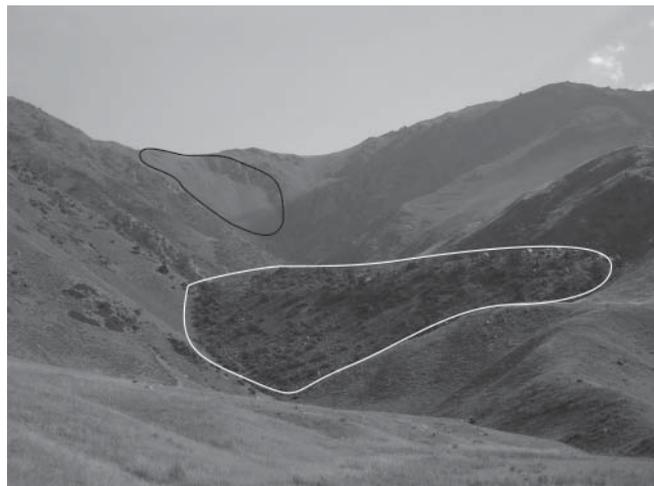
Figure 2: Seit Rock Avalanche. The majority of the deposit accumulated at the distal end, marked in white, some 2-3 km from the vacated source area marked in black. The reason for this may be that the steep source area grading into a more gentle but straight valley allowed for the entire mass to remain as a relatively 'intact' but comminuted mass.

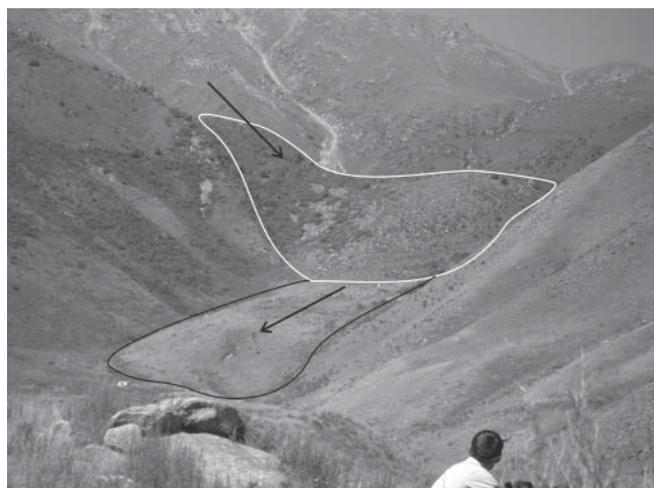
Figure 3: Northern Karakungen rock avalanche showing initial emplaced mass (white) and secondary failure deposit (black). The secondary failure occurred moments after the initial failure, with material being 'squeezed' out from the basal part of the initial mass upon its emplacement. The lack of failure scar in the initial mass gives support for a basal failure, rather than a side collapse like that seen at other landslides in the area. While the initial failure didn't develop long-runout behaviour, the secondary failure did, travelling about 2 kilometres. A likely reason in this case is the initial moving mass, travelling very steeply, was decelerated abruptly as it reached the valley floor. Arrows indicate initial and secondary movement directions.

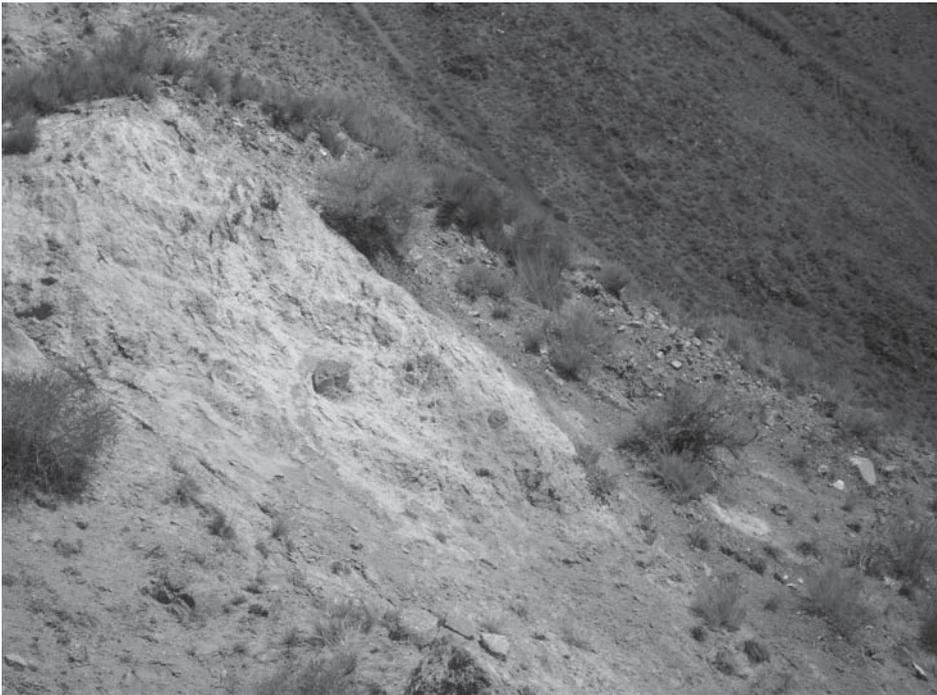
Figure 4: Kokomerren rock avalanche deposit (3-4 kilometres from source) showing perfectly preserved contact between two lithologies: pinkish granite on the left and grey metasediments on the right. Both rocks, unweathered, also retain their original structure but are completely comminuted and will break up in fingers. This part of the deposit is the remaining part of the crest of a 200 m high dam from the Kokomerren rock avalanche, which has since breached. Over 15 km of the valley upstream was inundated and the current river had to cut a new course through the valley to be in its present day position.

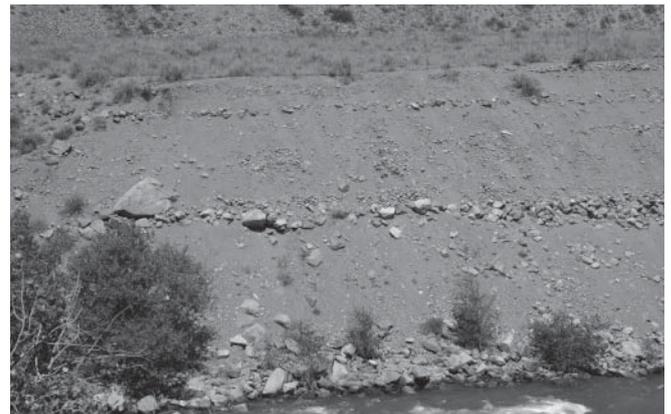
Figure 5: (below) Well sorted, stratified deposits with angular boulders 100 metres downstream from the remains of an old rock avalanche deposit. The material in this photo must have been deposited by water (dam breach) but has not travelled far since its initial deposition as a landslide. (Photograph by A. Strom.)

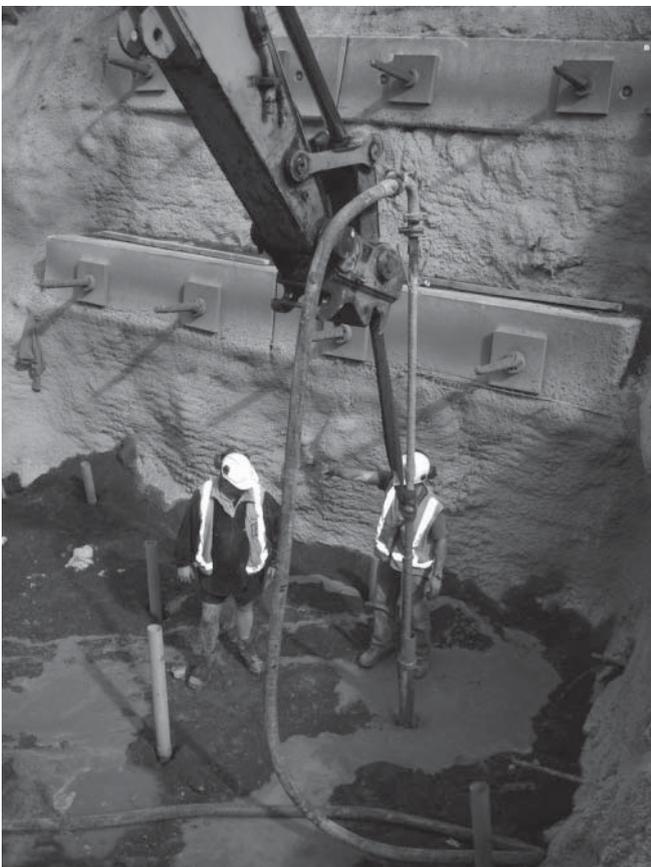
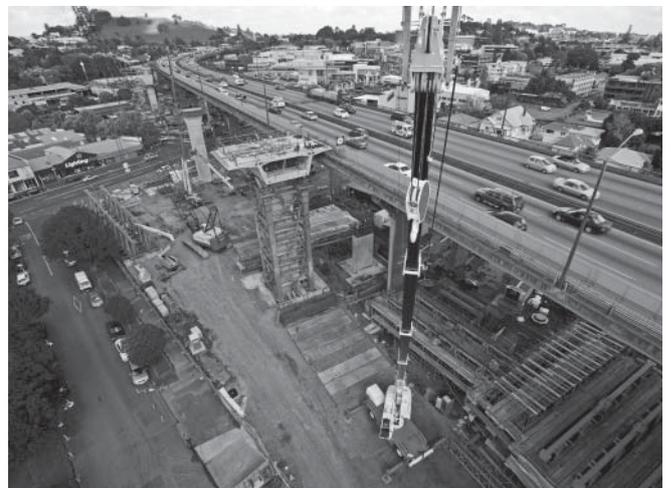
Top: Placing the first pier head

Above: Birds-eye view of first pier head and segment construction

Left: Grout consolidation of fractured basalt within an anchored deep excavation

Opposite: Lifting of the first pier head

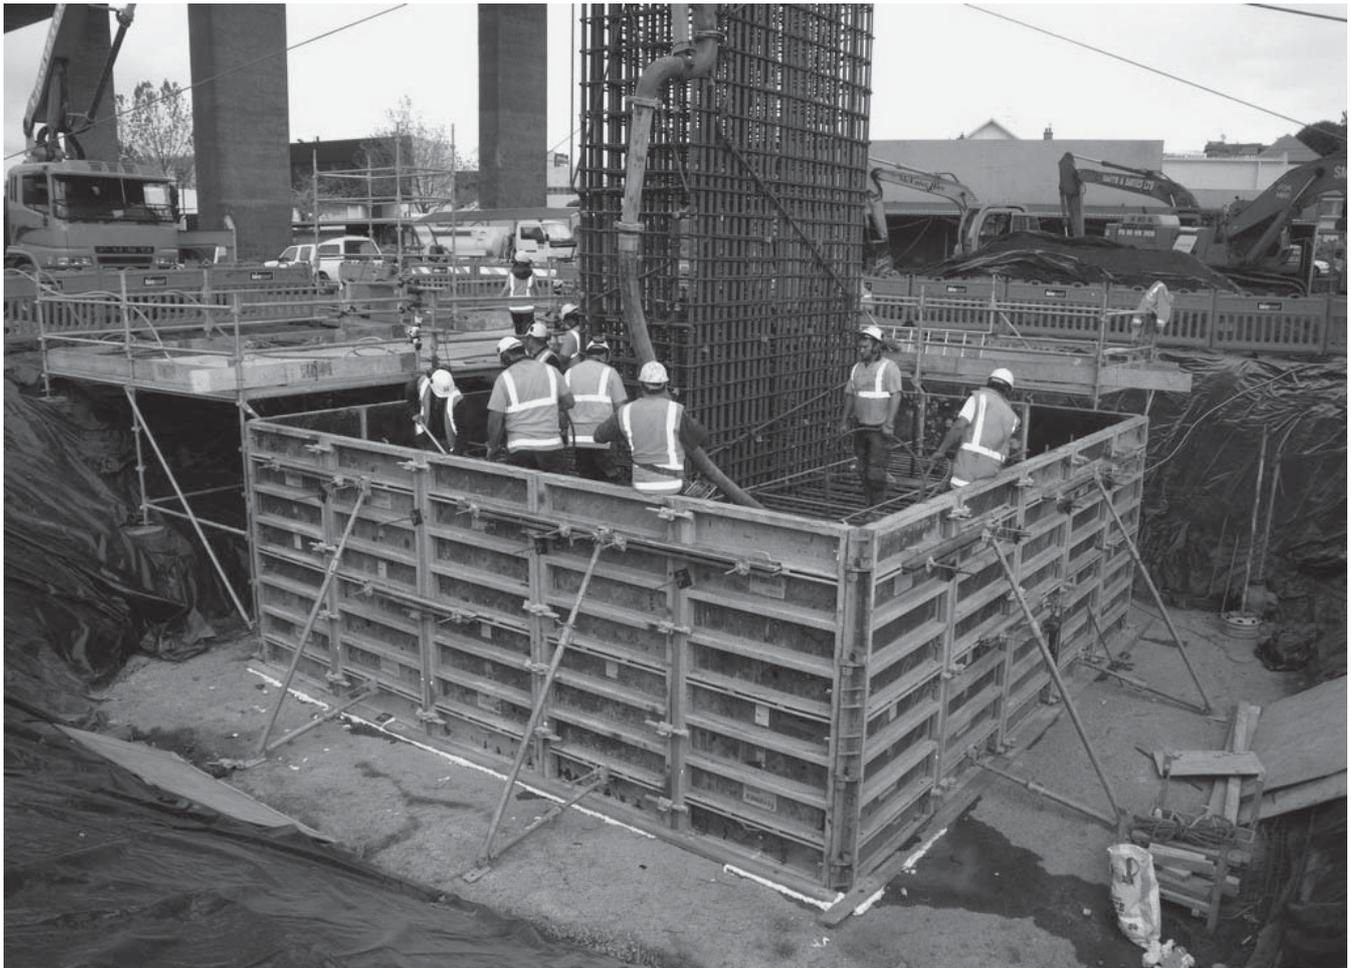
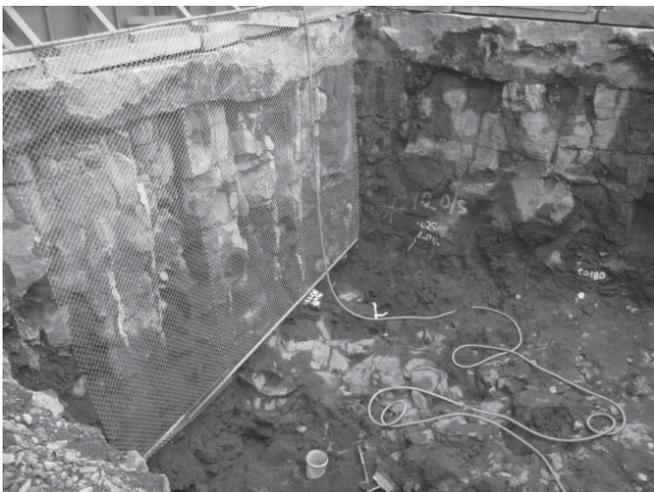
Top: Pile cap shuttering and pier stub reinforcement

Above: Deep excavation for a pad foundation within massive basalt

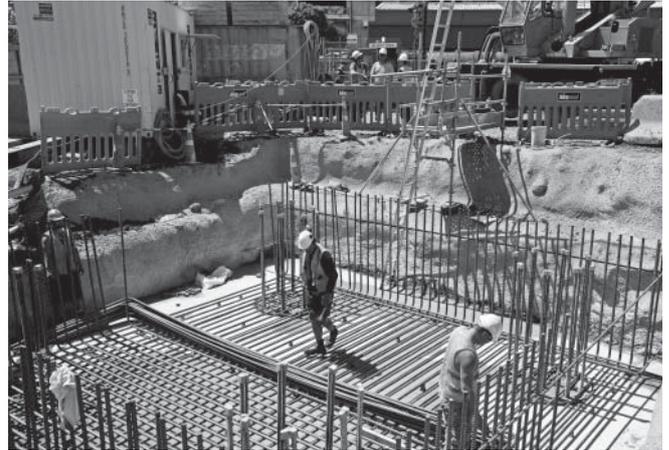
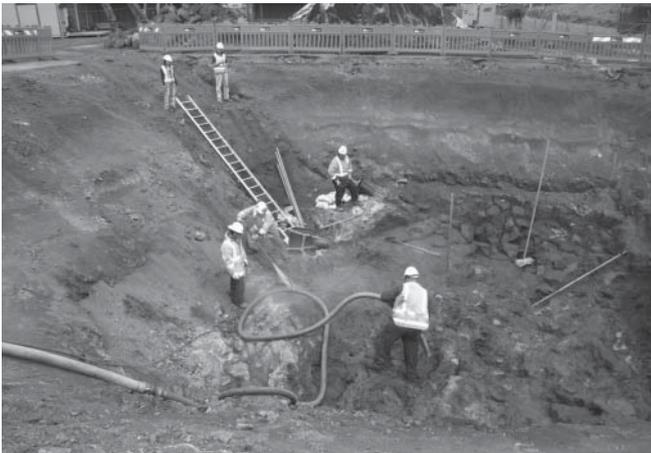
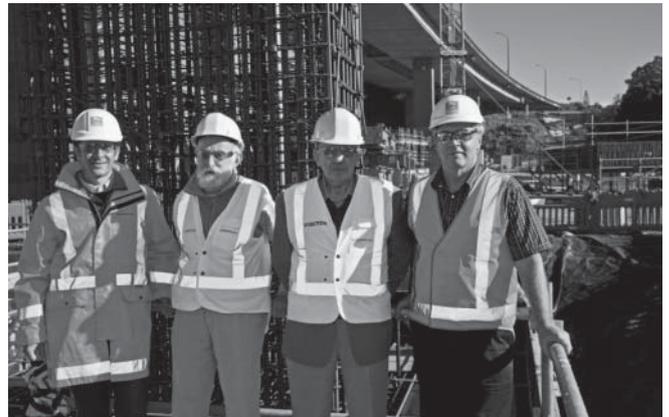
Clockwise from top left: Shallow pad, reinforcement cage (7m sq, 2m deep)

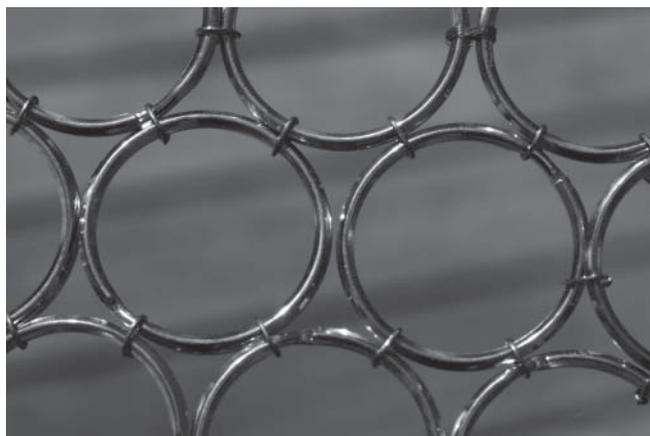
Figure 1 View of the “net” used in the physical model

The first series of experiments consisted of the blind throwing of single spheres at the centre of the net. Three unique outcomes were possible (Figure 3):

- 1) The sphere passes through the net without any physical contact (Sphere “A” in Figure 3);
- 2) The sphere clips or glances off the side of a ring and continues through (Sphere “B”);
- 3) The sphere squarely strikes the front of the net and bounces back (Sphere “C”).

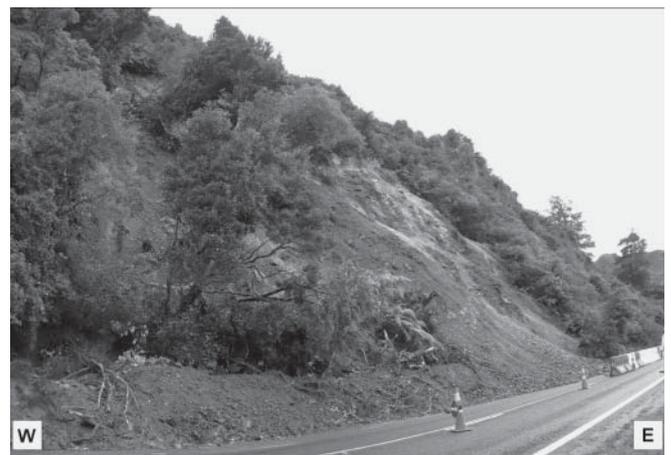
Photo 3: Tarawera Landslide before remedial works. The displaced material is covered by leaning and fallen trees. A head scarp is visible at the top of the slope.

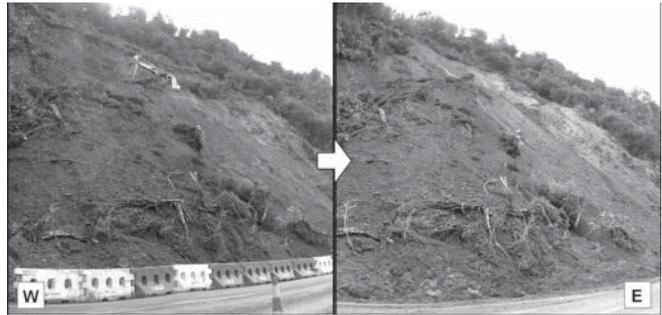
Photo 4: Before and after the secondary slope failure in the pumice material that carried the excavator across SH5.

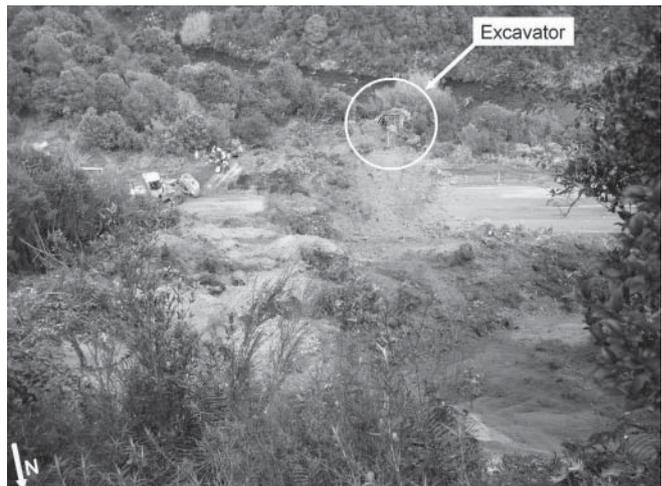
Photo 5: View from the top of the slope just after the slope failure. The earth flow struck a moving car and carried the digger in the Waipunga River.

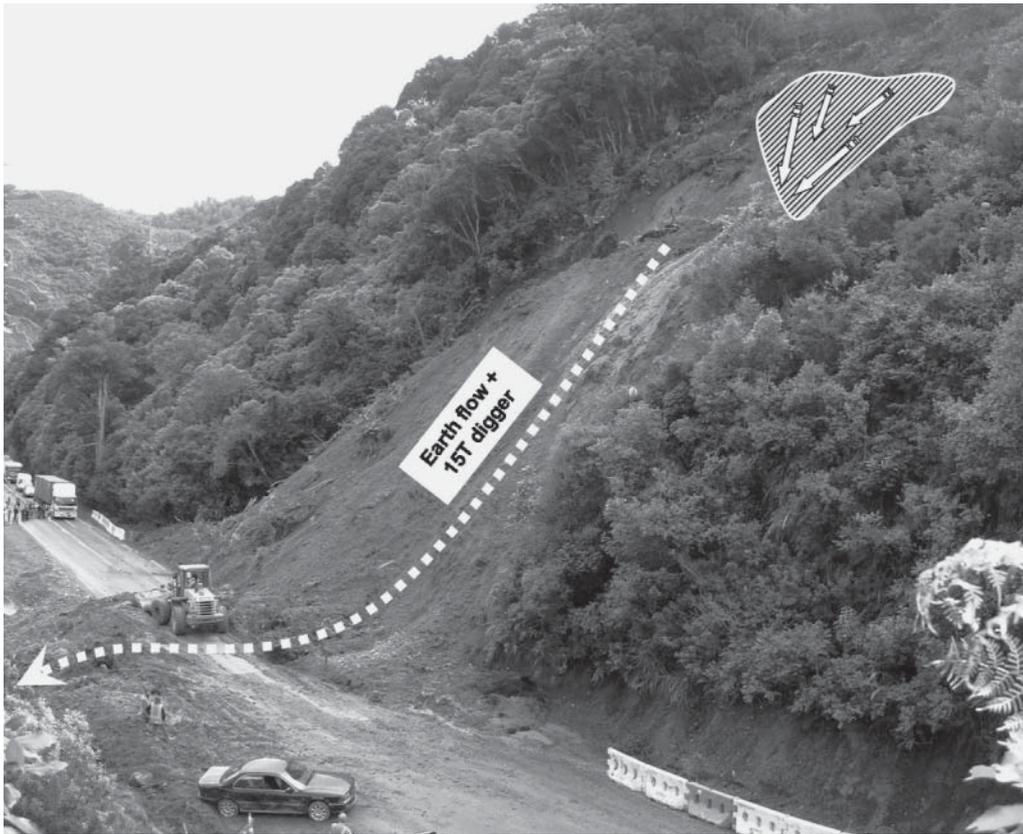
The displaced material then liquefied causing a powerful earth flow that carried the 15-tonne excavator 40m below its original location (see Photo 7).

- The contact of two different materials of different permeabilities: the almost impermeable greywacke rock mass and the permeable alluvial pumice sand,
- The zone of contact that crossed the initial landslide diagonally from the top to the lower section of the slope,
- Heavy rainfall that triggered the movement by developing elevated pore water pressure in the permeable pumice in contact with the rock mass,
- The intrinsic characteristics of the pumice material allowing it to retain a significant volume of water, highly crushable and prone to liquefaction.

The latter characteristic was responsible for the rather powerful earth flow that endangered the site workers and the road users.

Photo 7: Direction of the earth flow that carried the excavator down to the river and struck the car in the foreground.

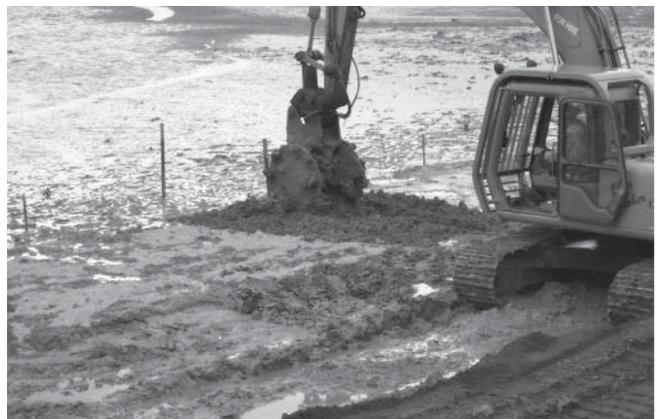
Figure 3: Mudcrete mixing equipment.

Mudcrete was produced by mixing sediments and cement within small on-site mixing basins and insitu within the shear key trench excavation, creating 30 to 50m³ per batch. The methodology adopted for mixing required little additional plant and resources, utilising hydraulic excavators to mix the product. The mixing basins were located in close proximity to the current work faces to improve efficiency and minimise haulage.

The sediments were placed within the mixing basin or excavated key trench with the volume accurately recorded. Prior to mixing, sediments were checked for consistency and large clumps of clay were premixed or removed. The cement quantity was calculated and spread over the surface of the sediments. The cement was tilled in with a hydraulic mixing head attached to an excavator; the mixing head is shown in Figure 3. Each batch was mixed until a uniform visual consistency was achieved. Mudcrete batched in mixing basins was transported to the placing excavator and placed at low tide within an hour of batching. The cohesive nature of Mudcrete prevented it from being washed away as the tide rose. The surface of the Mudcrete was shaped using the back of the excavator bucket as a trowel. In order to achieve an adequate bond between subsequent layers, the hardened surface of the Mudcrete was roughened with a toothed excavator bucket prior to application of the next layer.

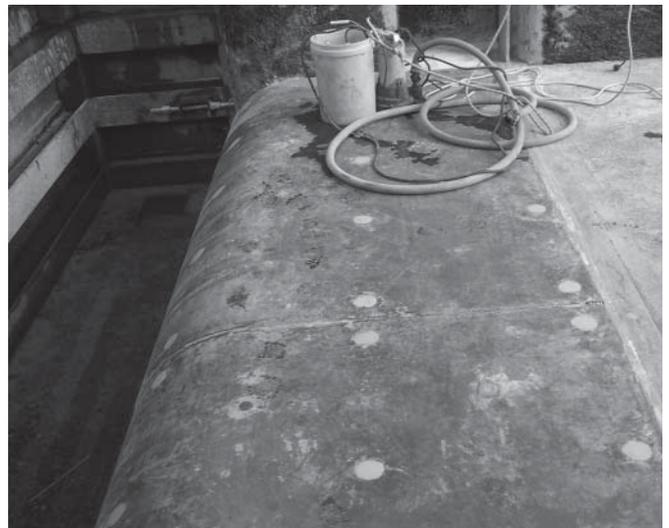
At the Poutu Intake the concrete sills had taken a beating from gravel coming down the river. We won a contract to fix curved steel plates over the four separate sills and grout the gap between the damaged concrete and the plates; all while the Tongariro River roared about us. Once again, due to the dedication of our workers, we finished early.

Above: Completed steel sill at Poutu

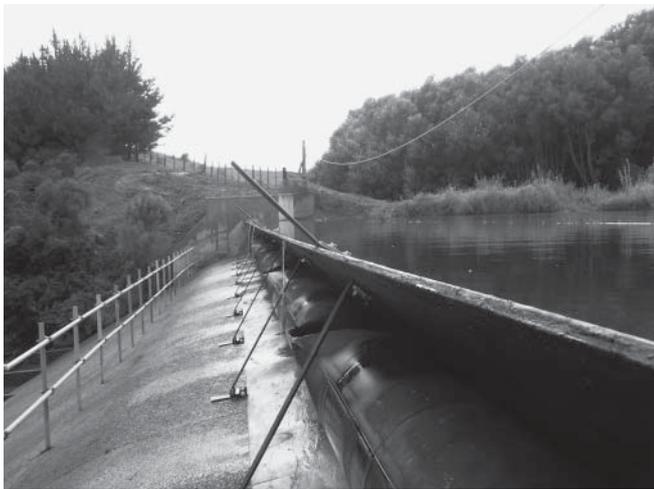
Last year we strengthened the abutments and installed some pneumatic gates across the spillway of the Mokauiti Dam for King Country Energy. This was an interesting project requiring some quite fine tolerance work. The steel gates are designed to be able to be raised and lowered by changing the air pressure in the large rubber bladders

supporting them. They are also designed to flex to enable debris to pass over the spillway. This project has significantly increased the storage capacity of the dam.

Above: The almost completed Mokauiti Spillway Gates

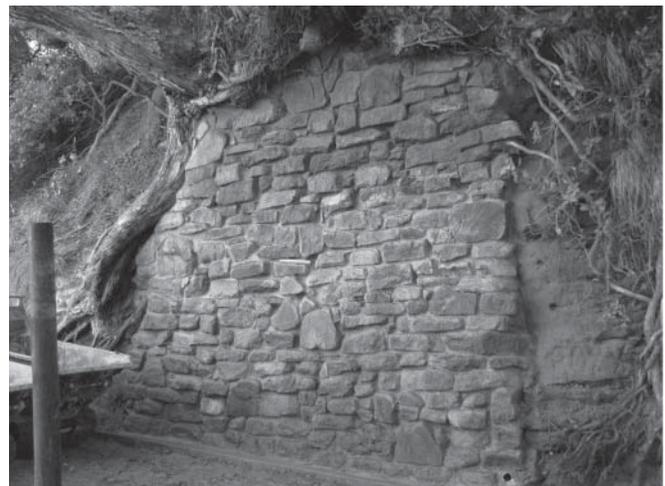
We have recently developed masonry skills, as at Mauao we were required to build a wall under a large pohutukawa to prevent it from being undermined (mainly by children). We built a stone faced reinforced concrete retaining wall fixed to the face with grouted rock anchors and backfilled with drainage sand. The stone used was sourced from a quarry in the same type of rock as at Mauao.

Above: Mauao stone faced wall
