# NZ GEOMECHANICS **NEWS**

Bulletin of the New Zealand Geotechnical Society Inc.

**BLUFF ROAD COROMANDEL:**

**MARLBOROUGH DAM**

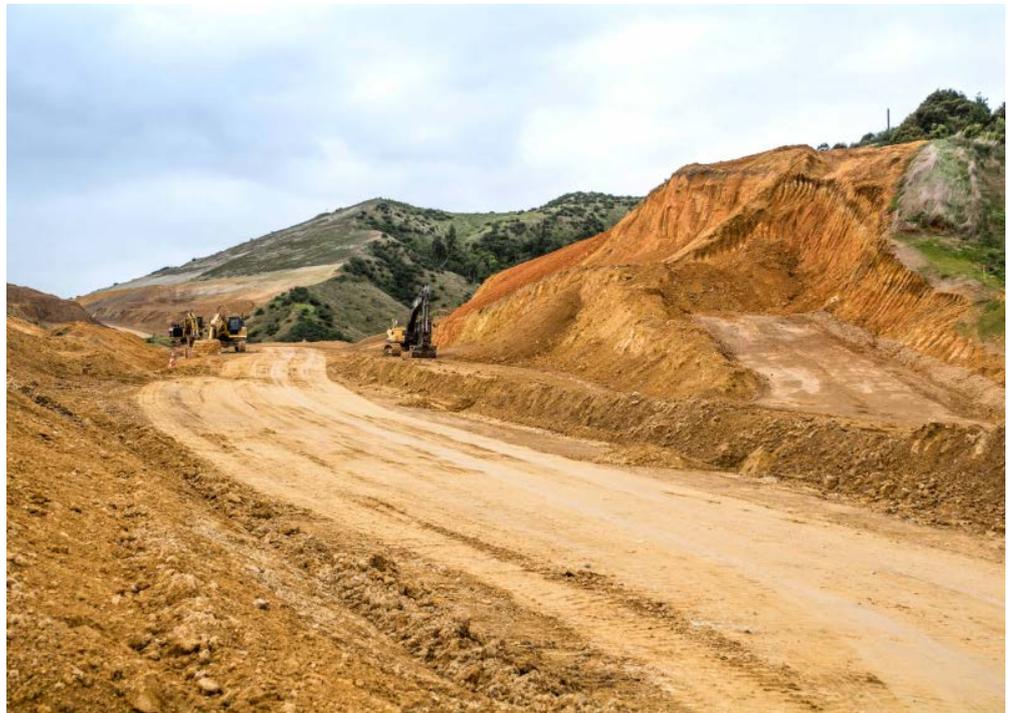
**Above:** Looking north towards the 57m deep Summit Cut in the distance.

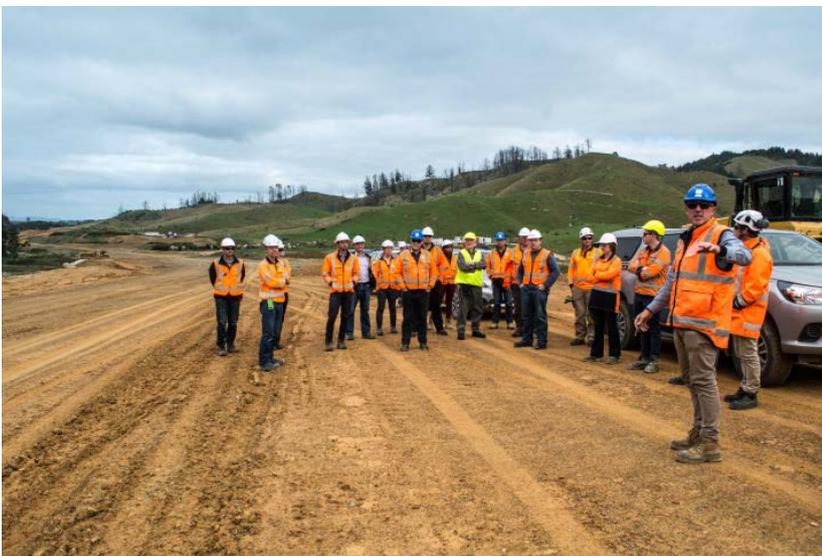
**Above:** Tony Adams describing the structural fill process.

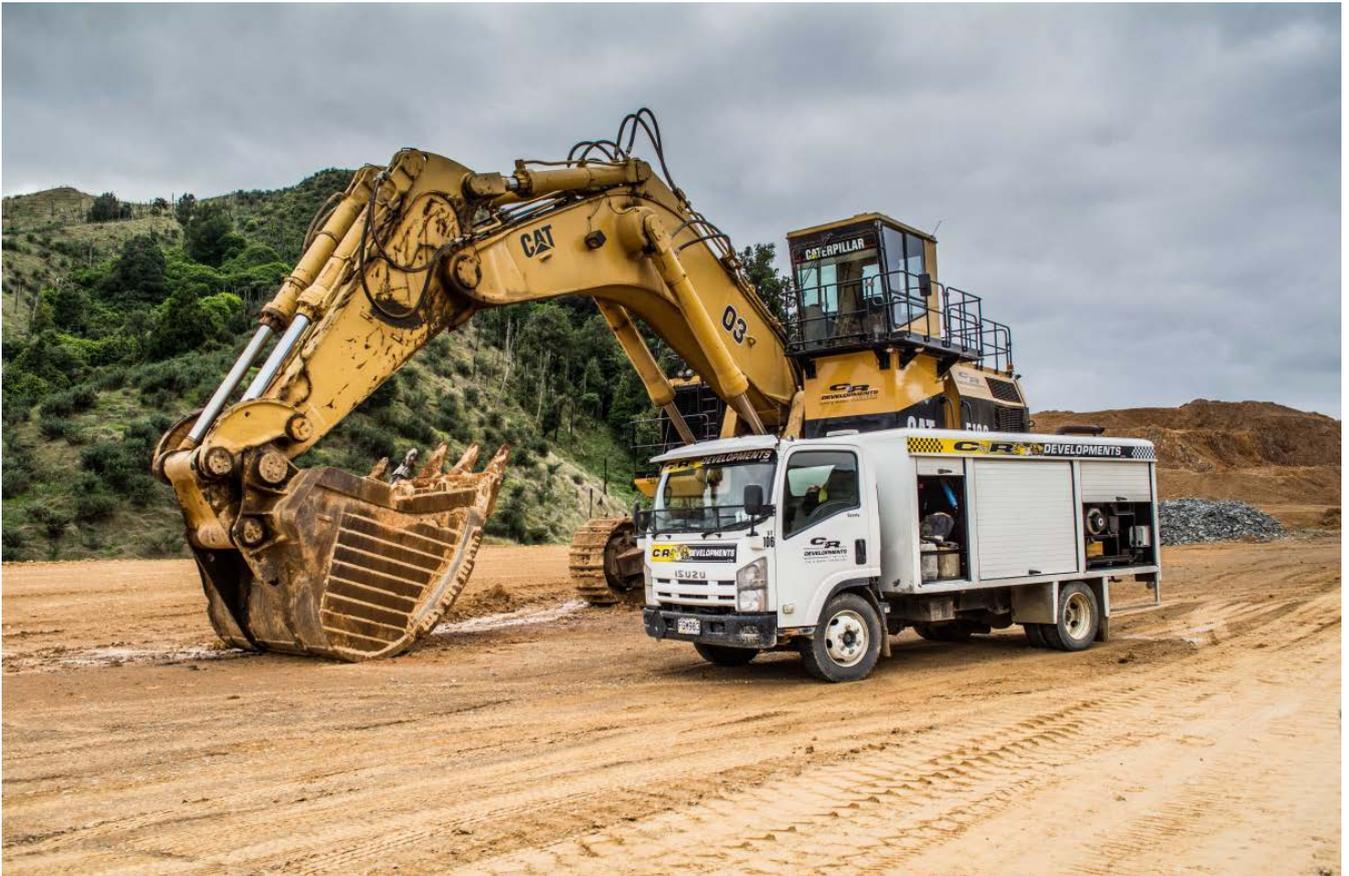
**Above:** The largest hydraulic excavator in New Zealand.

- 450,000 linear metres of wick drain installed in historic mine waste materials with 2m of settlement occurring under surcharge loading (to date)
- Four bridges utilising friction and end bearing piles up to 45m deep
- Timber piles were used under bridge abutments (four bridges) for stability under seismic / lateral spread conditions
- Cut to waste volumes of 900,000m<sup>3</sup>

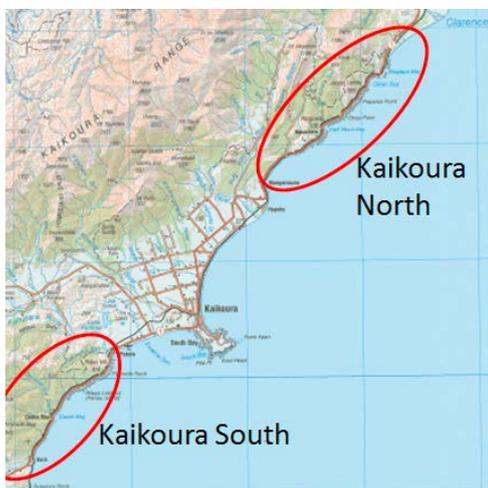
**Figure 1:** Location of coastal areas affected by landslides and slope failures burying SH1, Ohau Point

The M7.8 Kaikoura earthquake of 14 November 2016 generated very large peak ground accelerations (PGA's) that resulted in the closure of the coastal sections of both State Highway 1 and the Main North Railway Line due to slope failures originating from above the road and rail corridor at more than 50 locations north and south of Kaikoura (Figure 1).

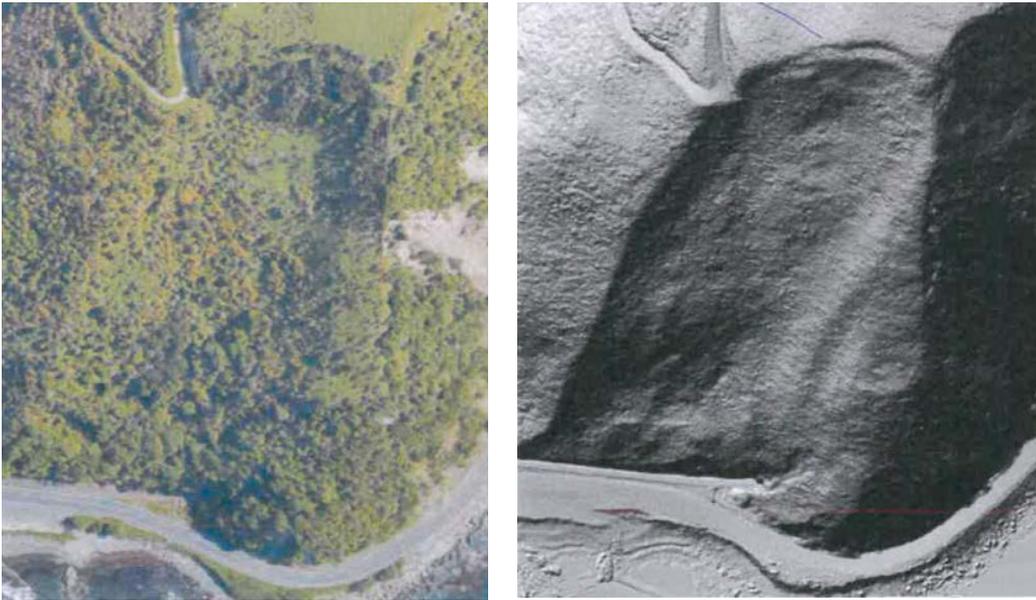
**Figure 2:** Site SR30A is an old landslide at Tunnel 8 portal (Kaikoura South) that did not react to the earthquake. The hillshade model shows geomorphic detail and clear indications of on-going creep movement.

DEM's based on LiDAR data identified that most of the large failures occurred in accumulations of debris from large old (ancient) paleo-landslides and/or thick accumulations of landslide-derived colluvium, or as failures of parts of the adjacent ridges (eg. Figure 3). Some of the paleo-landslide features (or parts of them) have been highlighted by tension cracks that developed along their margins as a result of the Kaikoura Earthquake; others show little sign of response to the earthquake (eg. see Figure 2).

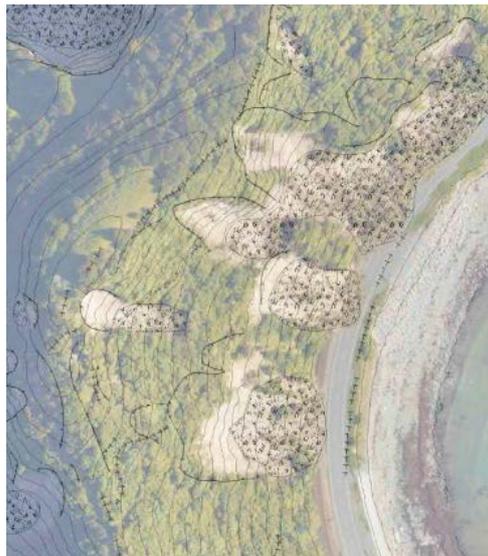
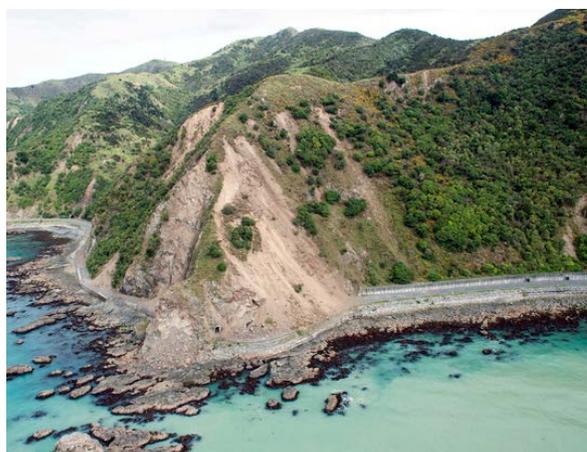
**Figure 3:** Slip area P3, Okiwi Bay (top) has secondary features that did not reach the highway. Site SR14 at (above) is an example of localised failure of an old landslide

Field mapping following the earthquake revealed extensive ground cracking, tension cracks and scarps within, around and in some cases well beyond these features (for example, see Figure 3). The mapping also highlighted that despite extensive damage, only a small proportion (~5% by area) of the slopes had actually failed.

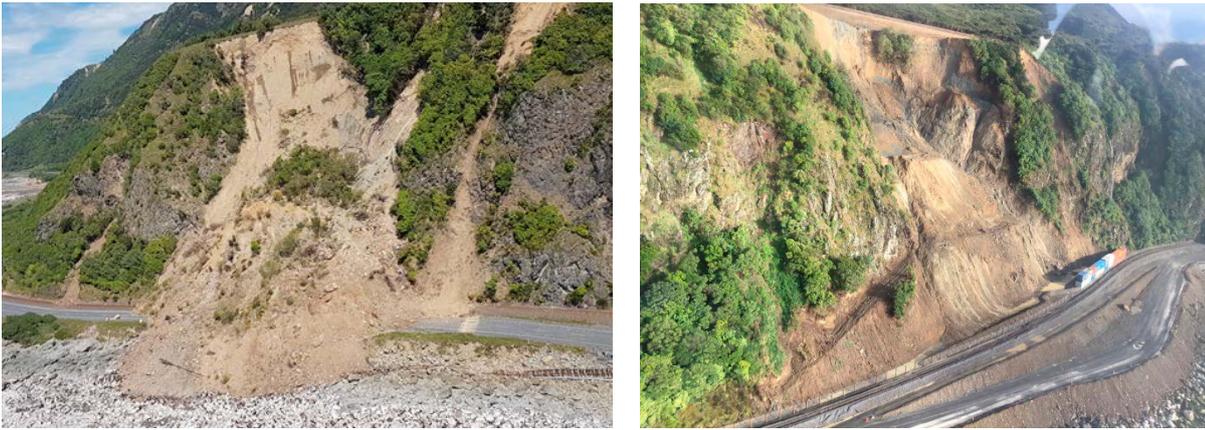
**Figure 4:** Site P8, December 2016 and in September 2017 after clearing debris and realigning rail. Temporary road alignment shown.

The landslide materials have been cleared from the road and rail formations, structures have been repaired or replaced, protective works have been designed and constructed at many locations, and sections of the road and rail have been, or are being, realigned to increase resilience of these important transportation links (for examples, see Figures 4 and 5).

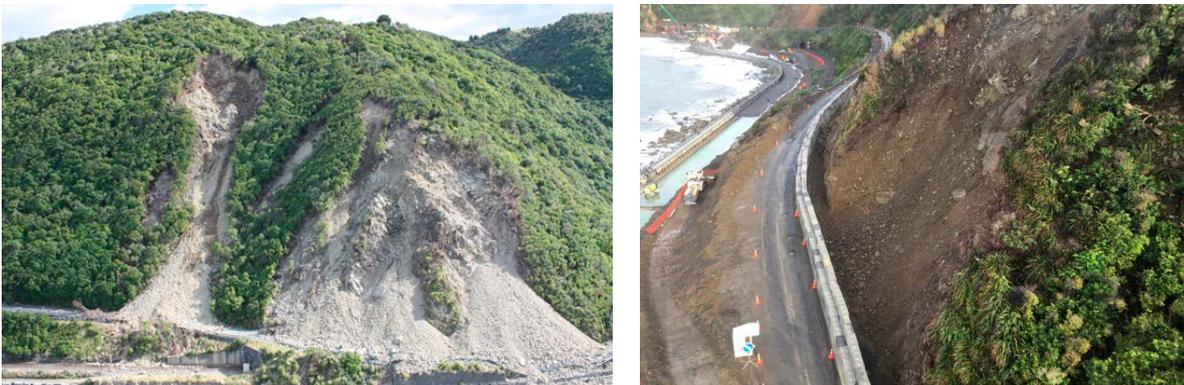
**Figure 5:** Site P2, December 2016 and in October 2017 after clearance. Road realignment underway. Old road is used for temporary access, protected by barrier.

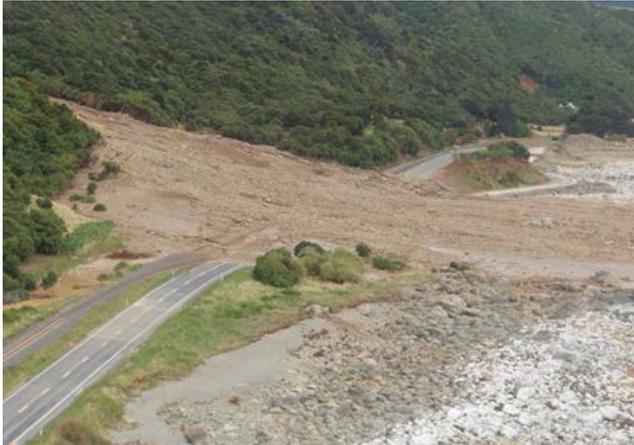
**Figure 8:** Debris flow covering road and rail at Jacobs Ladder, Cyclone Gita, Feb 2018.

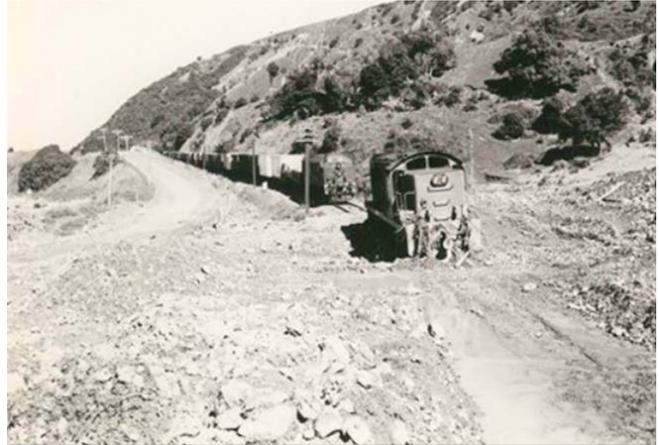
**Figure 9:** Debris flow at Black Miller Stream, Cyclone Alison, March 1975.

approximately 18,000 m<sup>3</sup> requiring removal to expose the road and rail. The road was closed for 10 days and the rail for 15 days. The nearby Black Miller Stream was similarly affected by Cyclone Alison in 1975, at which time a train was partially buried in the debris (David Bell, pers. comm, March 2018; see Figure 9).

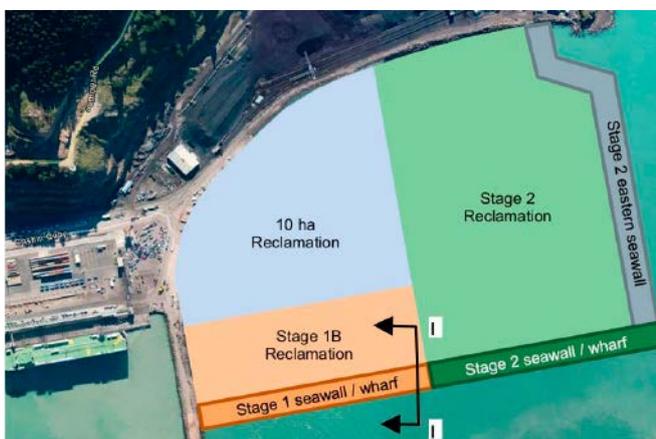
**Figure 1:** Project general layout (left) and proposed wharf structure (right)

Lyttelton Port of Christchurch (LPC) is embarking on a long-term plan to develop a modern container terminal at Te Awaparahi Bay. The first stage of works will reclaim 16ha of land and construct a 350m long wharf which is intended to be operational by 2024. A traditional wharf with revetment will be constructed and supported on five rows of piles driven to around 100m depth. Coffey Services (NZ) Limited (Coffey) has been involved with the project in a specialist geotechnical consulting role since early 2014, when is commissioned to provide a concept design through to the present day where our current engagement comprises of a detailed stage 1 geotechnical design of the land reclamation, and interaction analysis of the soil/structure. The modelled wharf pile structure and its geometry/spacing is based on sections provided by the Structural Engineer. Figure 1 below indicates the general layout and proposed wharf structures considered in the detailed design.

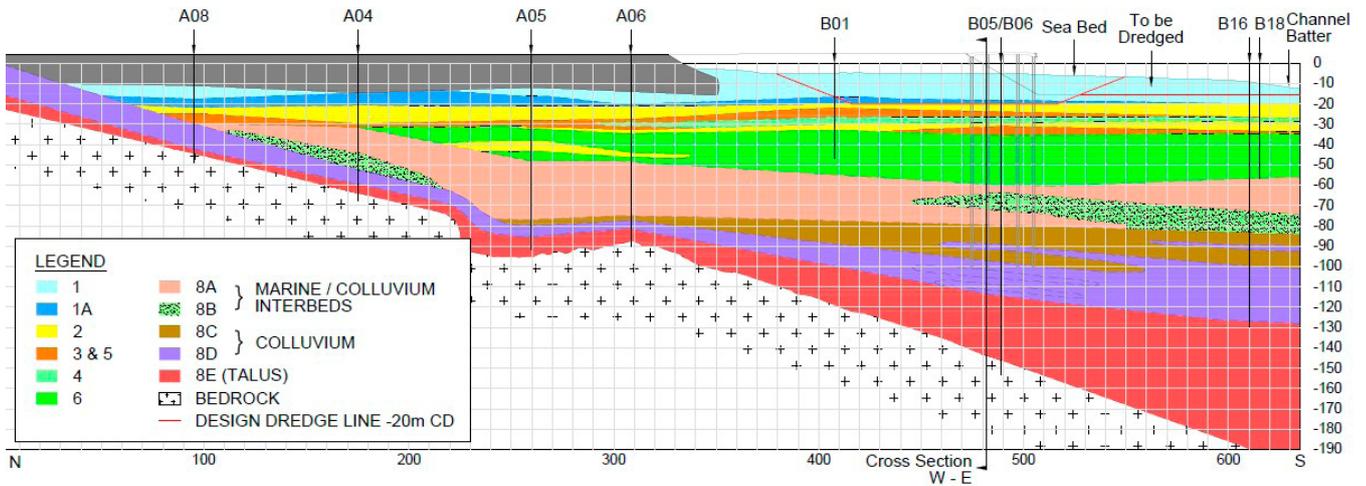
Figure 2: North-South cross section showing existing reclamation, proposed wharf and Te Bay geology

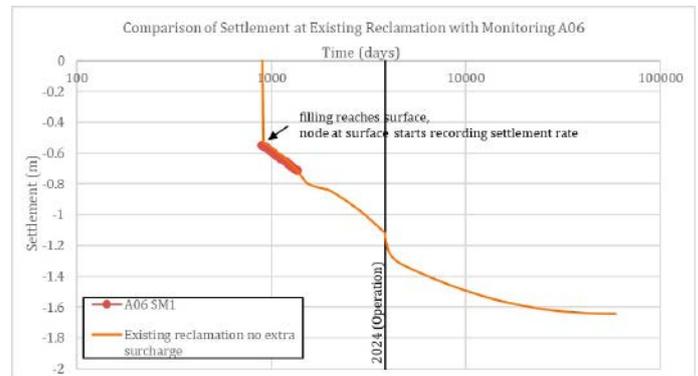
Figure 6: Settlement near crest of existing reclamation with model parameters back-analysed to match observed settlements.

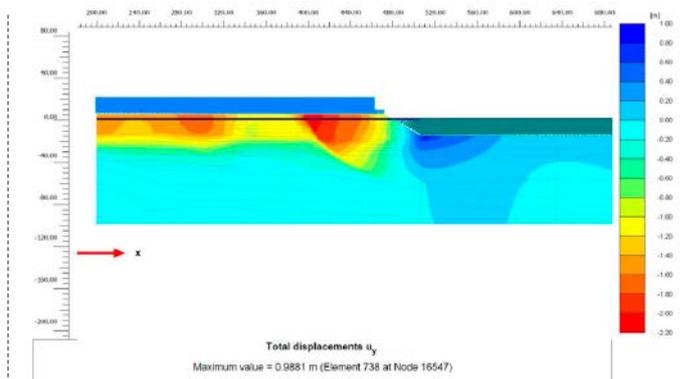
Figure 8: Plaxis output of vertical settlement at 95% complete at 2024.

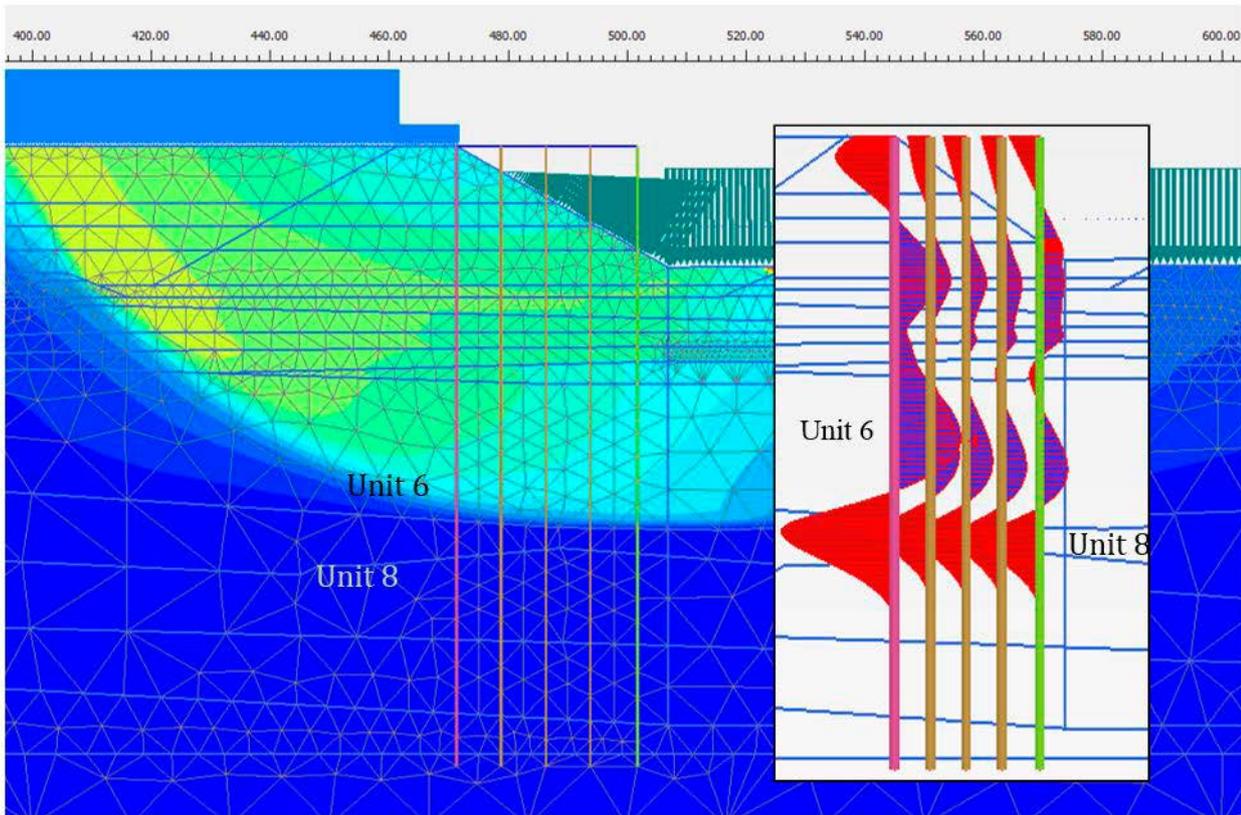
Figure 9 shows that the maximum reaction on the piles due to consolidation movement is between Unit 6 and Unit 8 (about -60m CD). This is due to the significant differential movement contrast in this area with the major consolidation movement occurring in Unit 6 (silt/clay), compared with the very minor movement that takes place in Unit 8 (very stiff colluvium).

**Figure 9:** Consolidation movement along the boundary of Unit 6 and Unit 8 superimposed with static pile bending moment - max. moment was near the interface of Unit 6 and Unit 8.

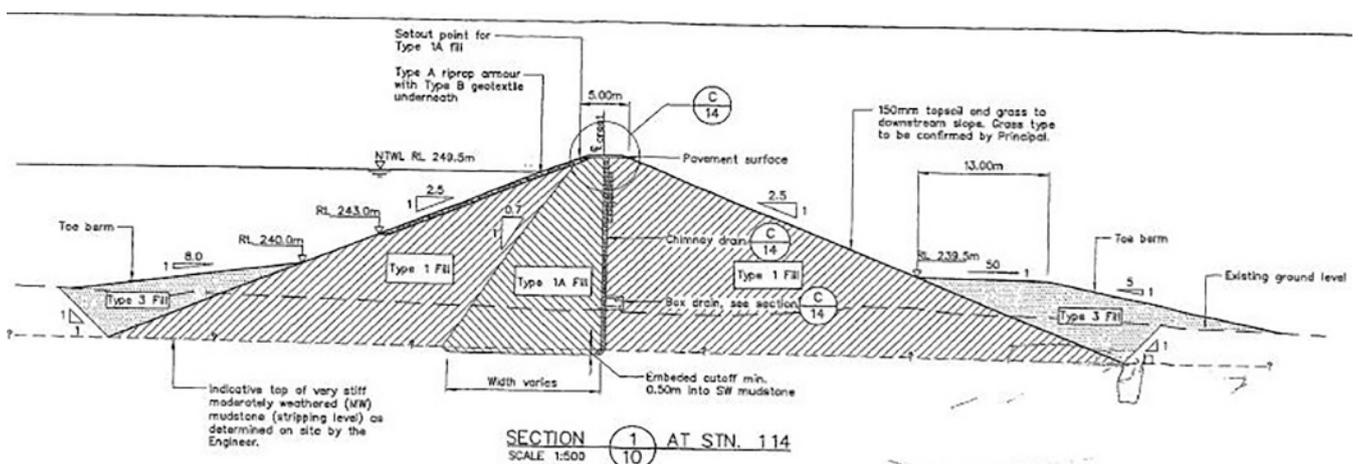
Figure 2: Typical Section of Original Dam Design

Between 2003 and 2008, investigations, design and construction of the original dam was completed. The original design comprised an approximately 15m high by 170m long crest embankment with conditioned mudstone core, alluvial gravel shoulders, and downstream chimney filter/drainage zone, with a storage volume of approximately 250,000 m<sup>3</sup>, and design flood event of 1 in 1000 Annual Exceedance Probability (AEP). It is founded

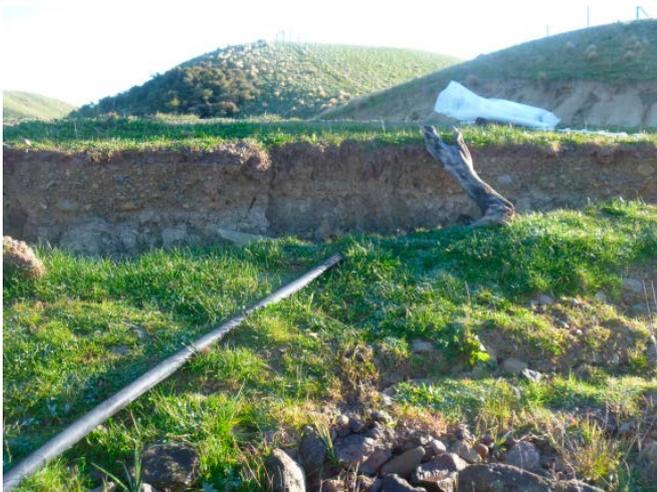
**Figure 4:** Vertical Settlement of Upstream Shoulder Following the August 2013 Event

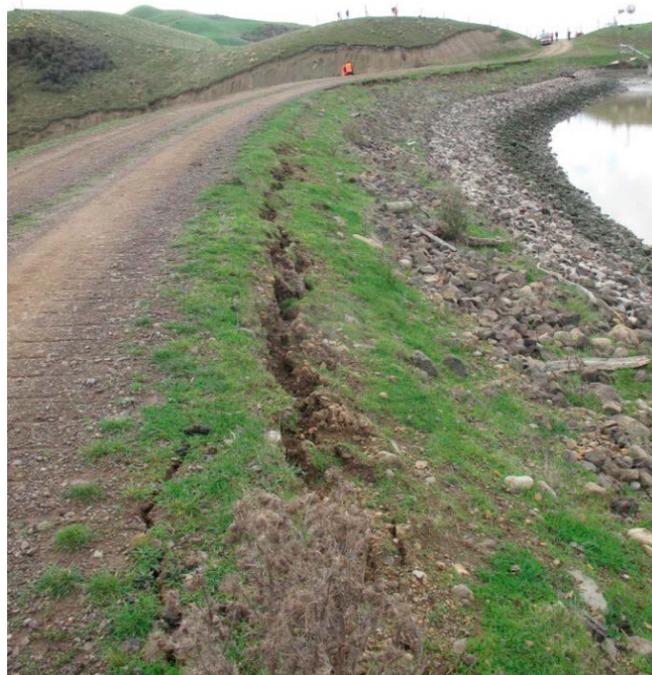
**Figure 5: Right:** Longitudinal Crack Following the August 2013 Event

Following the main earthquake of 21 July 2013, the dam experienced cracking along the crest. These longitudinal cracks were most evident on the upstream side of the crest, with smaller cracks down the centre of the crest. The longitudinal cracks varied in width up to approximately 100 mm with the widest cracking located where the embankment is at its highest.

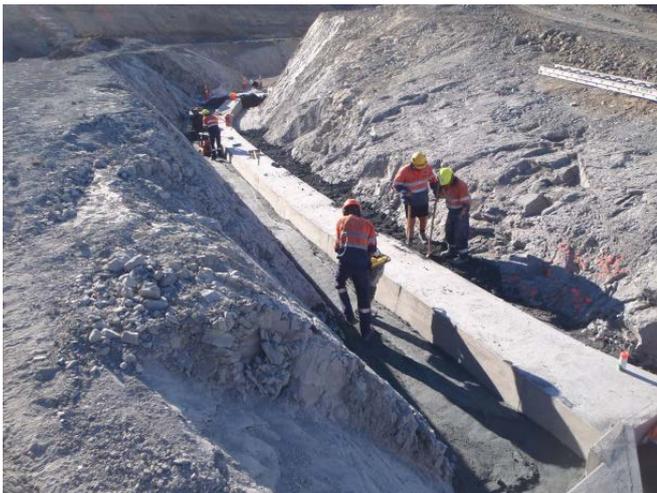
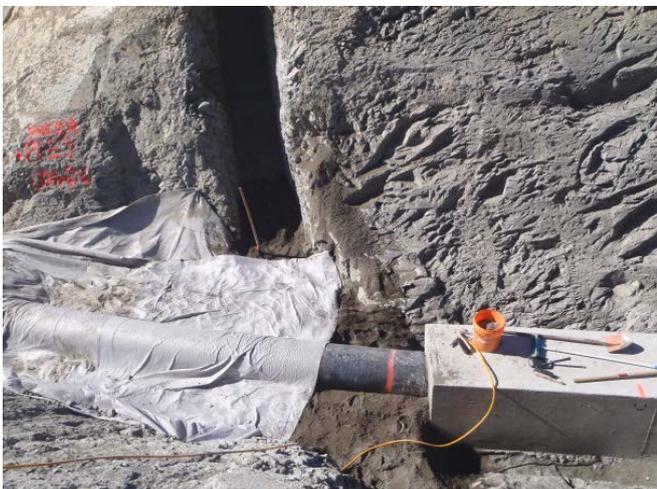
Figure 8: Construction of LLO Pipe

A typical section through the LLO pipe trench backfill is shown in Figure 7, and some photographs showing the installation of the LLO pipe are shown in Figure 8. Stage 1 remedial works were completed over the course of approximately 5 months from March to August 2016. Code Compliance Certification for the Stage 1 works was issued for the works by the regulator, MDC, on 8 November 2016.

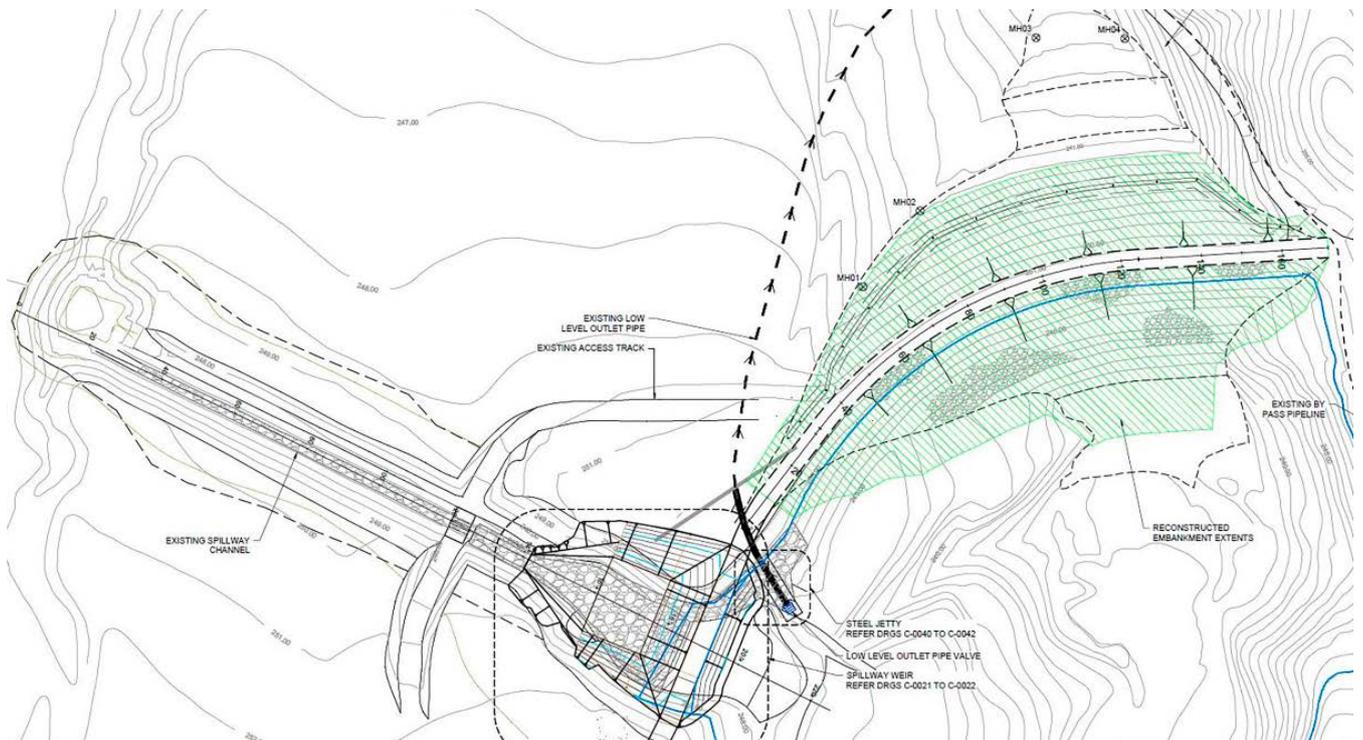
Figure 9: Stage 2 General Arrangement

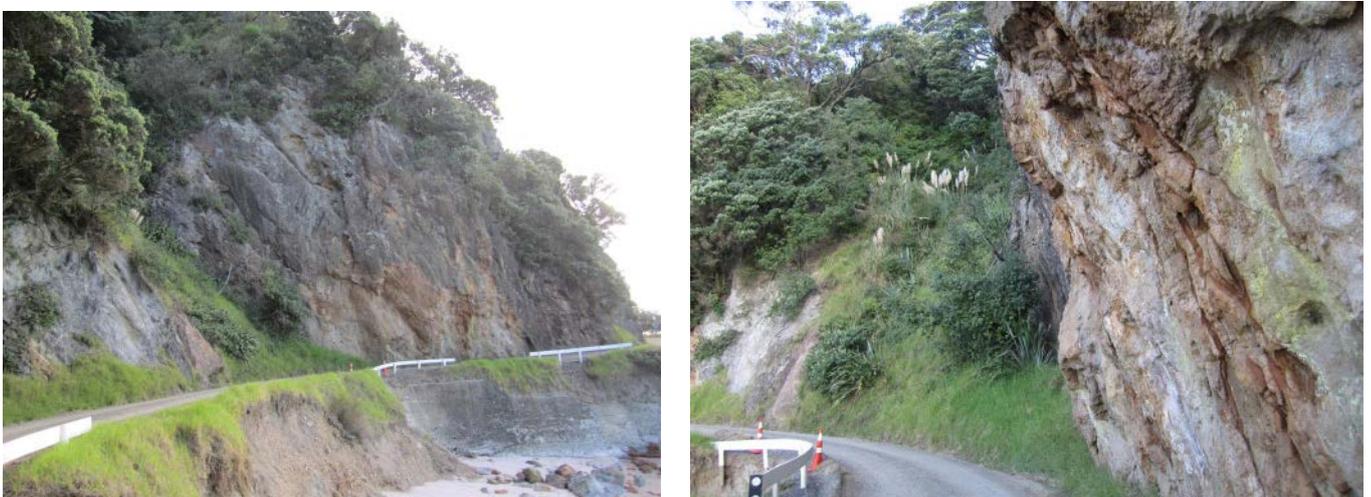
**Figure 2:** Views of Bluff Road section of concern showing overhang, fracturing and weathering/alteration

At one location close to the western end of the road, the road is overhung by a near vertical 20m high bluff of variably weathered and hydrothermally altered andesite, that is also locally sheared and closely fractured, Figure 2. Three major discontinuity sets are present. Two of them, dipping out of the face at angles of between 30 and 50° and a second dipping out of the face at 70 to 80° promoted planar and toppling failure respectively. The third, near vertical set, has a strike at almost 90° to the face and act as release planes for block failures. Weathering and hydrothermal alteration has particularly picked out the vertical discontinuities trending into the face, which are locally concentrated and may be localised

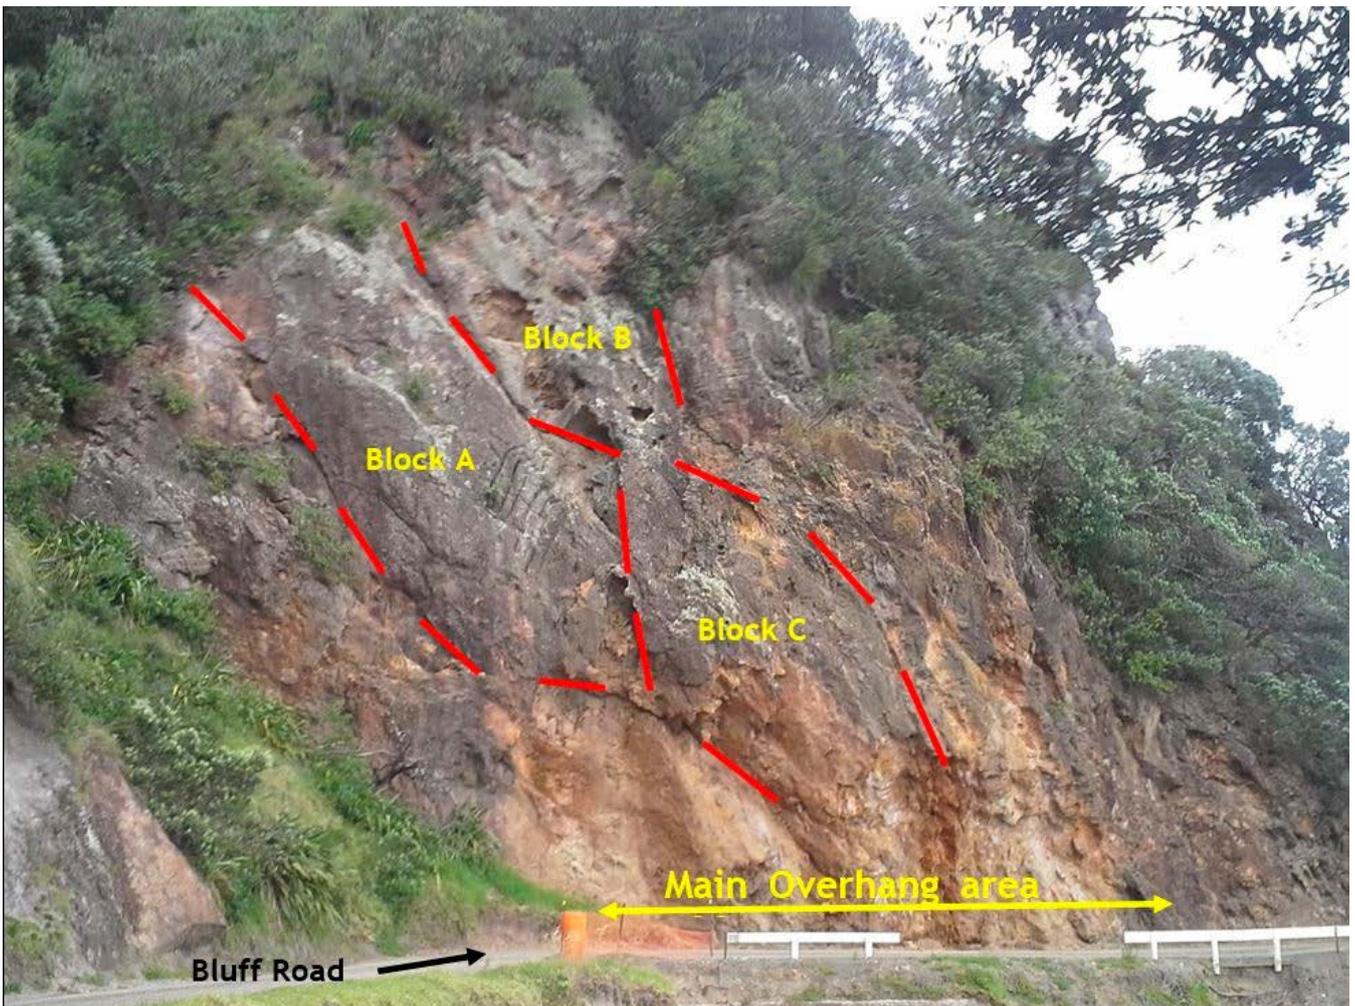
Figure 3: Potential failure masses observed in 2014.

At that time, we considered there was a high likelihood of small rock blocks (up to 0.5m diameter) continuing to fall onto the road. However we also considered that there was a high likelihood of a large volume (>10m<sup>3</sup>) planar / wedge type rockslide that would block the road, sourced from any of, or all the blocks A to C shown on Figure 3.

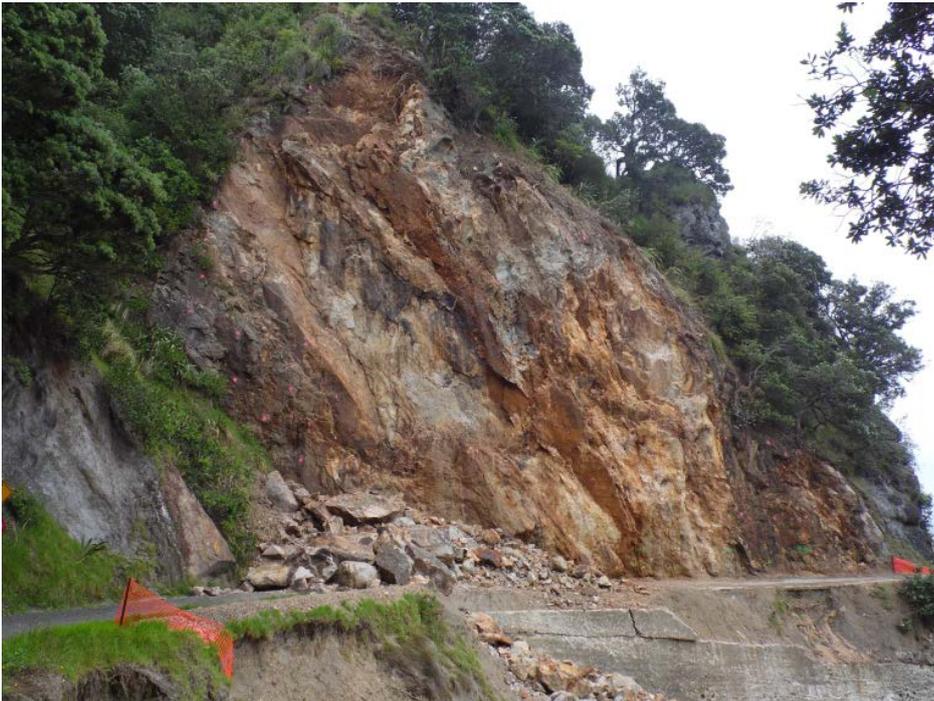
**Figure 4:** Rockfall of 25 December 2015.

A significant rock-fall occurred after heavy rain on the 25<sup>th</sup> of December (Figure 4). It is unclear if this was also related in part to the effects of the work, such as blasting and stress relief opening fractures.

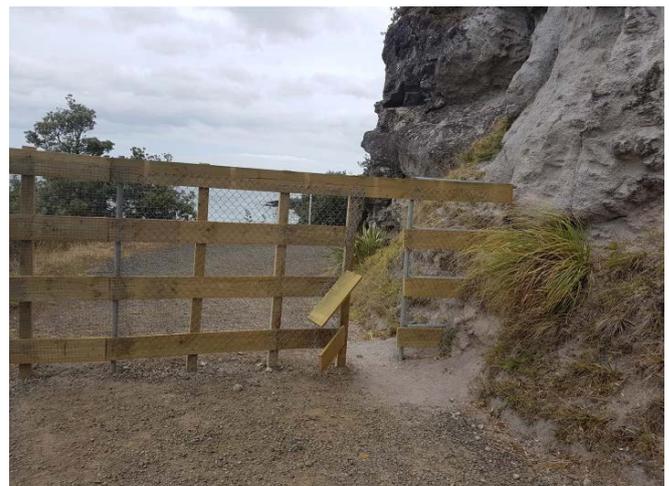
**Figure 5:** Vandalised fencing

However, over the next year the fences and barriers were repeatedly cut and broken down by members of the public seeking to use the road as a short cut between the two communities and to popular fishing and diving marks (Figure 5 and 6).

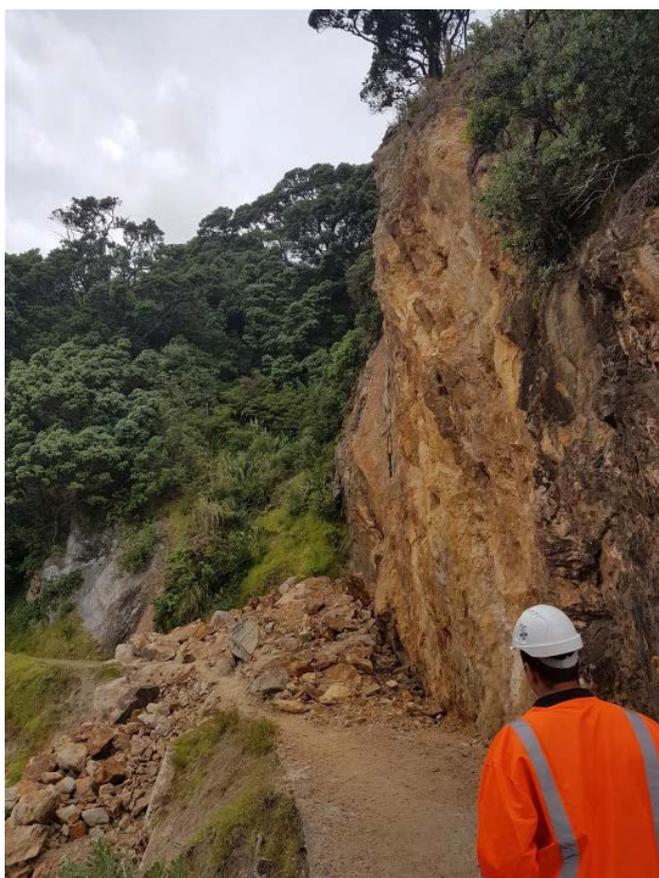
**Figure 6:** Footpath past debris

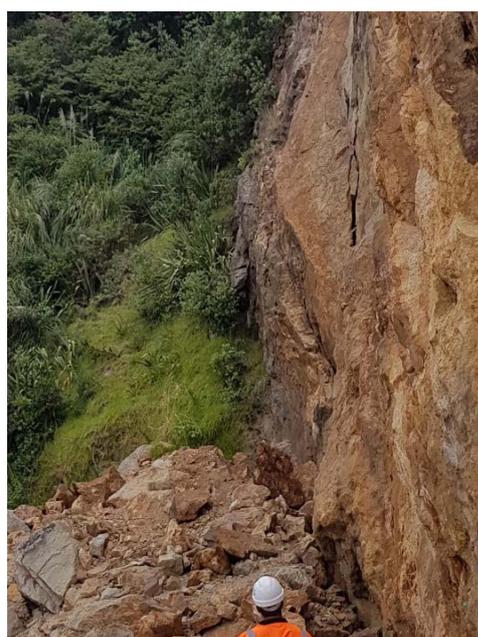
**Figure 7:** Open fractures above path

This was despite clearly hazardous conditions, as exhibited by wide open fractures, isolated fallen blocks (Figure 7 and 8), signage / barriers and warnings in the press.

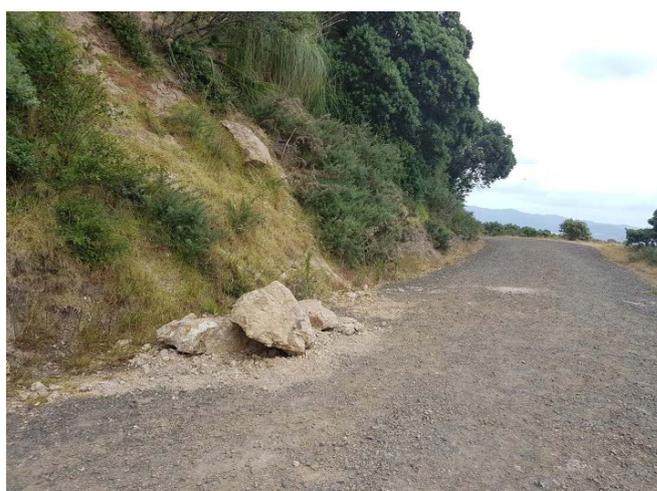
**Figure 8:** Fallen blocks on footpath

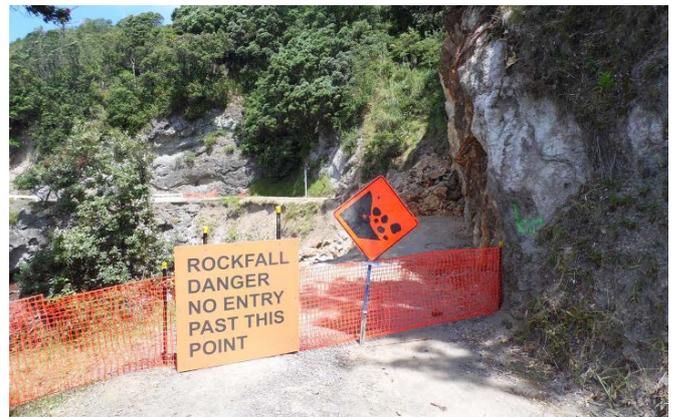
Figure 10: Signage during site work

through their actions at the site. Threats of prosecution, publicity (Figure 9) and signs warning of the danger (Figure 10) were ineffective and ignored, as was the actual occurrence of further rockfalls following road closure.

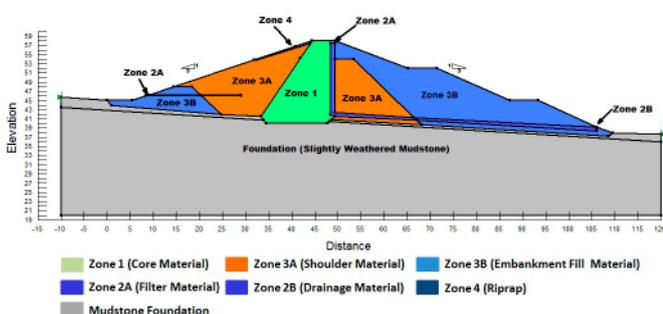
Figure 2: Typical Embankment Cross Section

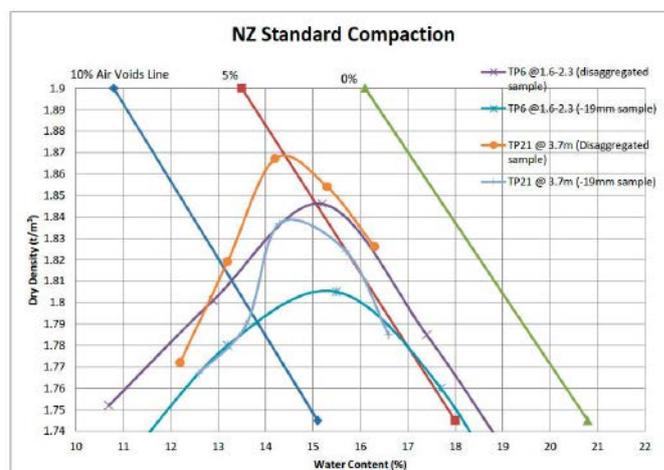
Figure 3: Loess Compaction Curves

without over-wetting (and loss of shear strength). In-situ loess had a moisture content approximately 2%-5% drier than the optimum moisture content (OMC) of 14.5% to 15%, and soil clods contained even lower moisture. The standard compaction tests conducted in a soil laboratory on disaggregated loess material showed a tight compaction curve with a sharp slope on the wetter side of OMC, as shown on Figure 3. Over-conditioned loess material results in loss of shear strength, causing heaving (due to excess pore pressures) at which point the target density cannot be met and the material becomes unworkable.

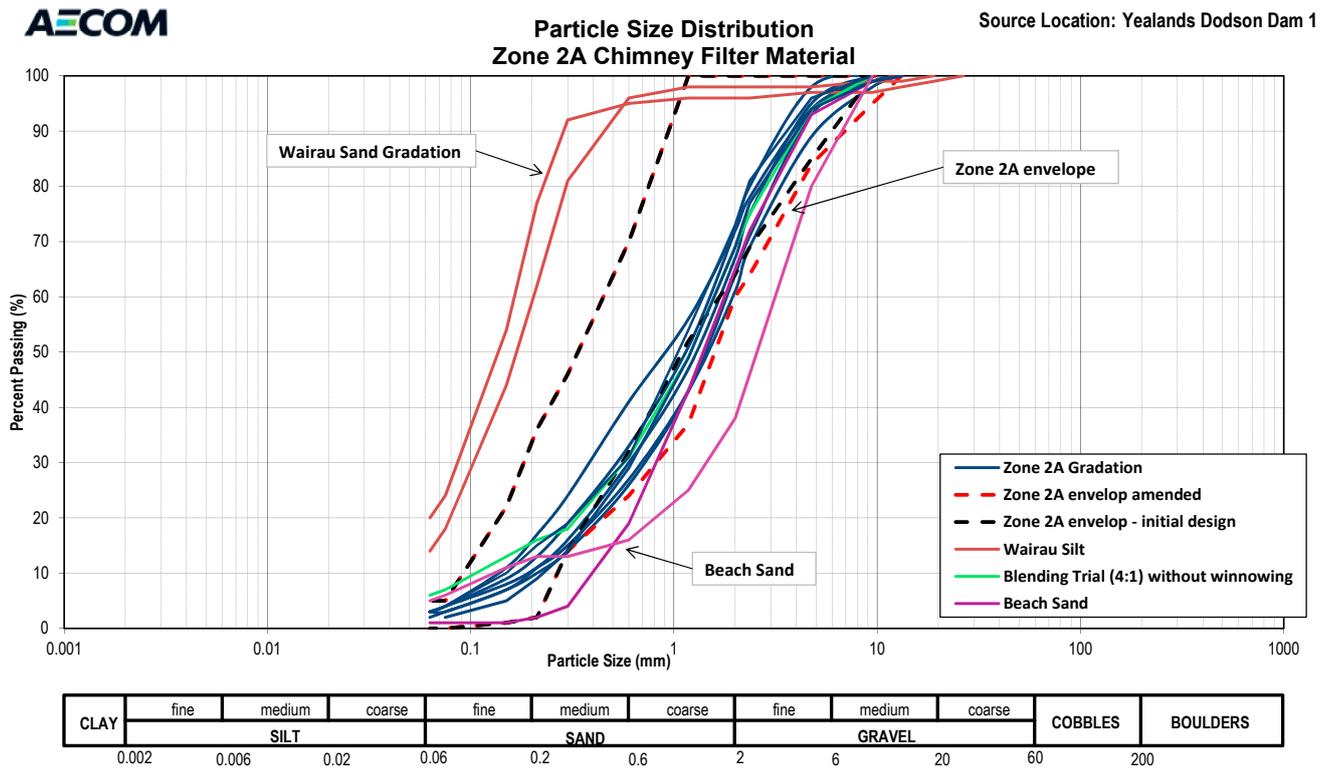
Figure 4: Zone 2A Chimney Filter Material Particle Size Distribution

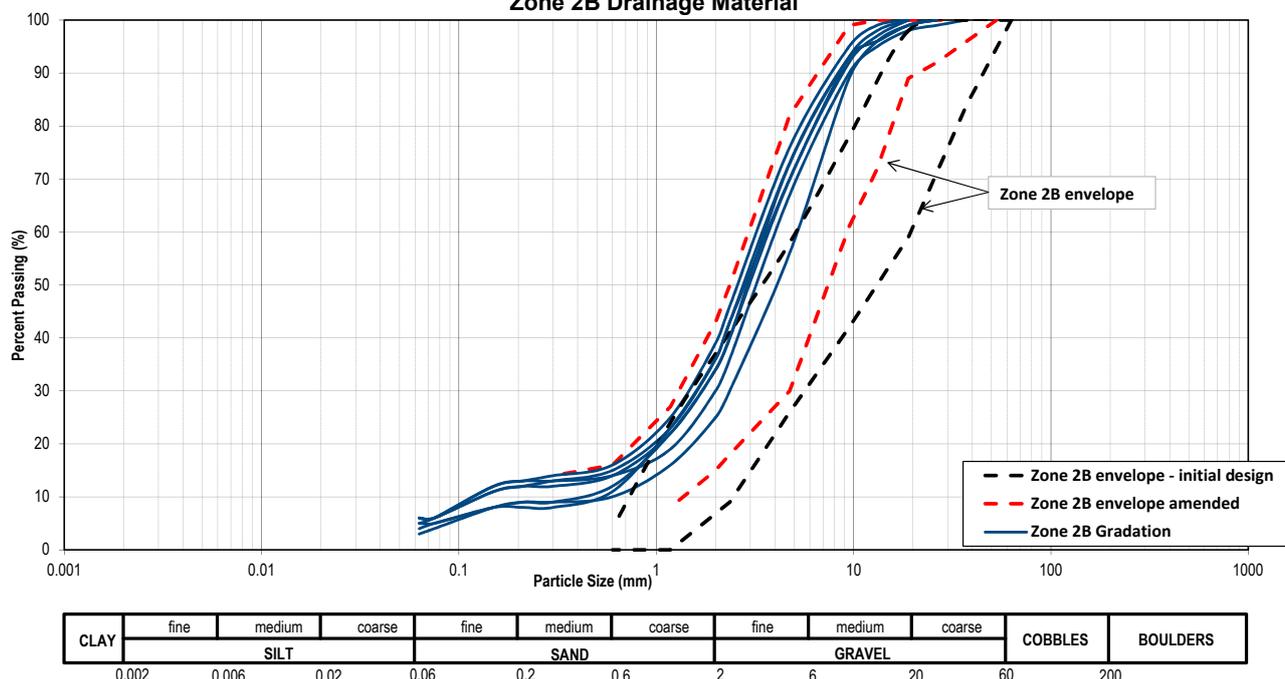
**Figure 5:** Zone 2B Drainage Material Particle Size Distribution

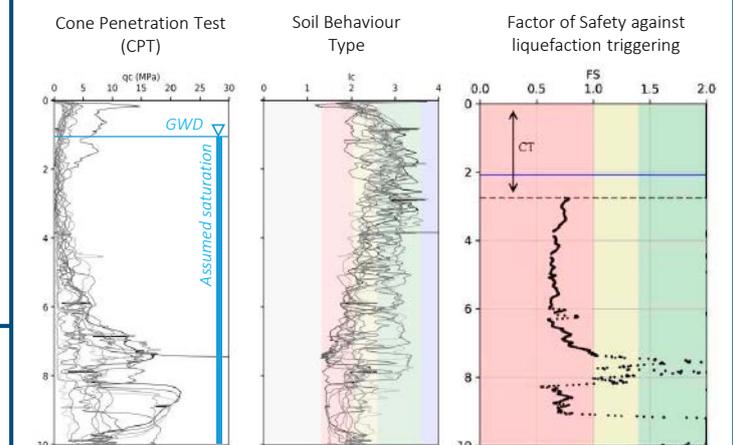
CPT  $q_c$  profile and inferred soil behaviour type along with factor of safety against liquefaction triggering at locations where liquefaction manifested during the 2016 Kaikoura earthquake.

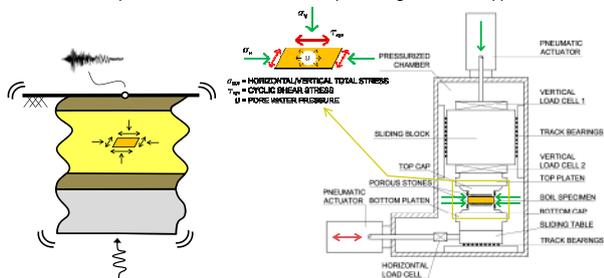
Figure 1. Propagation of SH seismic waves through level ground, free-field soil deposit.

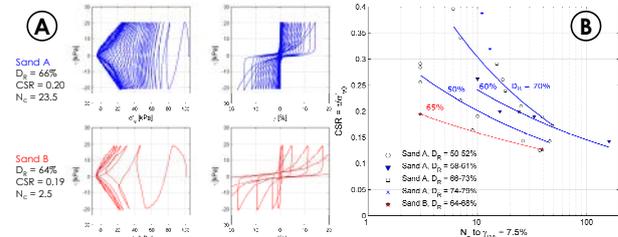
Figure 6. (A) Stress paths and stress-strain curves observed in cyclic DSS tests with similar CSR for two Christchurch sands at 65% relative density. (B) Number of cycles against CSR for  $\gamma = 7.5\%$  DA (double-amplitude, i.e. peak-to-peak) for cyclic DSS tests on Christchurch marine Sand A and fluvial Sand B.

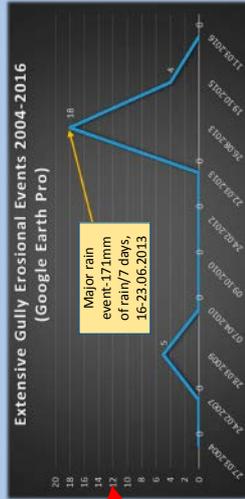
- Drone survey (19<sup>th</sup> June 2017-30<sup>th</sup> October 2017)**
  - 4/13 drone ACE surveys recorded land erosion due to gullying;
  - 3118m<sup>2</sup> of land area eroded due to gullying within 36 hours from the start of the 111.8mm rainfall event;
  - 31 gullies from the total number of 35 gullies have been reactivated
  - and three new gullies formed post the 111.8mm rainfall event;
  - A total amount of 3328m<sup>2</sup> of land has been eroded due to gullying for the surveyed coastline over a period of 133 days.
- Desk study (2004-2015)**
  - Calculated subaerial cliff erosion rate is 0.42m/year;
  - 28 gullies mapped in the 2004 survey, 34 gullies mapped in the 2015 survey;
  - 7 new gullies developed and one gully was lost due to inactivity.

- Flyover drone geomorphological survey for 1.7km of coastline on a weekly basis (subject to weather conditions);
- 13 ACE (Ashburton Coastal Erosion) surveys have been created between 19<sup>th</sup> June 2017 and 30<sup>th</sup> of October 2017 and include: orthomaps, DEM (Digital Elevation Model) and 3D models;
- 35 gullies have been mapped at the start of the project (ACE1) and monitored throughout the project.

- Google Earth Pro historical imagery has been used for the geomorphological mapping of gullies for the 2004-2015 period.
