# NZ GEOMECHANICS **NEWS**

Bulletin of the New Zealand Geotechnical Society Inc.

# KAIKŌURA EARTHQUAKE RECOVERY

# Kaikōura Earthquake Slope Hazards - Risk Mitigation and Network Resilience

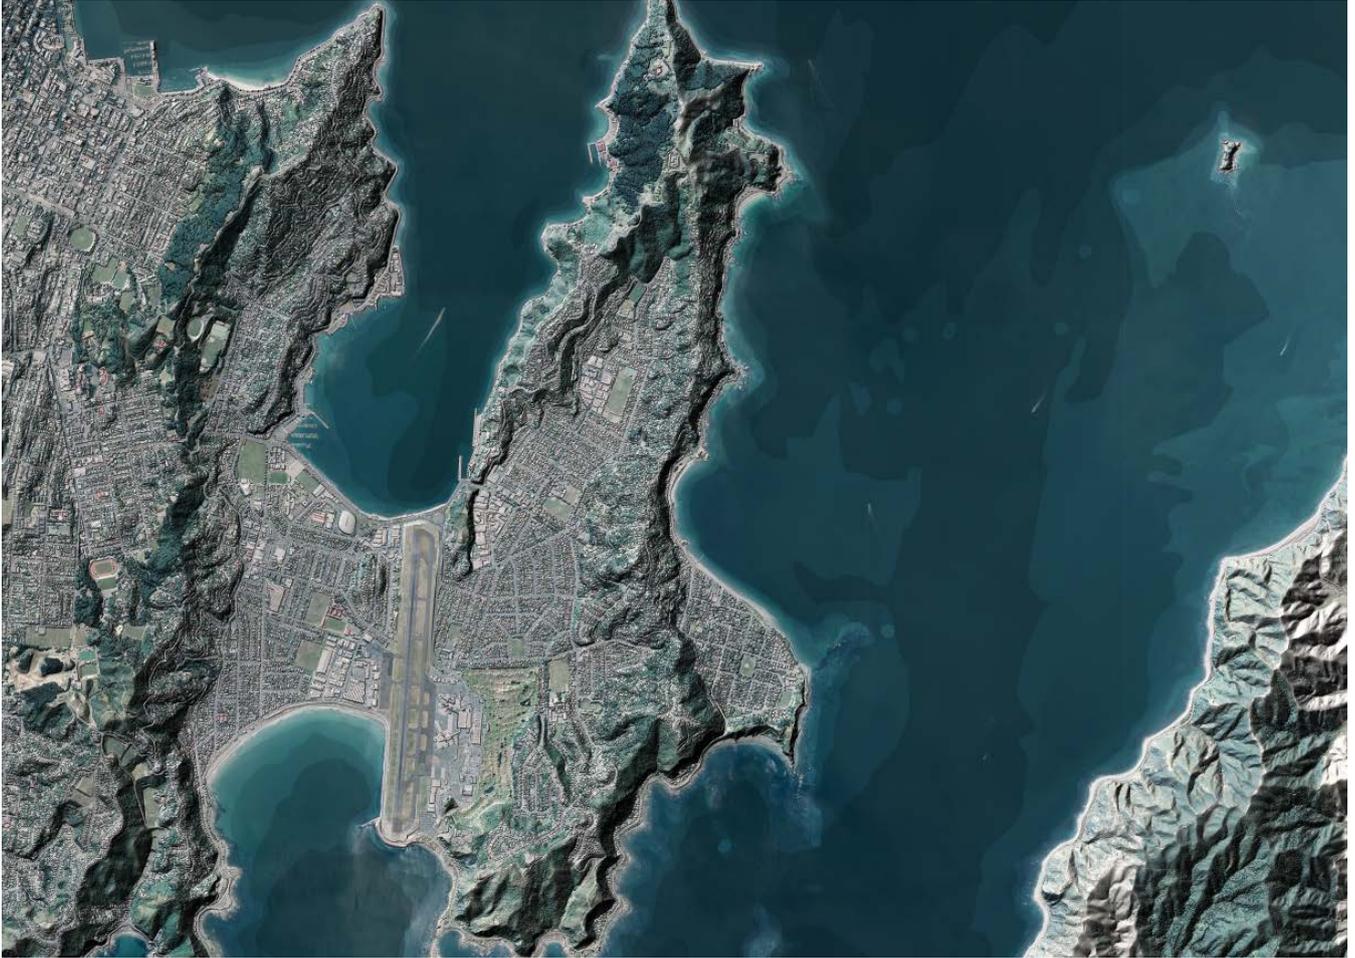
**Figure 1:** Image of Lyall Bay in Wellington that has been modelled by blending aerial imagery, a digital surface model and building footprints.

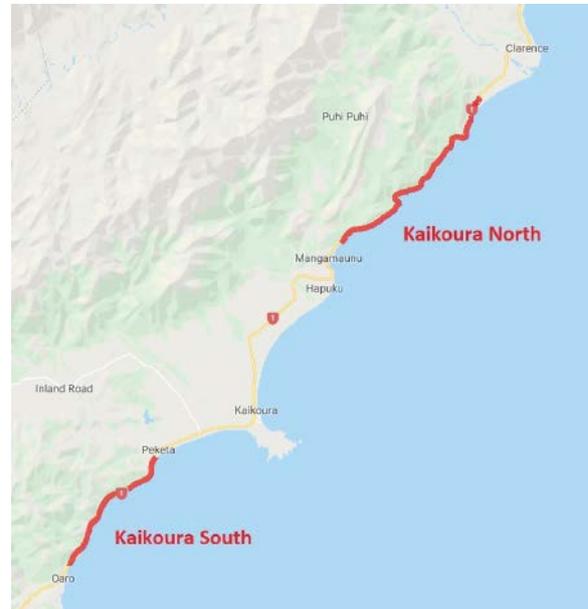
**Figure 1:** Site locations with coastal corridor sections indicated

More than 20 faults are inferred to have moved in the M7.8 November 2016 Kaikōura Earthquake, which resulted in extensive damage to the coastal slopes and caused uplift at several locations. Between Clarence and Oaro, the transport corridor is located on a narrow coastal strip of land between steep mountainous slopes and the Pacific Ocean. Over 80 landslides occurred along this section of the transport corridor, severely affecting State Highway 1 (SH1) and KiwiRail's Main North Line (MNL). Lengths of around 10 km to the south of Kaikōura and 14 km on the northern section of the coast (Figure 1) were most heavily affected.

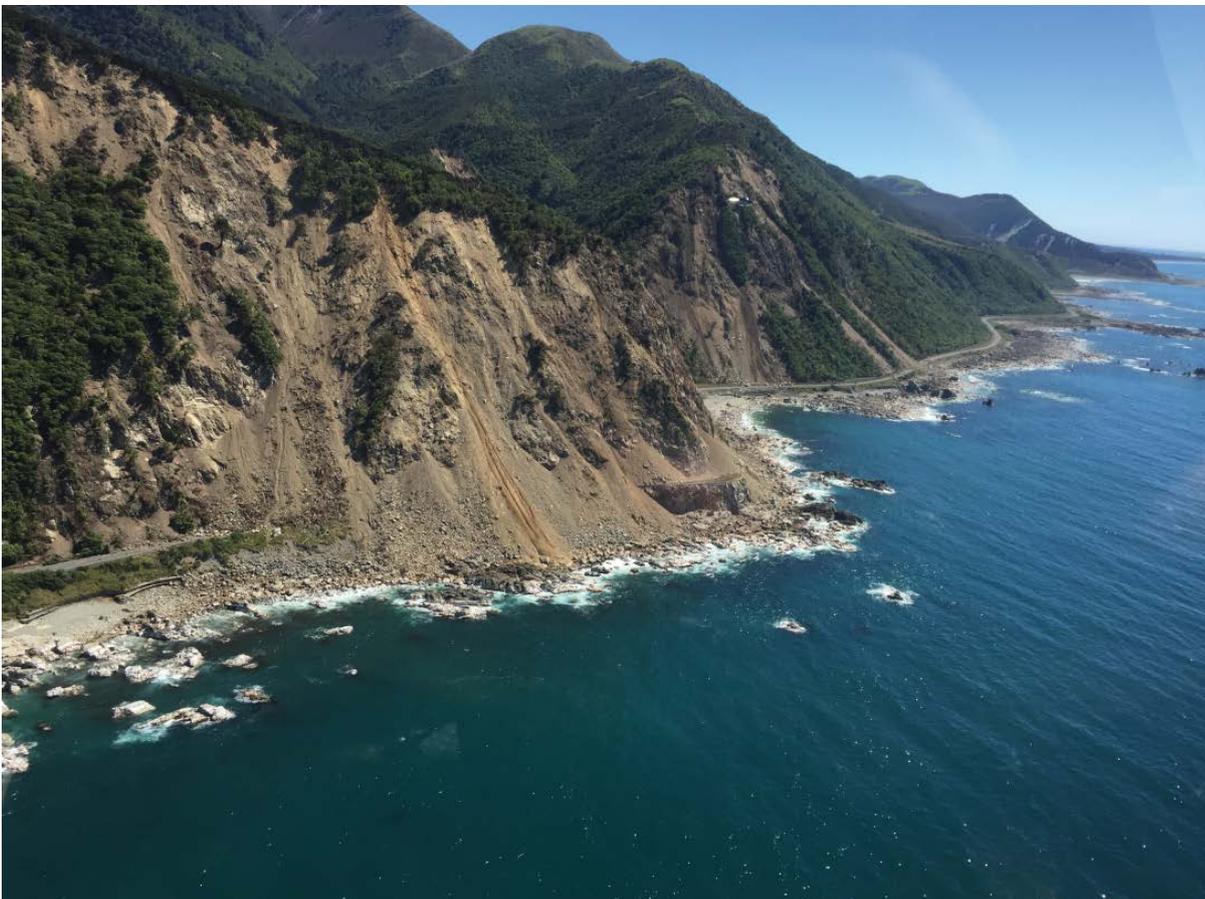
**Figure 3:** Slip P6, Ohau Point Kaikōura North, buried SH1

The majority of the slope failures caused by the Kaikōura Earthquake were evacuative rock and debris avalanches (Figures 3 to 6) that, in some cases, involved the release of large volumes of material (in excess of 50,000 m<sup>3</sup> at Ohau Point for example, Figure 3). Between these large failures, smaller volumes of slope materials or rock were released downslope. Some of this debris reached the road/rail corridor, but in many cases this material has halted on well vegetated hillslopes which are around 35° to 40°. In addition, widespread hillside and ridge cracking occurred during the earthquake, without downslope release of material.

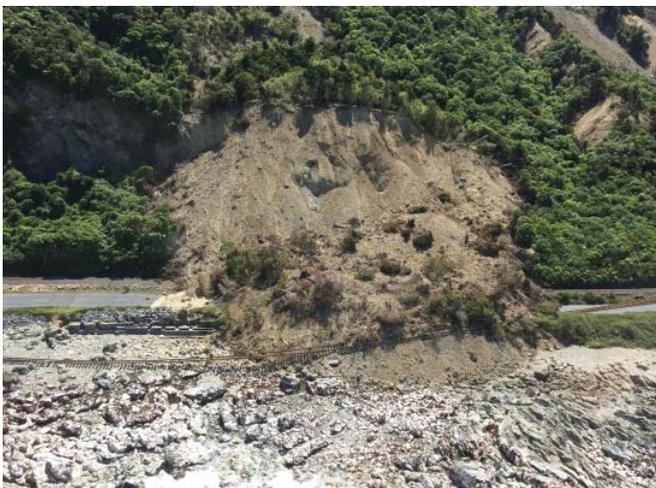
**Figure 4:** Slip P4, Kaikōura North, buried SH1 and displaced the rail track

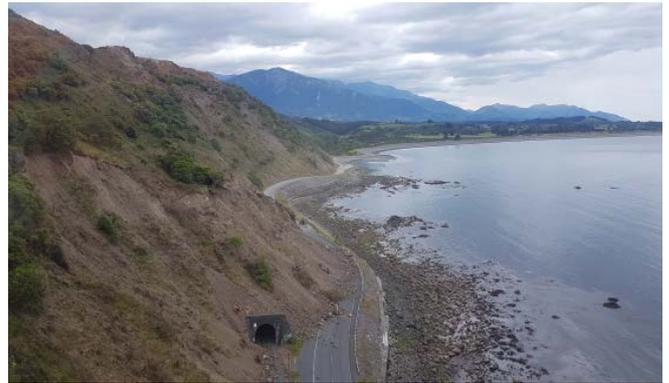
**Figure 5:** Rock and debris avalanche at the south portal of Rail Tunnel 13, Kaikōura South

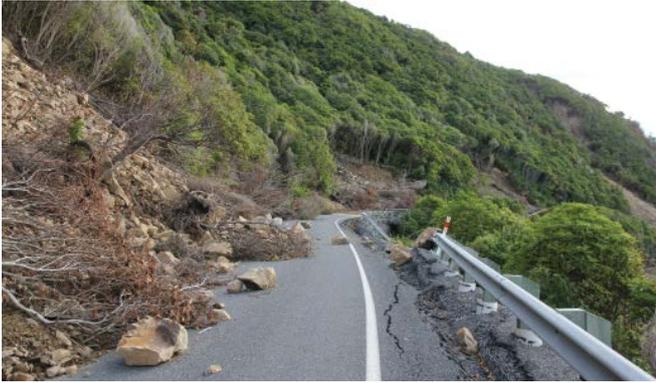
**Figure 7:** Rockfall debris at site P2 near Irongate Stream, Kaikōura North

Rockfall triggered by strong shaking was widespread throughout the project area (Figure 7). Source areas included rock outcrops and deposits of boulder colluvium. The scale of rocks observed ranged from fist-sized cobbles to large boulders up to several metres across. The associated ground damage effects of earthquake shaking on the hillslopes included denuding of soil slopes, tension cracking and dilation of rock outcrops, all of which have increased the potential for future rockfall onto the transportation corridor.

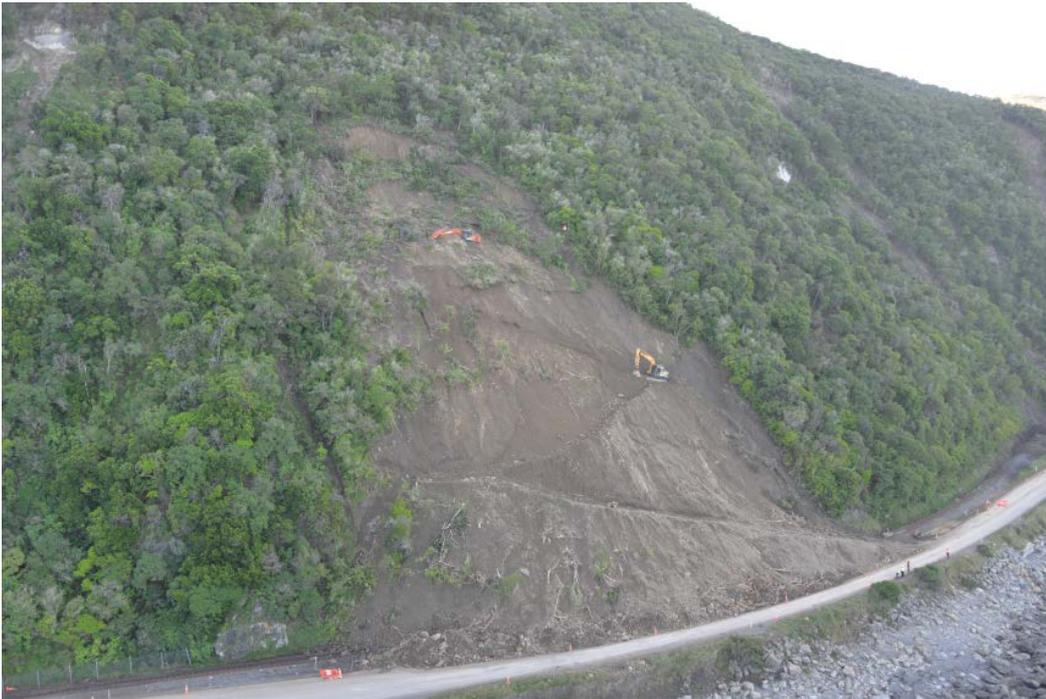
**Figure 10:** Slip 29A, following failure in April 2017.

- Active landslides are prone to further debris movement in very small rain events, proportional to the antecedent rainfall condition and the amount of rainfall on the day of slope failure.
- Antecedent rainfall has a strong influence on the amount of rain required to trigger further slope movement.
- Few failures are initiated under heavy rainfall with low antecedent rainfall.
- Relatively large scale failures are commonly initiated following the cessation of rain under high antecedent rainfall conditions.
- Landslide debris fans are being mobilised into channelised debris flows in modest rain events and cause on-going problems to the transport corridor.
- Slopes that did not show obvious signs of failure or deformation in the earthquake have the potential to develop into large slope failures (e.g. Slip 29A).

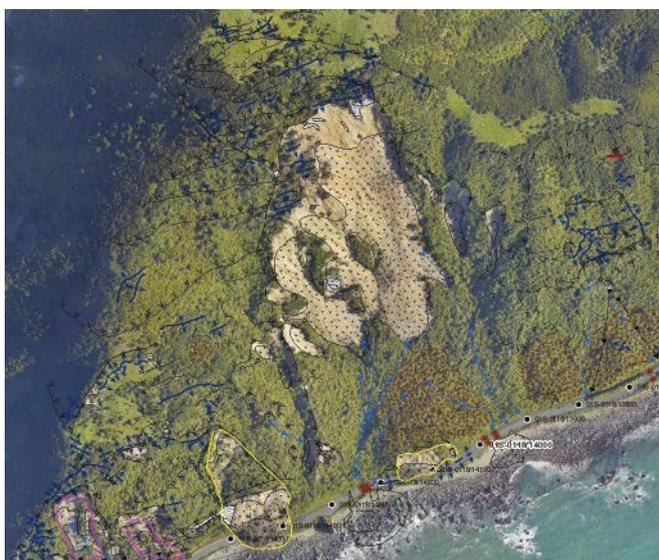
**Figure 12:** Example of GIS-based field mapping data (December 2016 aerial imagery) of area shown in Figure 11.

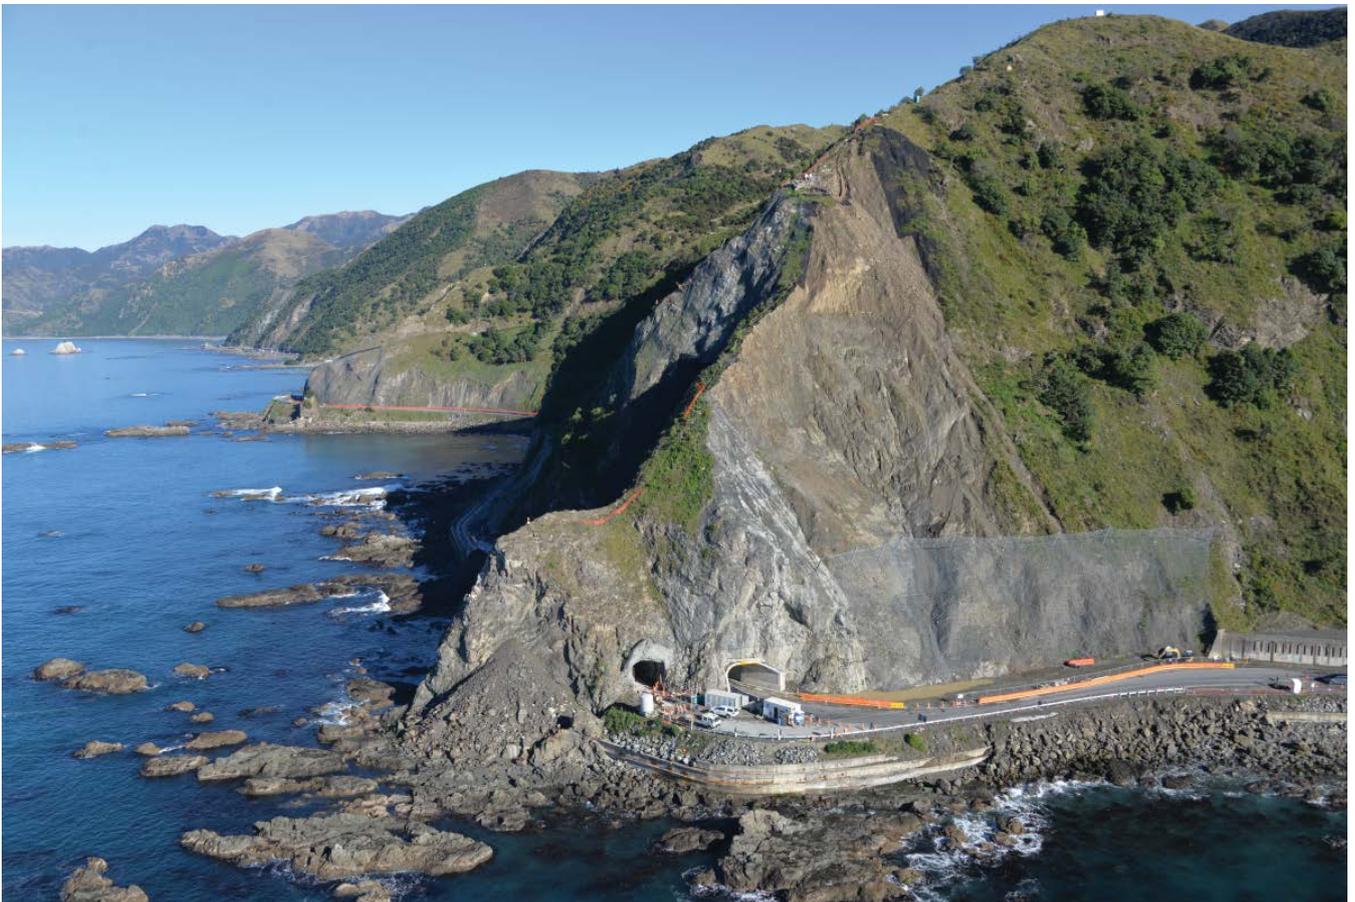
**Figure 15:** Rockfall Attenuator, Parititahi Tunnel North Portals, Kaikōura South

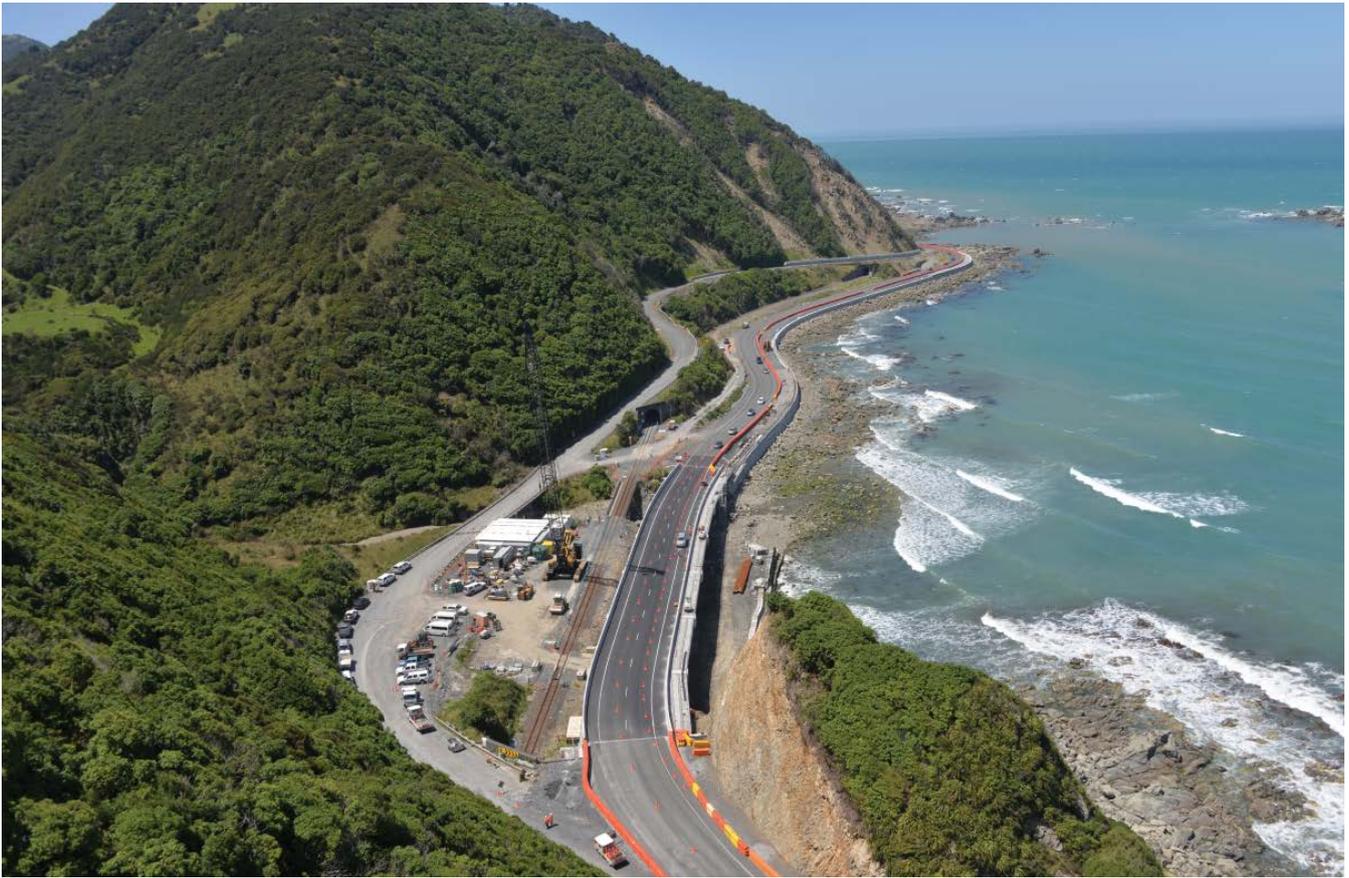
**Figure 17:** Irongate Bridge and SH1 realignment at Slip P2, Kaikōura North

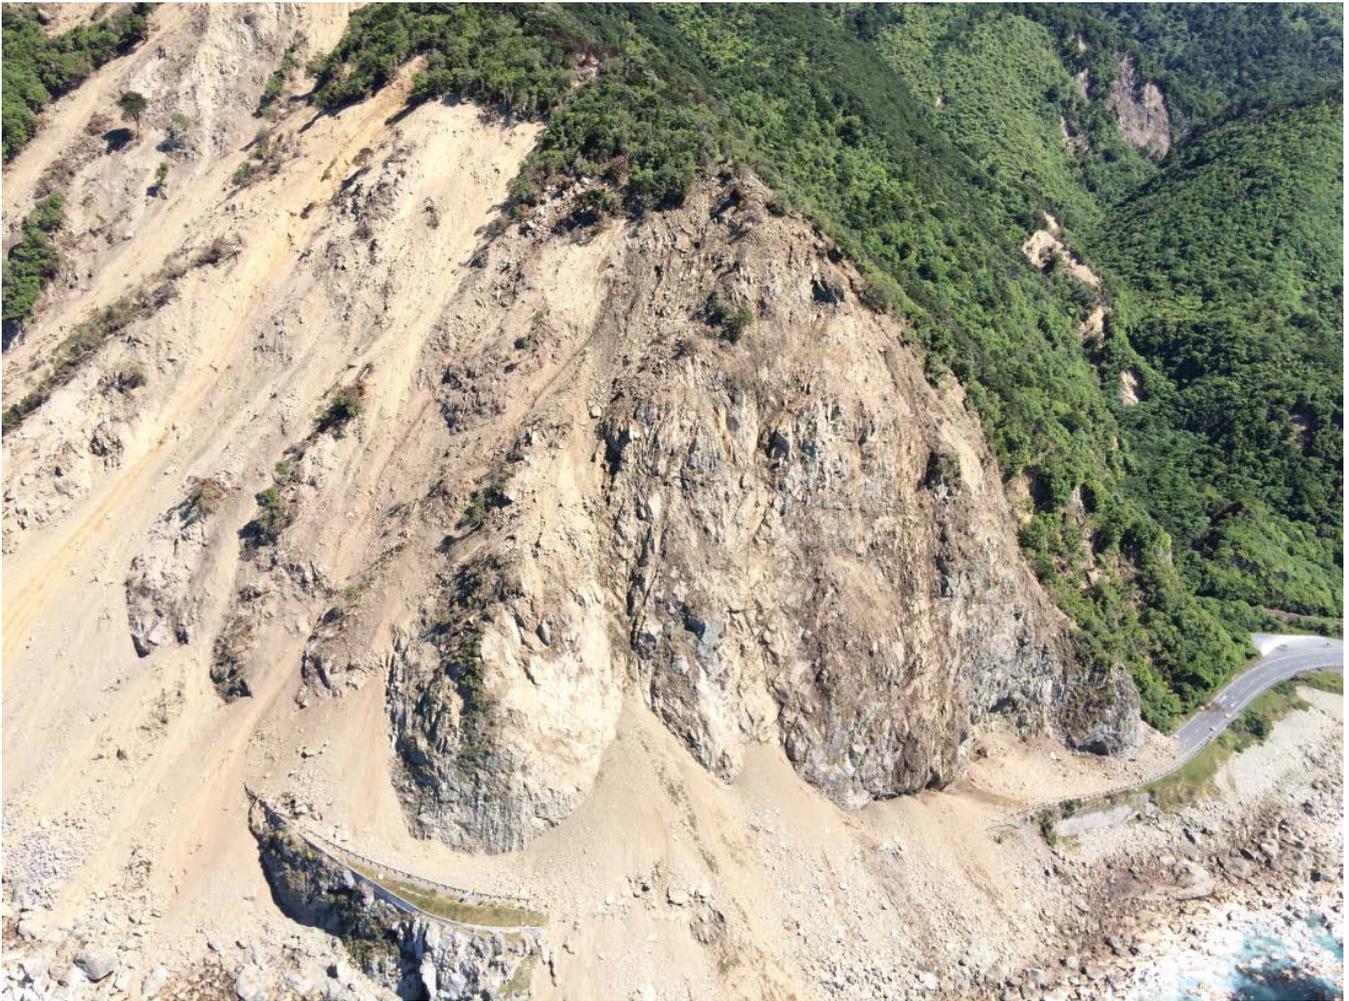
**Figure 1:** Ohau Point, December 2016 (photo courtesy Opus)

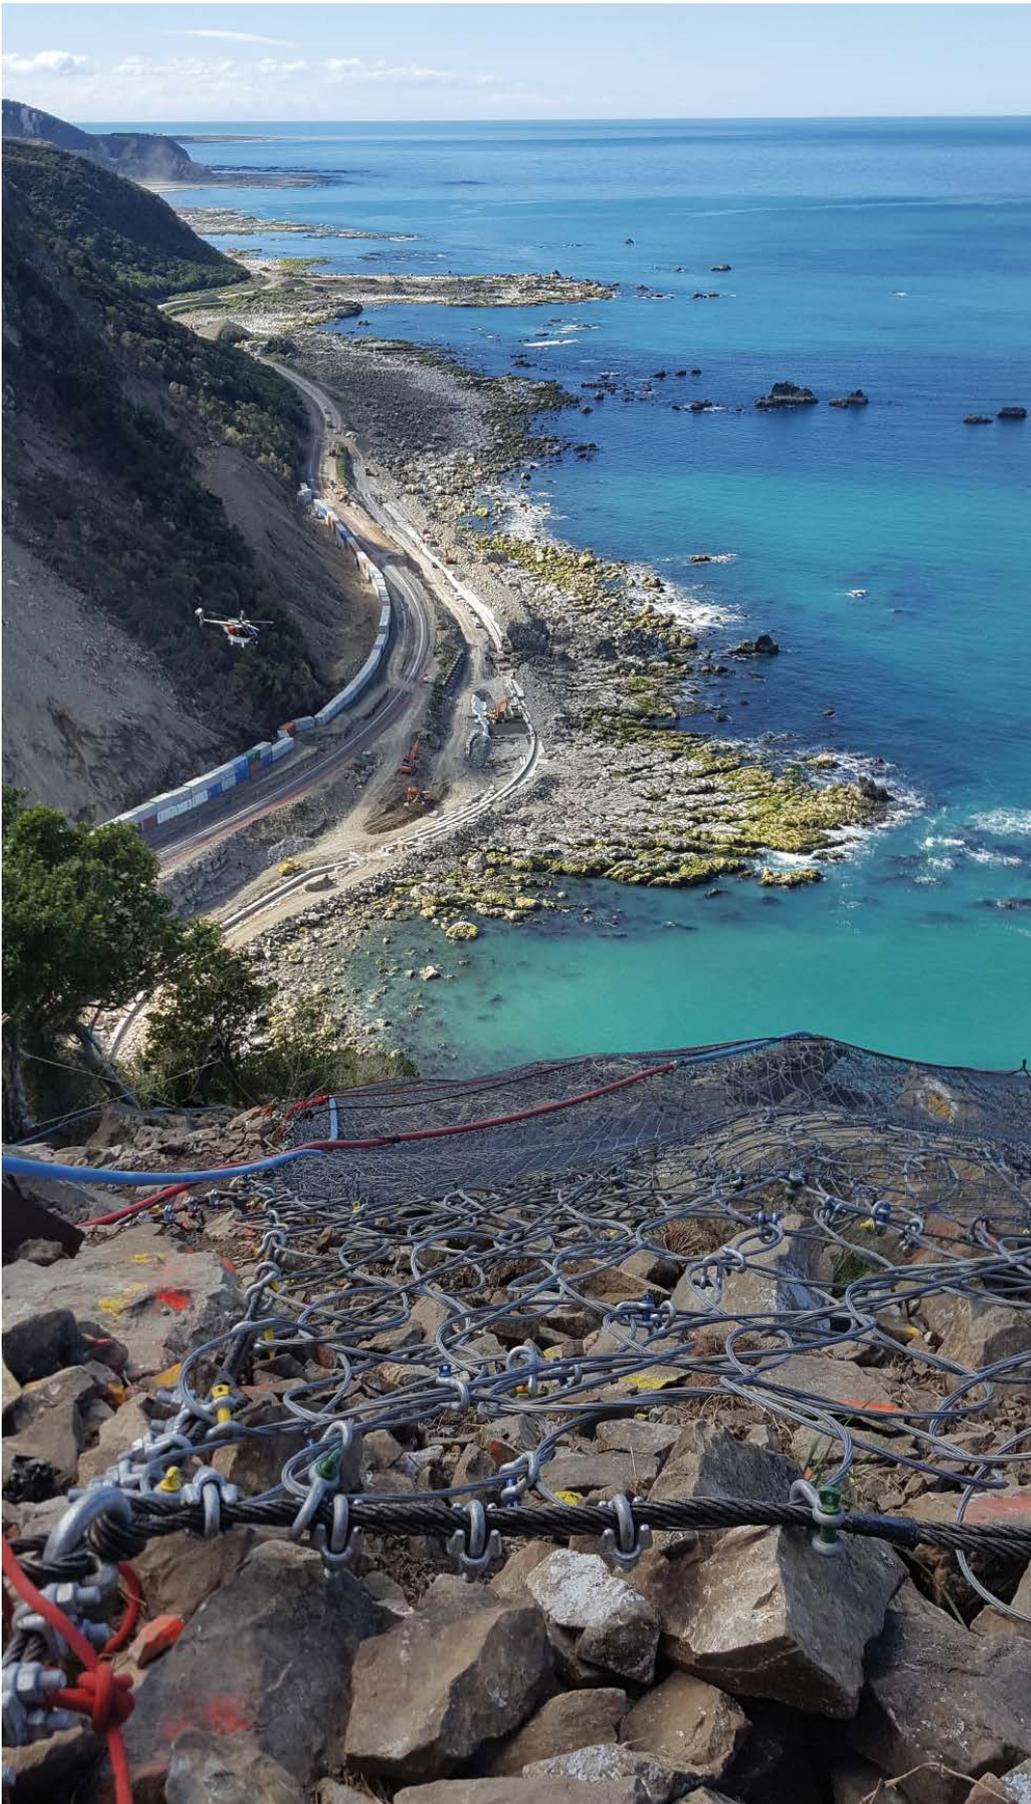
**Figure 6:** Completed drape showing perimeter anchor connection detail

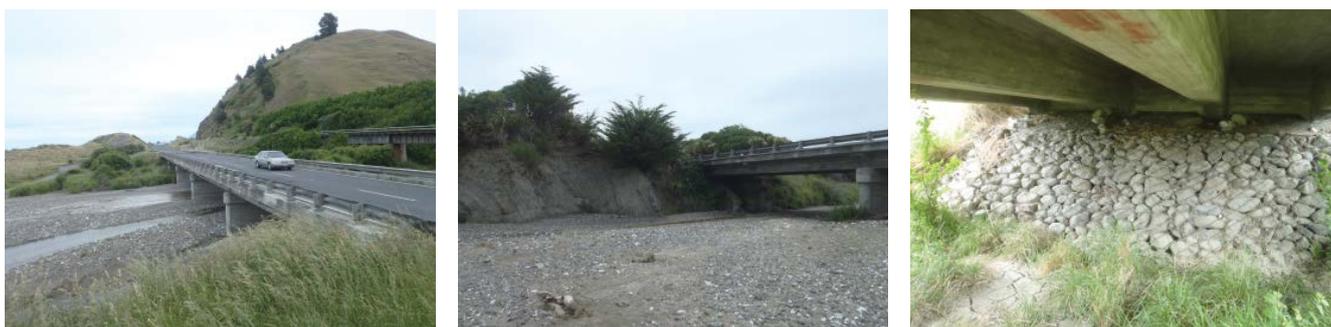
**Figure 2:** Kekerengu River Bridge, bridge overview looking south (left); north abutment on rock (middle); south abutment on soil (right) prior to earthquake

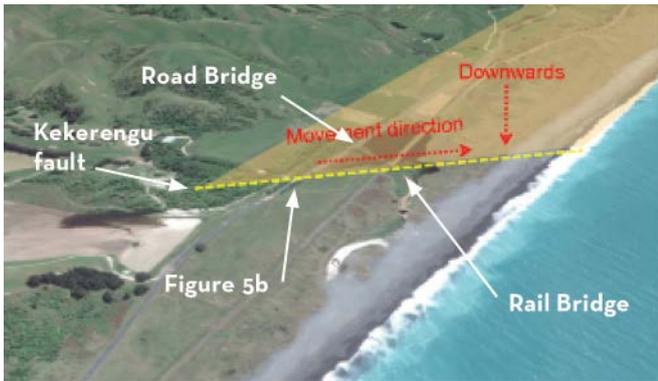
**Figure 6:** a) Strike-slip fault causing, ~2.5m downwards and 5m horizontal eastwards b) Road damage 185m away from bridge site (Photos courtesy of NCTIR)

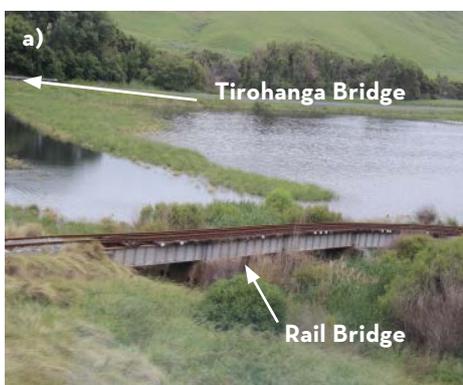
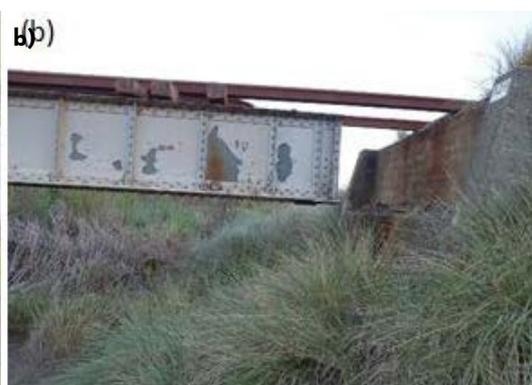
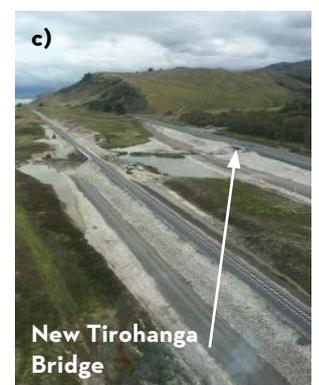
**Figure 7:** a) Flooding of the bridge site after earthquake, b) Rail Bridge unseated girder, c) new Tirohanga road and Rail bridges (photos courtesy of NCTIR and GEER)

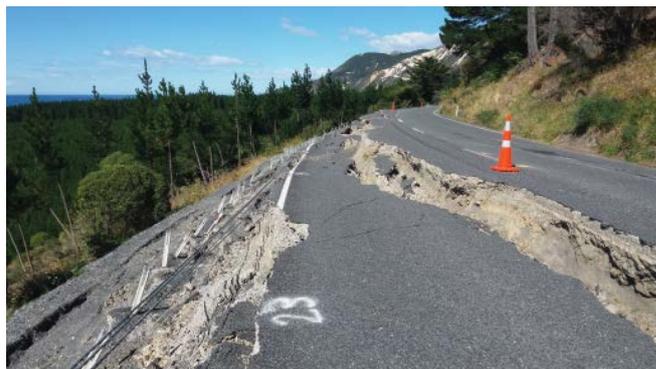
**Photograph 1:** Embankment failure at the Sand Pit, photograph taken January 2017.

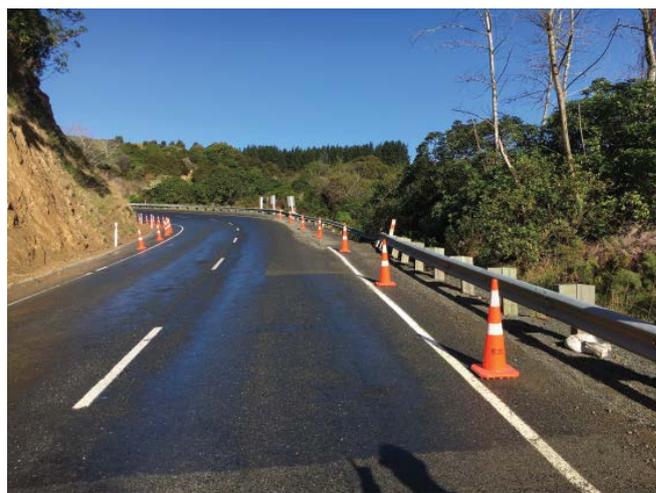
**Photograph 3:** Shoulder failure at the site of Wall 375.

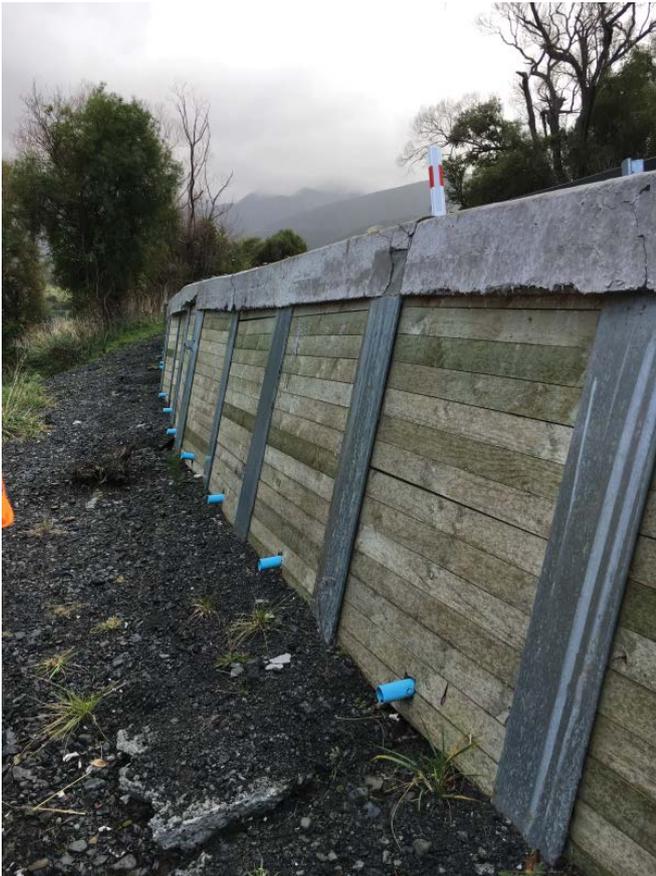
**Photograph 5:** Damage to Wall 433 due to the 2016 Kaikōura Earthquake, photograph taken early 2017.

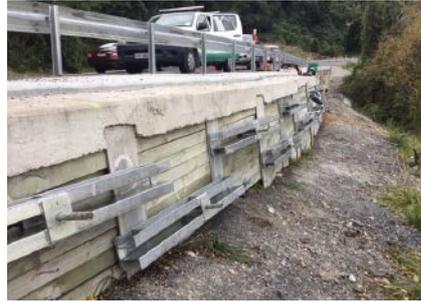
**Photograph 6:** Photograph of Wall 433 before anchor heads were installed, taken May 2018.

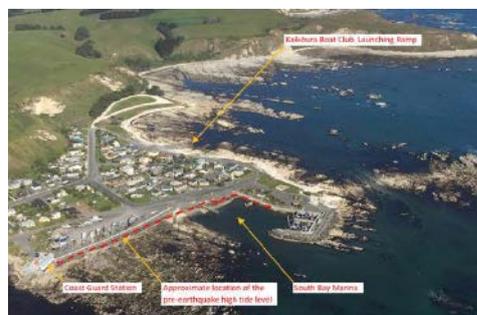
**Photograph 1:** South Bay Marina and Coast Guard Station. This photograph was taken on 25 November 2016, within approximately 30 minutes of high tide.

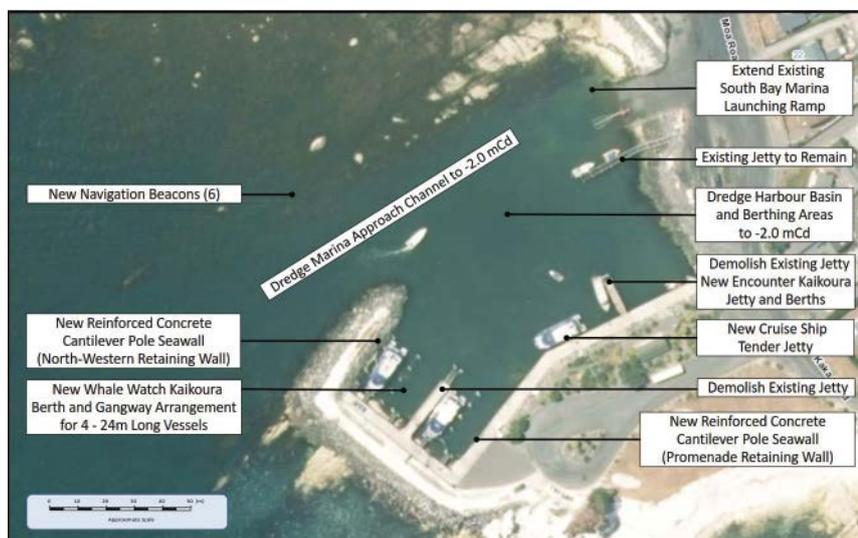
**Figure 2:** Overview of the works that were completed at the South Bay Marina site as part of the NCTIR program.

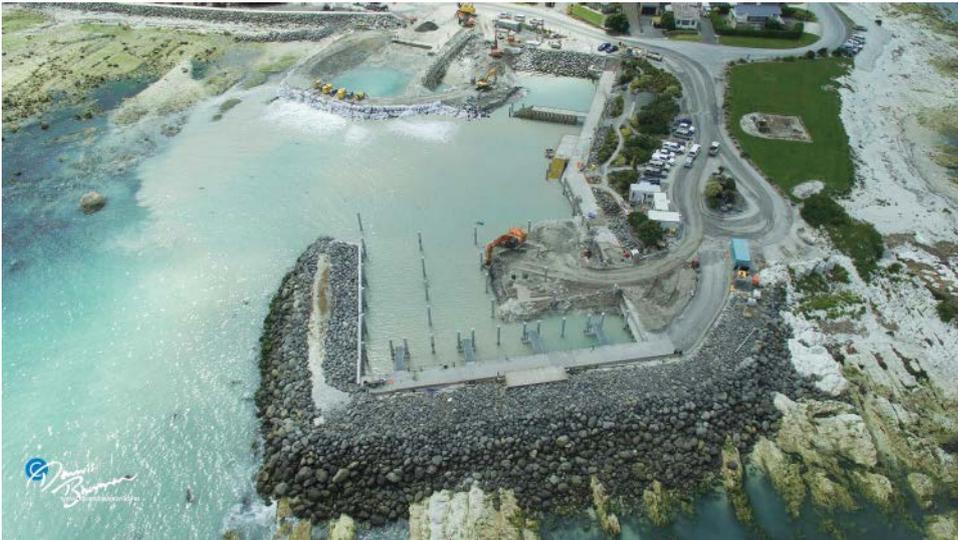
**Photograph 6:** South Bay Marina, 24 October 2017. Construction of the temporary coffer dam around the marina launching ramp is complete (top left-hand corner of photograph).

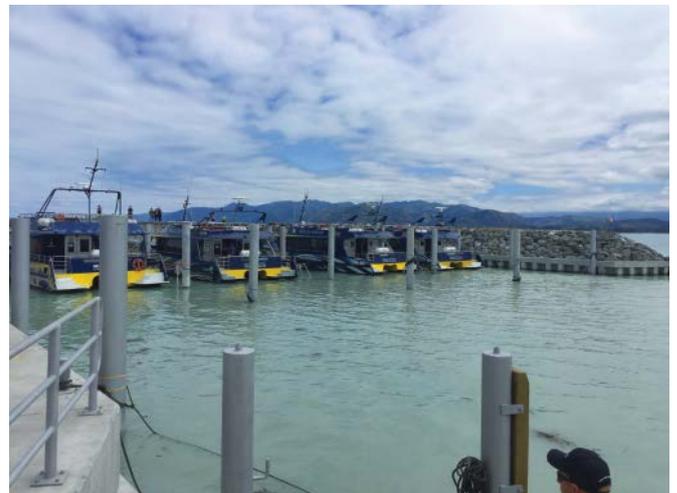
**Photograph 7:** Completed Whale Watch Kaikōura berthing area and north-western retaining wall. (Photograph taken at approximately high tide on 14 November 2017).

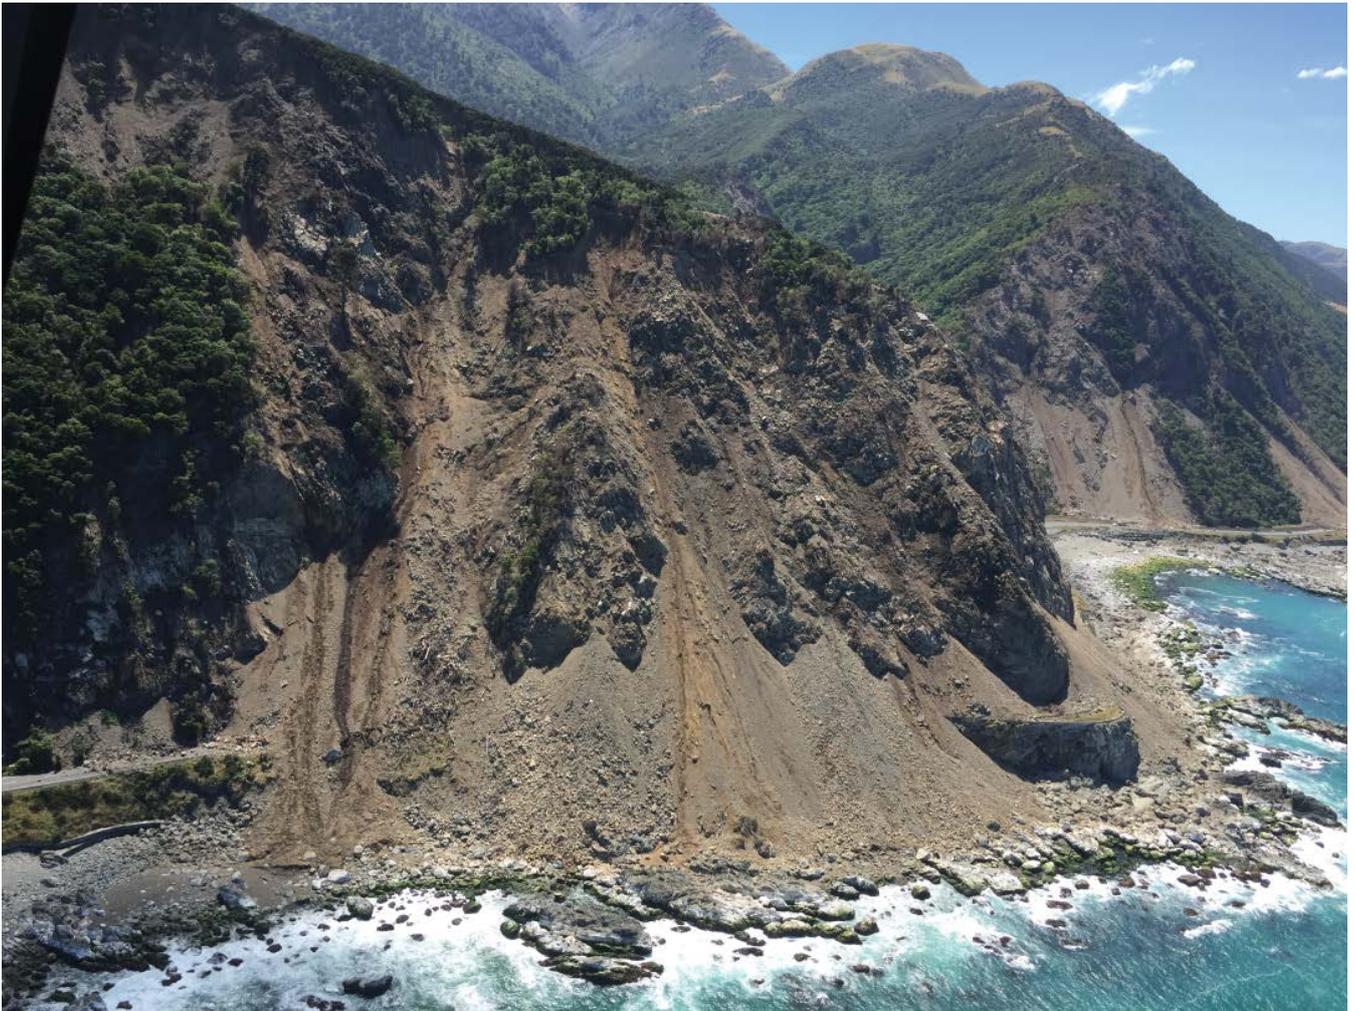
**Figure 1:** Ohau point landslide debris covering SH1

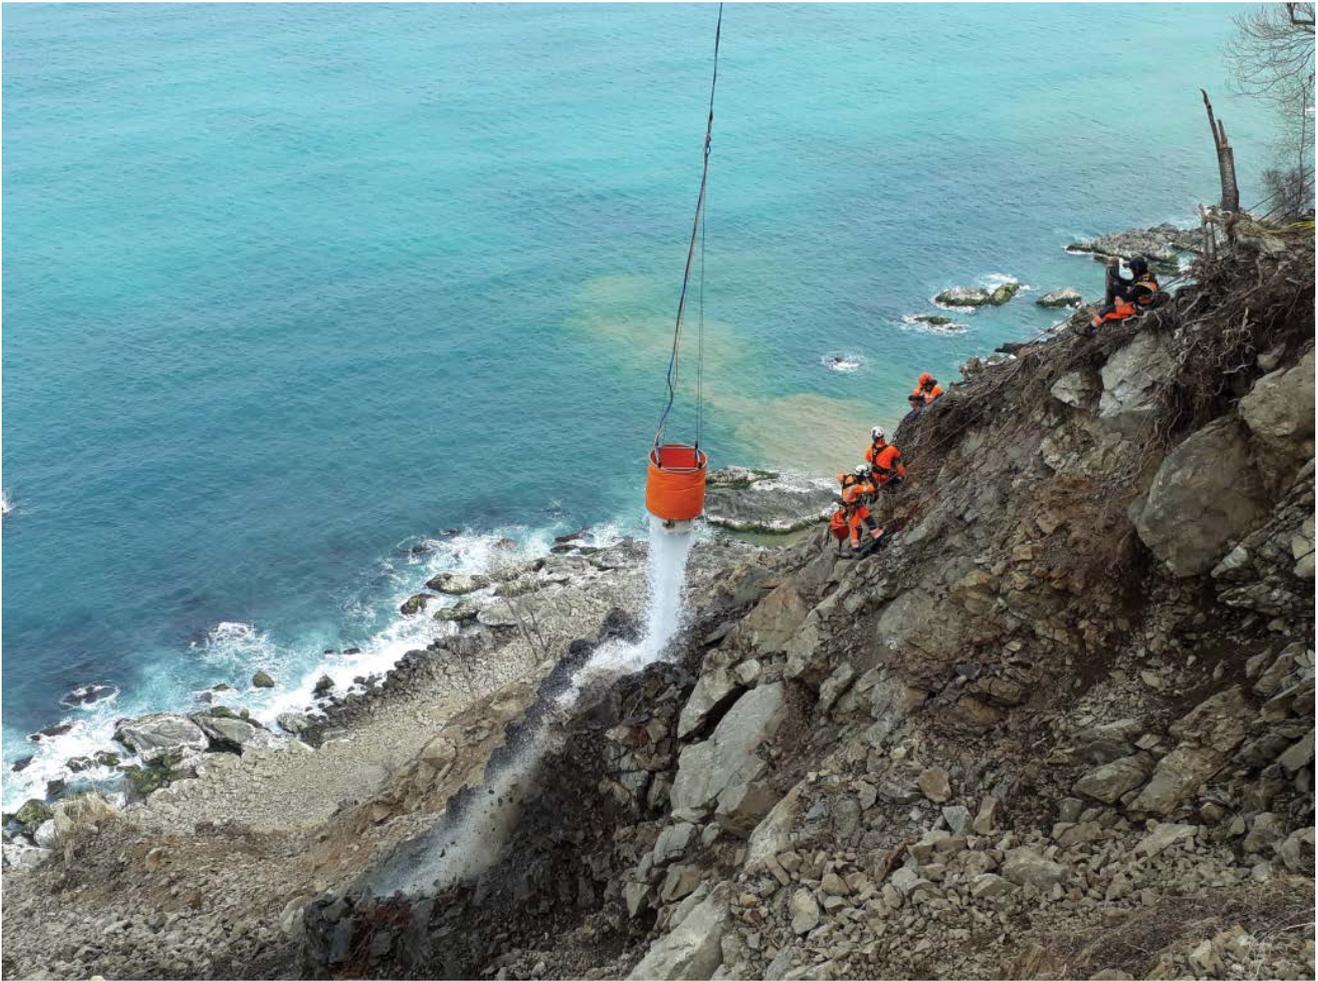
**Figure 5:** Abseil scaling and targeted sluicing

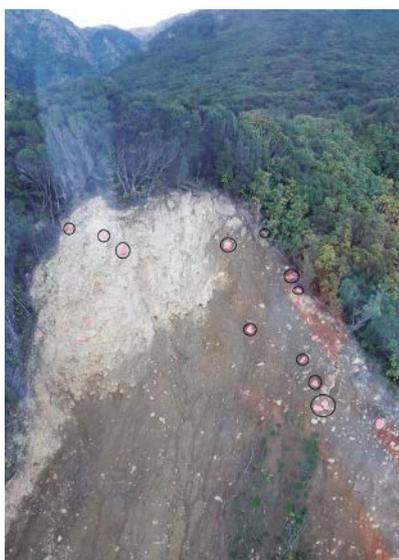
**Figure 10:** Spray-painted rocks in a rockfall source area for tracking during rock-roll trials
