Turning Disaster into Knowledge

J. D. Bray¹, E.M. Rathje², and J. D. Frost³,

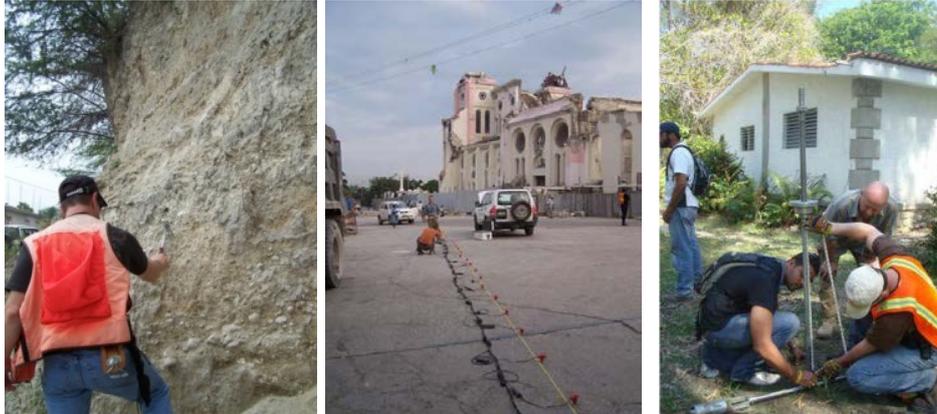
Figure 1. Field activities in Haiti: geologic and damage mapping, MASW testing, and DCPT testing

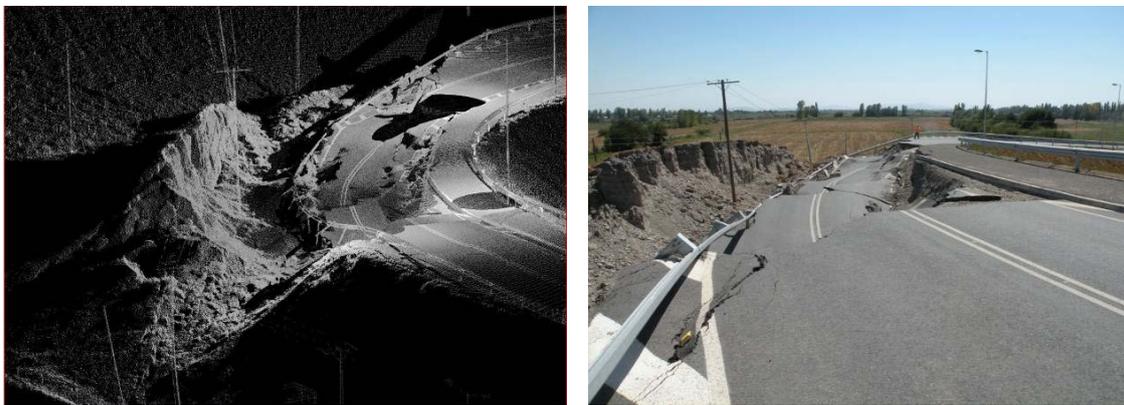
Figure 2. Ground-based lidar and optical images of a failed overpass embankment on Ruta 5 as a result of the 2010 Chile Earthquake (lidar survey by Kayen presented in Bray and Frost 2010)

example is the detailed depiction of a failed highway overpass embankment in Chile, which is shown in Fig. 2. The lidar image is analogous to a detailed digital photograph wherein each pixel is identified with its x, y, and z location.
