Good grounds for the future

24-26 March 2021 • Dunedin • New Zealand

Diana Falls – Then and now, moving from innovation to improvement.

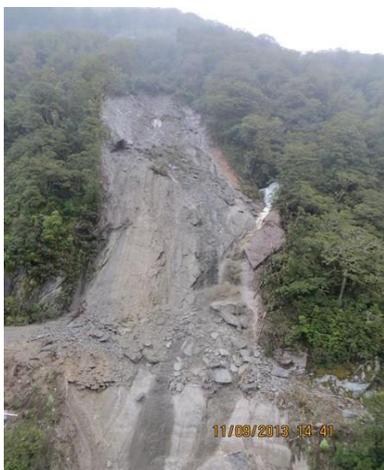
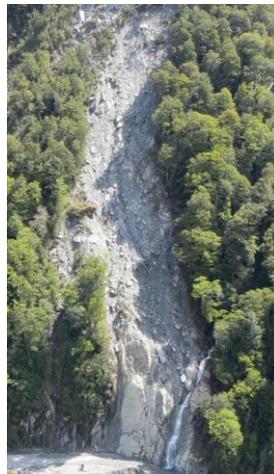
The resultant failure feature measured nearly 250m in height, 50m in width and nearly 5m in depth at select locations. The slip face angle varied between 35 and 42 degrees. The site is dominated by a steep vertical face some 40m high with an upslope above it of around 150m.

The composition of the failure ranged from silty gravel to large schist boulders up to 300t / 125 m³.

Figure 2 - Extent of the failure following repeat upslope failures dated November 2013 through to February 2014.

The failure originated at the crest of a vertical face with a large vegetation collapse. The slip quickly regressed upslope by around 100m as a rock and colluvium debris slide. The initial failure deposited around 10,000 cubic meters of colluvium and vegetation directly onto the road, bridge and slope over the Diana Falls stream. Over the following month the failure regressed up the steep slope by a further 100m with subsequent minor failures and slides depositing a total of over 30,000 cubic meters of debris. The failures were mainly associated with periods of heavy rainfall through the months of September and early October.

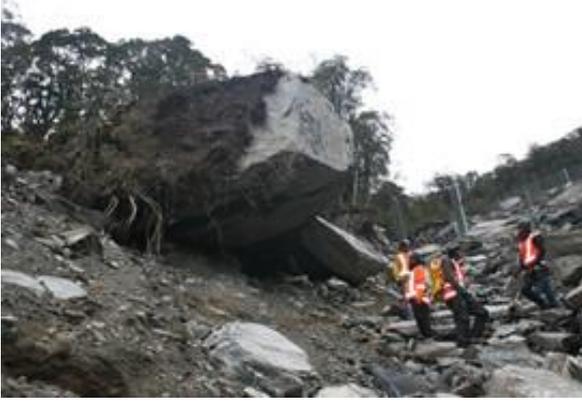
Figure 3 - Example of large boulder.

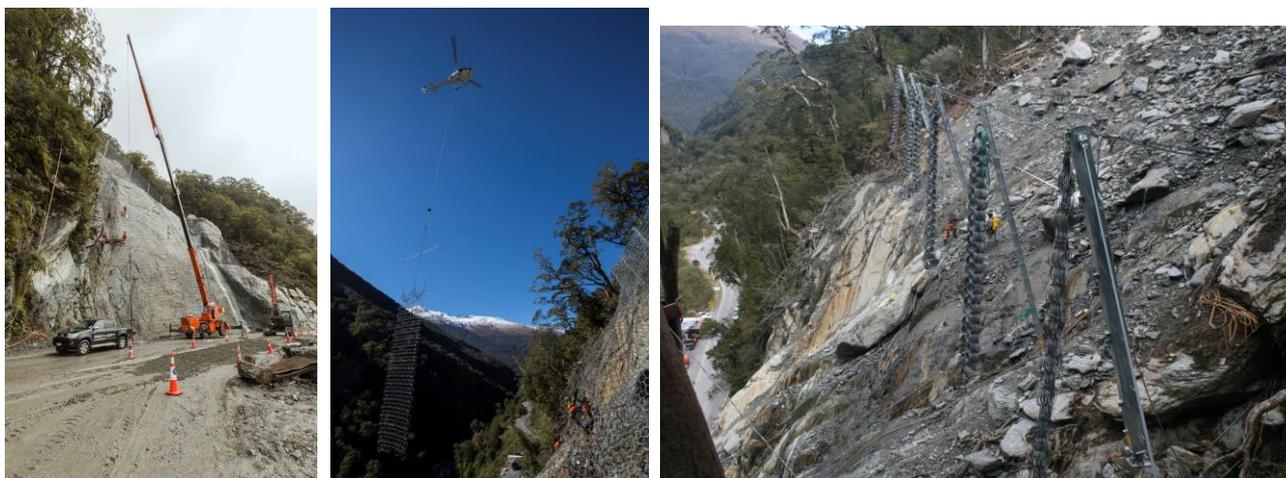
Figure 5 - Helicopter and Crane lifting (courtesy Geovert) And A3 under construction.

The installation commenced in 2014. The installation of the three attenuators were carried out by the specialist rope access contractor Geovert Ltd with barrier materials being sourced from Geobruigg Switzerland, Australia and New Zealand. The construction required helicopter lifts for the upper two attenuators (A1 and A2) and a crane for the lower attenuator (A3). A top down approach was used to maximise the safety of the installation crew and to enable additional road level works to be advanced on an accelerated programme.

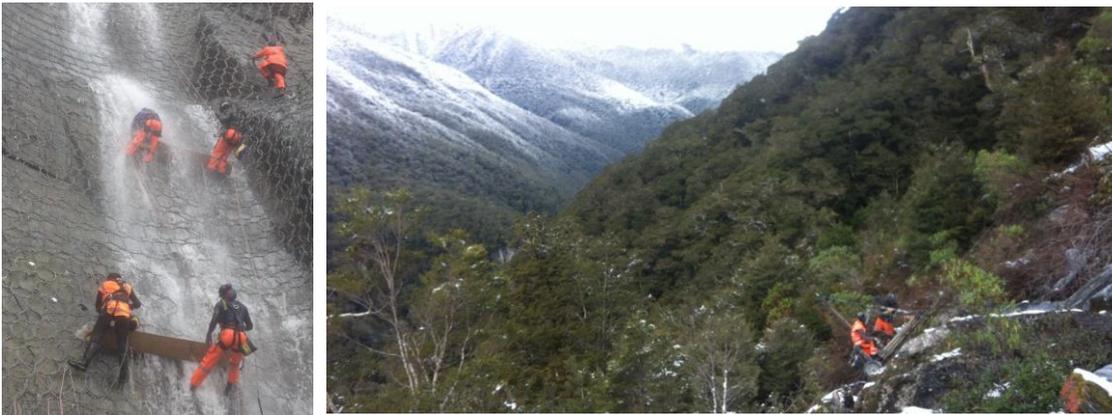
Figure 6 - Extreme working and weather conditions (courtesy Geovert)

The lateral anchors and base plate anchors were installed following a large blasting, scaling and sluicing operation. The 6-8m long 32mm grouted bar anchors were installed with onsite abseil crews and site based geotechnical staff providing full time supervision and observation of rockfall events. Communication to the traffic stop go operators was by radio as no direct line of sight could be achieved. The active monitoring of the works and the slip enabled partial and controlled openings of the road throughout construction. Due to the nature of the site and the environmental conditions, frequent rain, seismic and snow events created rockfall and debris slides throughout the duration of the works. These were managed through a developed site management and operations plan with developed site triggers, inspection policies and safety zones established for both on the slope and at road level operations. Repeater stations and mobile phone

communications were temporarily established and maintained throughout the works to enable quick and efficient updates to NZTA, emergency services to be made.

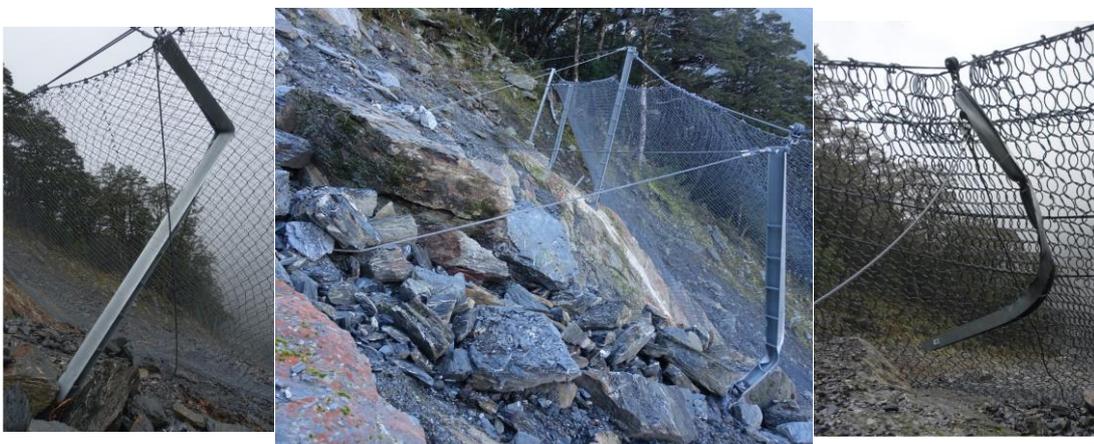
Figure 7 - Examples of post impacts and component failures due to static and dynamic loads

After replacing several posts due to rockfall damage over the first 3 years the system was modified to remove the frequently impacted posts completely. This design change required re-assessment of rockfall impacts on the posts and barriers recorded over the previous 3 years and review of the management of sliding boulders above the attenuators. The accepted re-design allowed for additional top rope sag of 0.5m, reduced the post replacement programme and made significant savings on maintenance operations and component replacements.

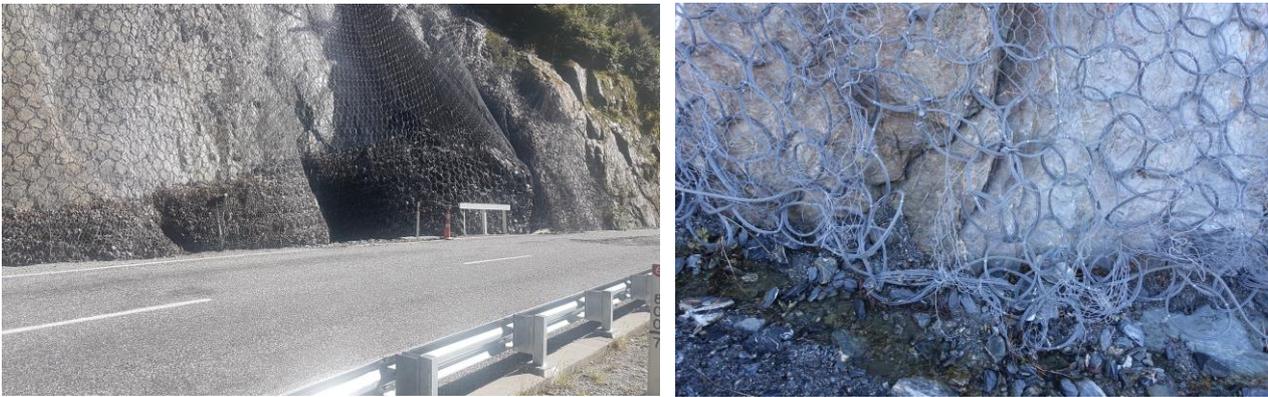
Figure 8 - Debris catch in A3 following heavy rainfall

The barrier impact's and attenuator loads have been monitored annually enabling a full assessment of component failures and design alterations to be instigated as the system has been activated. Examples of changes include removing the posts on A1, adapting the bottom rope of A3 to facilitate easier clearing of slip debris and replacing the secondary mesh on A3 to reduce puncturing and tearing by tree fall. This level of monitoring and continual improvement is key to developing a successful and economic rockfall protection system.

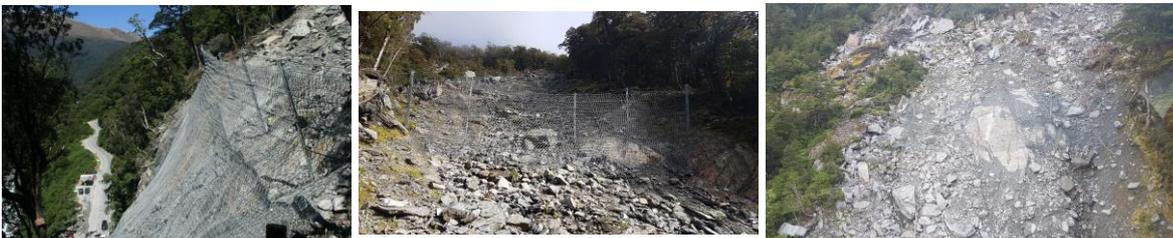
Figure 9 - completed Attenuators A3 left A2 middle A1 Right

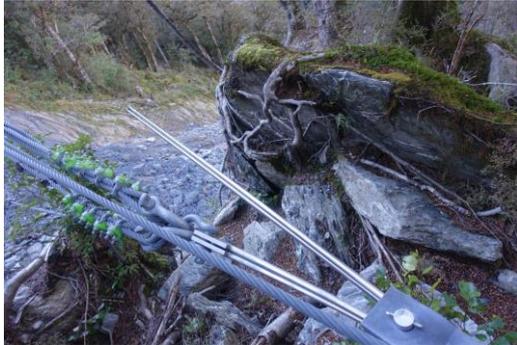
Figure 10 - 400mm elongation of a 3000mm U-brake at Diana Falls.

The key learnings from the 1:1 attenuator testing included significantly lower anchor forces with no requirement for braking elements or transmission ropes. These simplifications make the new style attenuators more economic compared to the equivalent modified EAD rockfall barrier. These findings are in line with the performance of the Diana falls attenuators as to date only the top transmission ropes U brakes on attenuator 2 (A2) have slightly elongated after many design level impacts.

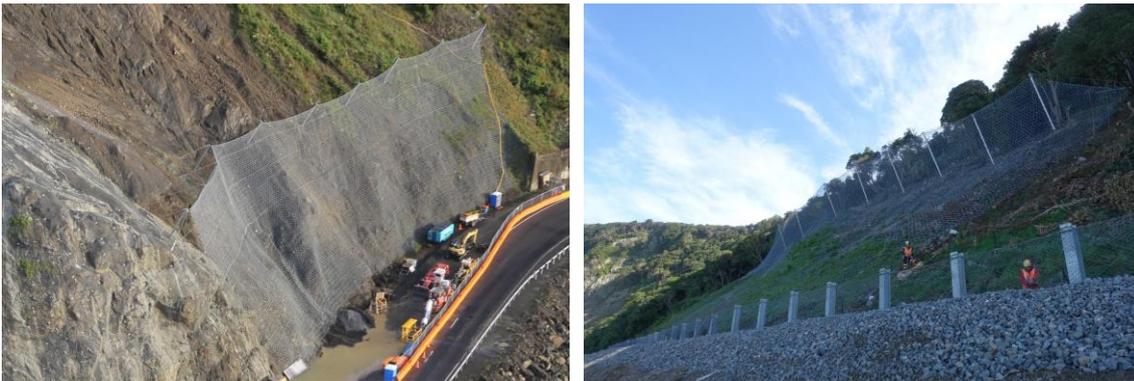
Figure 11 - Kaikoura Modified RXE2000 Attenuators

In 2017/2018 two similar attenuator systems were installed in Kaikoura. The Kaikoura systems were based on 4m high RXE 2000 EAD class A approved rockfall barriers. The main difference with the Kaikoura systems are that the impact block size is smaller than that for Diana Falls (<1m³) and only a single attenuator was required. Although likely over engineered the systems are working well.

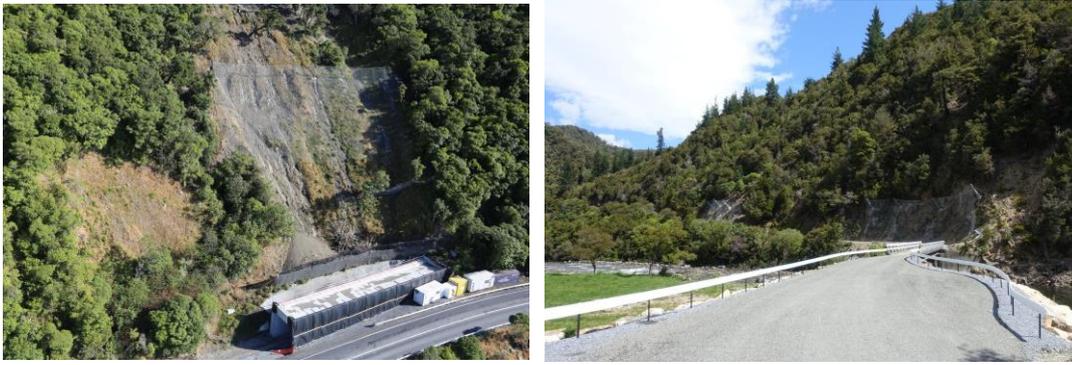
Figure 12- ATT-60 (left) and ATT-40's(right)

In 2019 a new Style ATT-60 was installed in Kaikoura. The system was selected over an EAD modified barrier due to the faster and lower cost installation with no need for a secondary mesh. The ATT-60 also has a lighter tail so the frequent low mass high velocity impacts on the shallower ~45 slope can pass through.

Two ATT-40's have also been installed in Cobb Valley, NZ the systems utilise a fixed post (no upslope ropes) which meant they could be installed from the road with an excavator mounted drill.

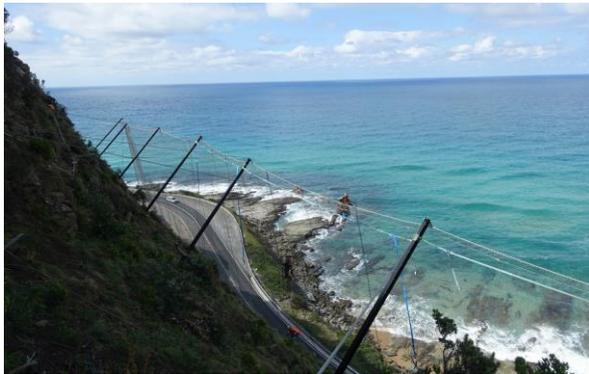
Figure 13 - (left) Stainless steel ATT-40.

In Australia the design approach is much the same as New Zealand. A Stainless-steel ATT-40 was recently installed (2020) on the Great Ocean Road. Stainless steel and galvanised epoxy posts with isolators were selected to meet the design life in the aggressive coastal environment. Several more ATT systems are in the planning and installation stage across Australasia.
