Sensitive pyroclastic soils in the Bay of Plenty, New Zealand: microstructure to failure mechanisms

Keywords: sensitive soil; tephra; halloysite; microstructure

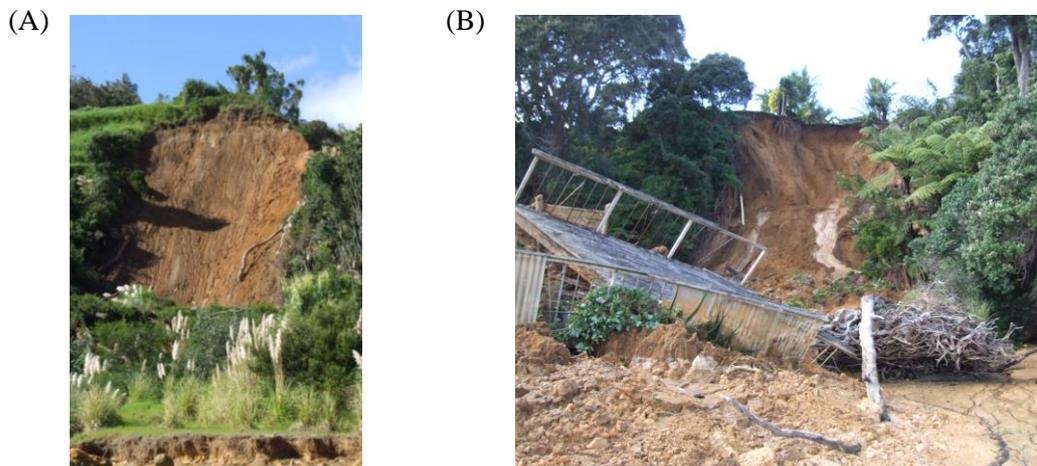
Figure 1. Translational (A) and flow-slide (B) landslides initiated following the passage of Cyclone Debbie on 4/5 April 2017. Although translational failures can denude large areas of the slope, flow-slides cause greater excursion into the slope and hence pose greater risk.

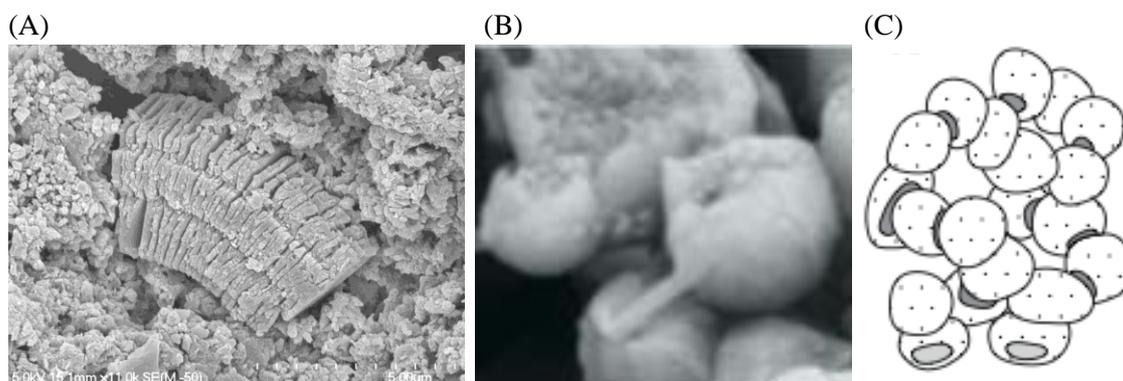
Figure 2. Scanning electron micrographs of (A) book and (B) mushroom-cap morphologies of halloysite. (C) Inferred framework network of mushroom cap clay minerals. Image credits: (A) Helen Turner, (B) and (C) from Kluger *et al.* (2017).

Recently we have recognised two more morphologies of halloysite in Bay of Plenty sensitive soils: books (Cunningham *et al.*, 2016) and mushroom-caps (Kluger *et al.*, 2017). The book morphology (Figure 2A) mimics a common morphology of kaolinite, and may have been responsible for mis-identification of halloysite clays in the Bay of Plenty in previous work. The mushroom-cap morphology (Figure 2B) is recognised from the same location at Bramley Drive as the spheres described by Smalley *et al.* (1980). With improved SEM technology, we identify these spheres as incomplete: individual halloysite spheroids are typically ~250–400 nm in diameter with openings ~80–160 nm in diameter on one side, giving the “mushroom-cap” appearance. We infer that the spheroids observed are composed of concentrically stacked 1:1 layers, reminiscent of the structure of an onion. A complete silanol layer, as comprises the outer sphere surface, carries a net negative charge. In the openings, ends of both silanol and aluminol sheets are exposed, giving a neutral or weakly positive overall charge. Electrostatic or van der Waals forces lead to attraction between the negatively charged convex surfaces of the silanol sheets and the weak positive charges of the concave openings, allowing the individual minerals to aggregate into a network of connected particles in the undisturbed state (Figure 2C). The attractions are short-range however, and detachment by remoulding allows a disaggregation, giving the material a low remoulded strength. While the various halloysite morphologies occur mixed throughout the profile; the mushroom-caps are most abundant in the highly sensitive layers, whereas tubular halloysite is more abundant in the upper, less sensitive materials.

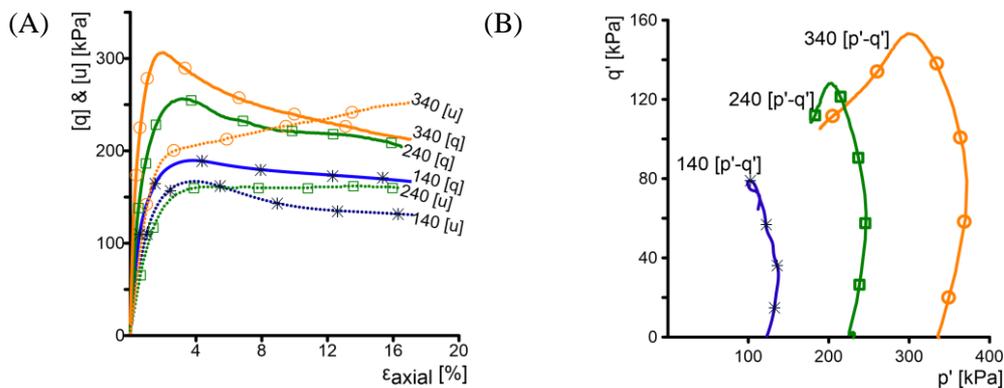
Figure 3. (A) Deviator stress versus axial strain, and (B) effective stress path plots for static triaxial tests (from Mills and Moon, 2016)

samples were stored in their tubes in sealed chambers until immediately before testing. Testing followed standard NZ procedures (NZS4402 (1986)), with the exception of the rate of stress application where a high rate of 0.5 mm min^{-1} was chosen following the model of Gylland *et al.* (2013). B values greater than 95 % were achieved during saturation, and isotropic consolidation stresses of $140\text{--}340 \text{ kN m}^{-2}$ were applied to bracket field overburden stresses. Test results are summarised in Table 2 and plotted in Figure 3.

Samples failed at axial strains of 3.2 % or less, and exhibited significant strain softening post-failure as expected for sensitive soils. Pore water pressures climbed sharply on application of axial stress, then dropped or plateaued post-failure in the samples tested at lower effective confining stresses ($\sigma_c = 140$ & 240 kN m^{-2}), but continued to increase after failure in the sample at the highest confining stress ($\sigma_c = 340 \text{ kN m}^{-2}$). Effective stress path plots show contractive behaviour, particularly at the higher confining stresses.

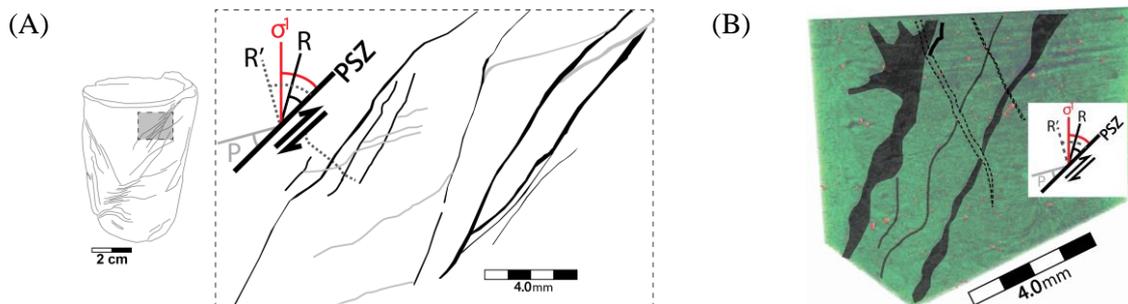
Figure 4. Thin section (A) and microCT section (B) of failure surfaces (from Mills, 2016).

Thin section samples (tested at 240 and 340 kN m⁻²) show multiple principal shear zones evidenced by zones of particle reorientation up to 1.0 mm wide that have distinct boundaries with the surrounding matrix material (Figure 4A). The shear zones are continuous across the full length of the thin sections, and commonly show branching and coalescence, most notably around weathered zones or particle concentrations. As well, minor shears that are not continuous are commonly observed. A portion of the micro-CT scan image (sample tested at 355 kN m⁻² effective stress) is shown in Figure 4B. A matrix of clays is indicated in green, dense particles are red colours, and shear zones are highlighted with pale green, black and pink annotations. All angles are measured with respect to the angle of the macroscopic principal shear (PDS) identified on the failed core. Two small shear zones 0.05–0.1 mm thick and spaced 2–3 mm apart are apparent in the core. These are most closely oriented to the direction expected for Reidel R shears, and are linked by antithetic R' shears. Reorientation of particles within these shear zones is not apparent, but the clay matrix within the shears is notably denser than in the surrounding matrix.

Overall, we observe brittle failure occurring along multiple shear zones oriented approximately as expected for Riedel shears, with some antithetic (R') shears observed linking the principal shear zones. Clay minerals are densified in the shear zones compared with the matrix density, and larger grains are reoriented to parallel the shear zone.

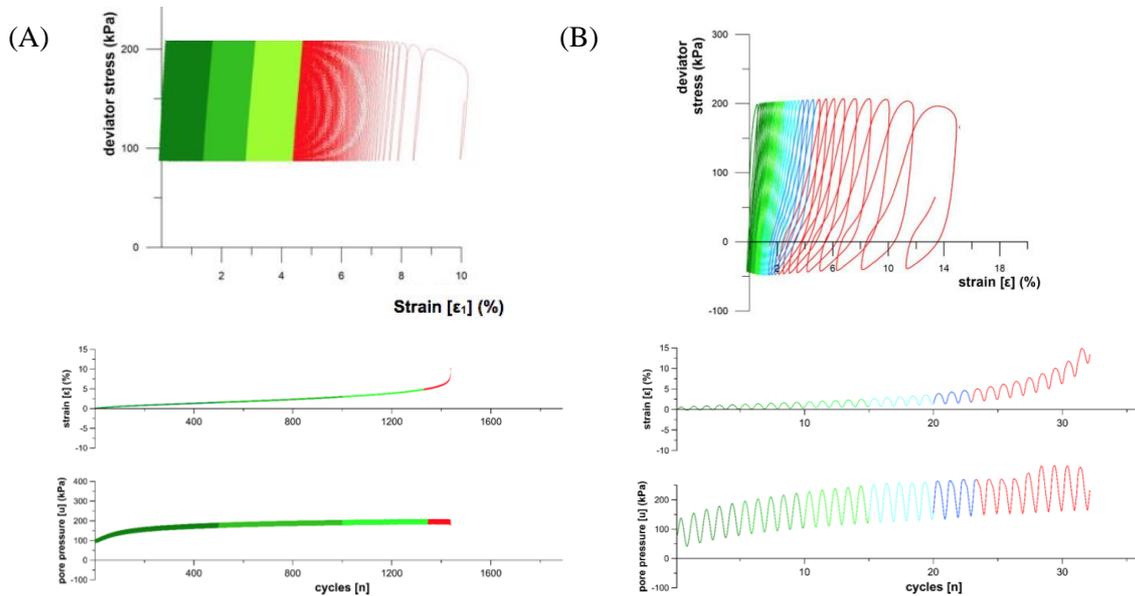
Figure 5. Cyclic triaxial test results for two samples. (A) 75 kN m⁻² average applied stress, 30 kN m⁻² cyclic stress; (B) 40 kN m⁻² applied average stress, 60 kN m⁻² cyclic stress (from Mills, 2016)

Figure 5A shows the test results for one sample tested at with high average shear stress of $\tau_{av}=75$ kN m⁻² and low cyclic shear stress of $\tau_{cyc}=30$ kN m⁻², meaning that the sample remains in compression throughout the test. Notable is that the hysteresis loops remain relatively unaffected by loading cycles for most of the test, then the sample fails suddenly over a few cycles (failure in this case is defined as 5 % single amplitude axial strain). Pore water pressure rises sharply as the stress is initially increased, then remains high throughout the test. By contrast, Figure 5B shows the results of a test run with average shear stress of $\tau_{av}=40$ kN m⁻² and cyclic stress of $\tau_{cyc}=60$ kN m⁻² (ie. the sample experienced extension for part of each loading cycle). Both samples described develop compressional strain and increased pore water pressure throughout, but in the second test

the hysteresis loops develop a much more distorted shape (decreased stiffness), especially in the extensional regime, as the sample approaches failure; post-failure the pore water pressure increases and the stiffness decreases markedly.
