## A risk based assessment to rockfall mitigation

C J Parkes  
Opus International Consultants, Christchurch, New Zealand.  
[Christine.parkes@opus.co.nz](mailto:Christine.parkes@opus.co.nz) (Corresponding author)

The Health and Safety at Work Act (2015) requires companies to provide safe working environments for its staff. In response to this, our client sought to identify effective mitigation solutions for a rockfall hazard above an operational access road. The slope consists of a near vertical, 15 m high, cutting into a steep ( $\sim 35^\circ$ ) natural slope. Below the cut face there is a single lane access road, with the natural slope continuing below. Groundwater seepage near the top of the cut face has resulted in ongoing rockfall, presenting a hazard to staff using the access road. Previous geotechnical assessments had recommended large scale earthworks to reshape the cutting to remove the hazard. This paper presents an alternative risk management approach developed by Opus, identifying the most appropriate mitigation solution. The current level of risk was evaluated (using the AGS Landslide Risk Management Guidelines), and compared with industry standards to determine an

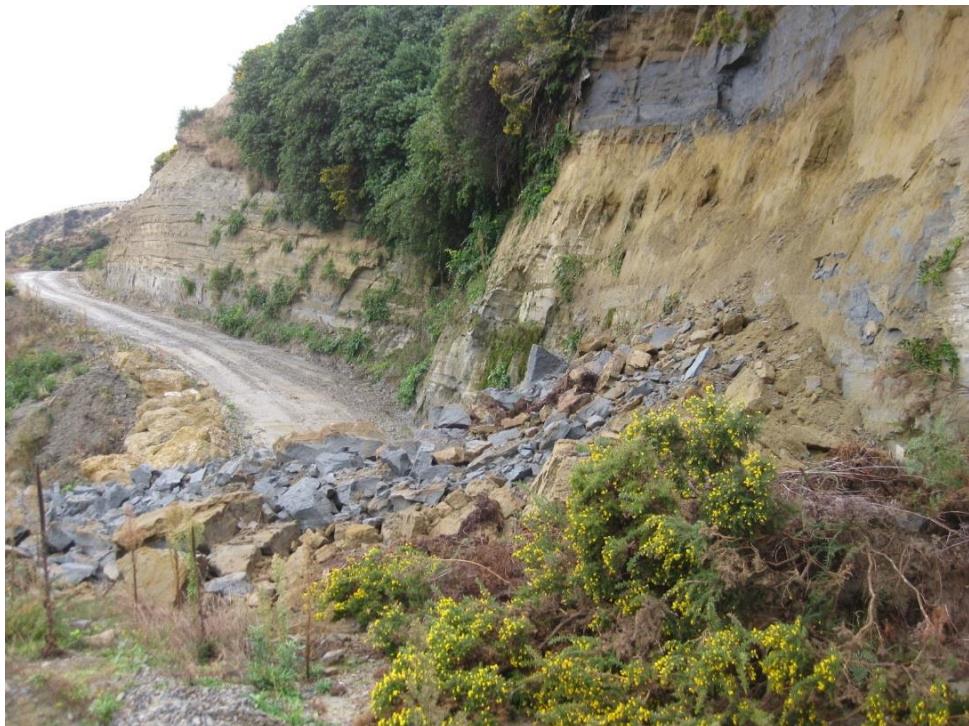
The full length of the cutting is prone to isolated rockfalls, however a section of cut approximately 20 m in length has a higher frequency of rockfalls, and occasional larger batter failures. The client indicated that small rockfalls ( $< 2 \text{ m}^3$  in volume) occur 1 – 2 times per annum. A larger event occurred in 2010 which inundated the full width of the access road (refer to Figure 3).

**Figure 3: Slip in 2010, debris extending over the access road**

Individual rock blocks of typically 100 mm to 200 mm size were observed at the base of the slope. Thicker bedding further up the slope will likely result in larger blocks being dislodged (as is evident in Figure 3).

Weathering of material at the face being exacerbated by seepage is the inferred mechanism for small rockfalls. Subsequent undermining of upper portions of the slope then eventually results in

a larger failure (refer Figure 3). The face is expected to continue unravelling via regular small rockfalls and intermittent larger rockfalls.
