Post earthquake rockfall protection resilience for a lifeline transmission pylon in Christchurch

ABSTRACT

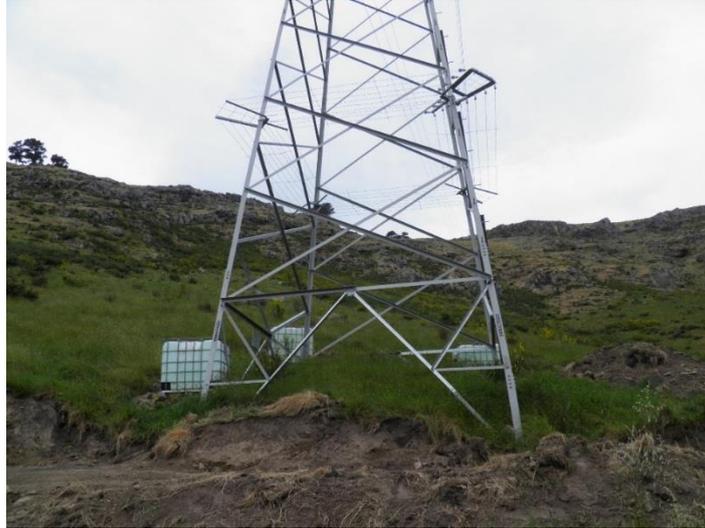
Figure 1: Transmission pylon prior to works

The pylon is situated on sloping terrain approximately 75 m above sea level, see Figure 1. Outcrops of volcanic rocks from the Lyttleton Volcanic Group are located approximately 180 m upslope of the pylon.

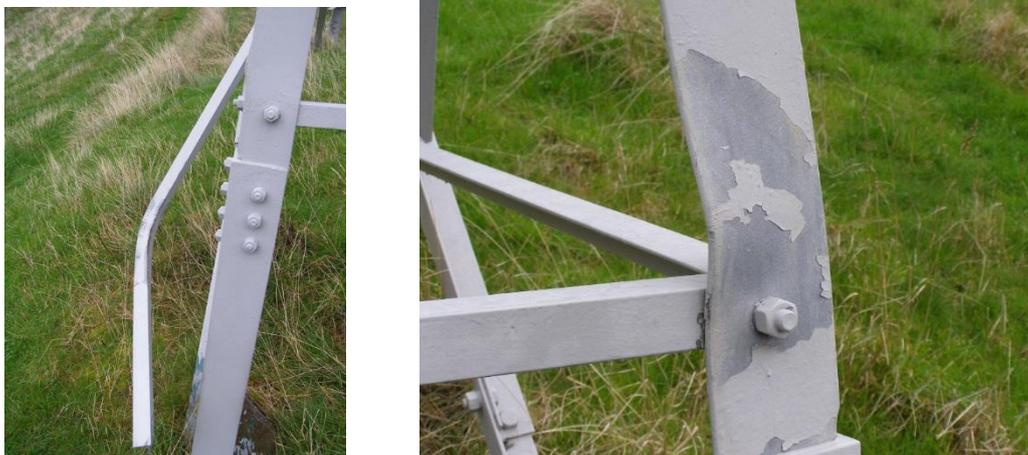
Figure 2: Examples of rock damage to pylon

Field mapping was undertaken by GHD staff to map and quantify; the number, type / size of fallen boulders as well as, potential source boulders from both rock outcrops and the slope around the pylon. Bounce height data at the pylon location was measured from impact marks on the pylon, see Figure 2.

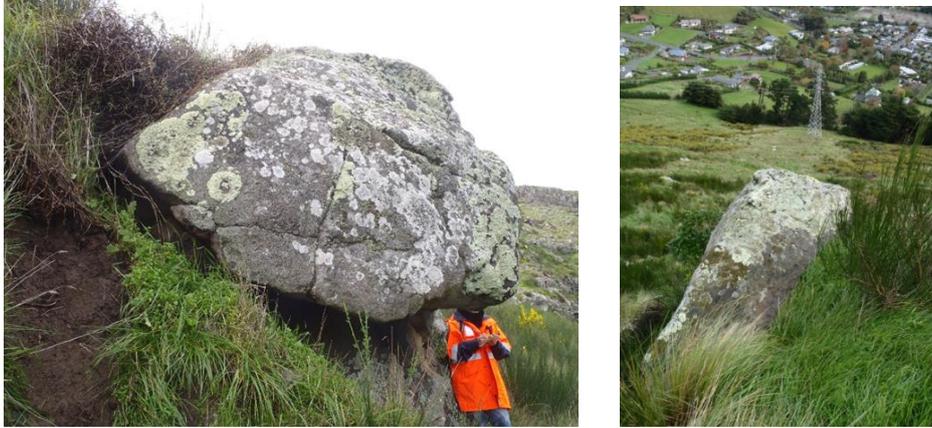
Figure 3: Precarious source rocks identified during walkover

Field mapping, see Figures 3 to 5, identified two types of potential rockfall boulders:

1. Boulders formed by defects in the bluffs (i.e. not yet released);
2. Boulders that had previously released from a bluff onto the slope below and were now supported by soil.

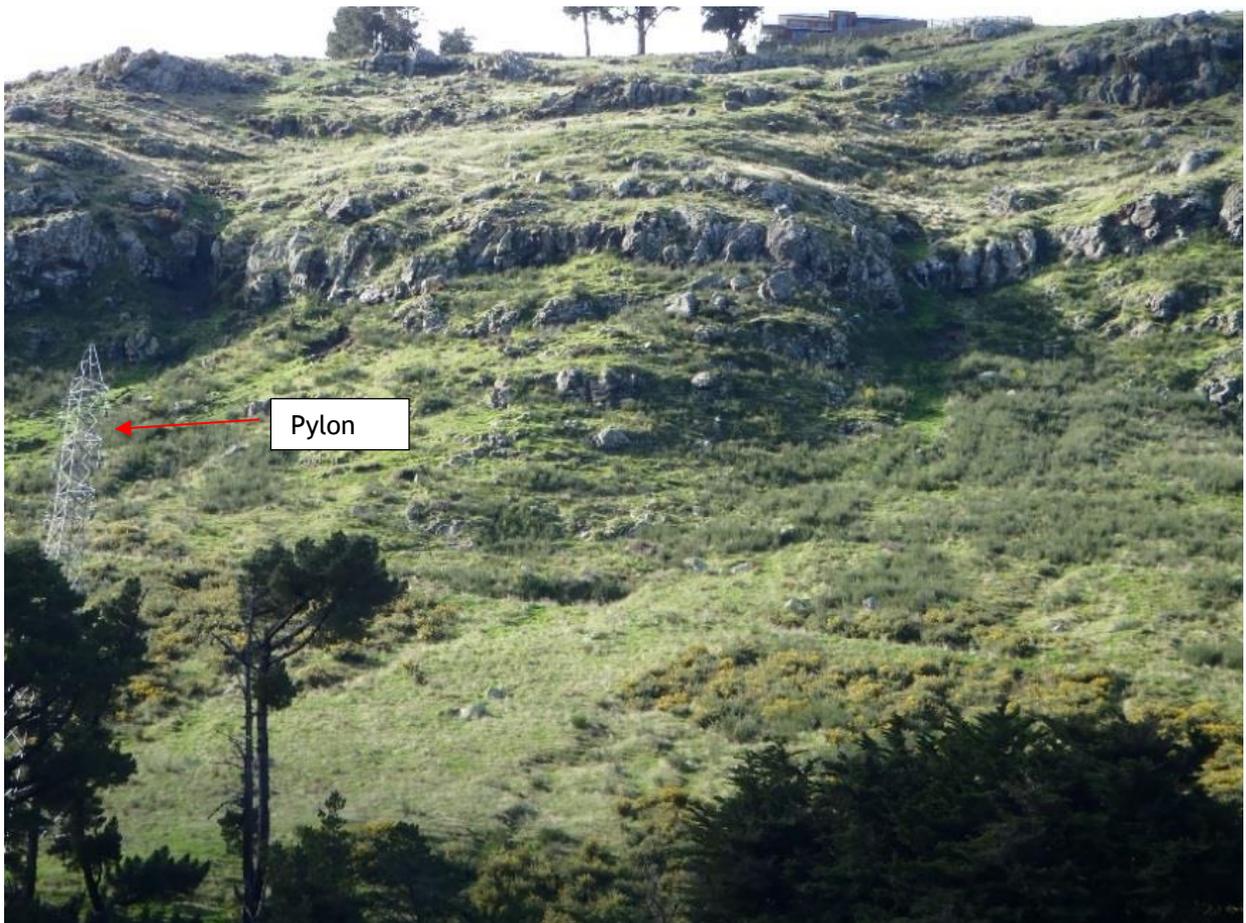
Figure 4: Looking upslope with pylon to the left.

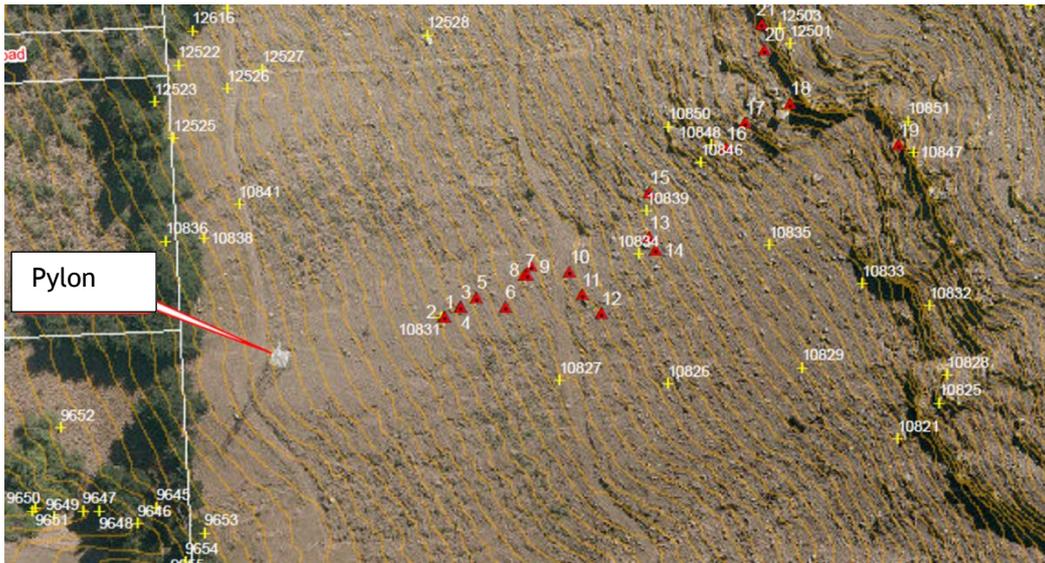
Figure 5: Mapped precarious boulders

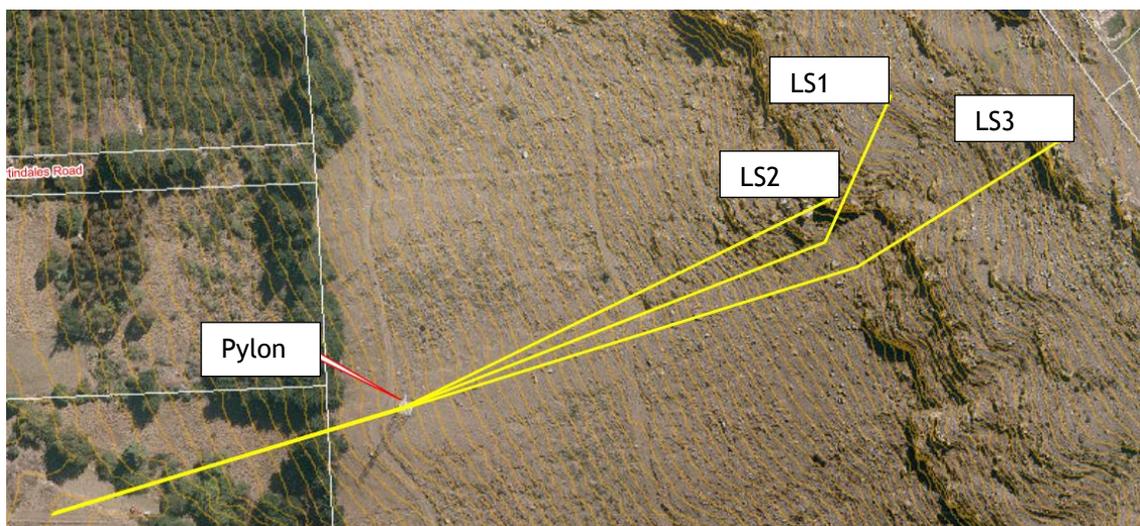
Figure 6: Boulder Runouts For Selected Sources

Three transects (LS1 to LS3) were run downslope from the bluffs through the pylon, see Figure 6. Two boulder sizes were considered for the modelling of potential rockfall risk:

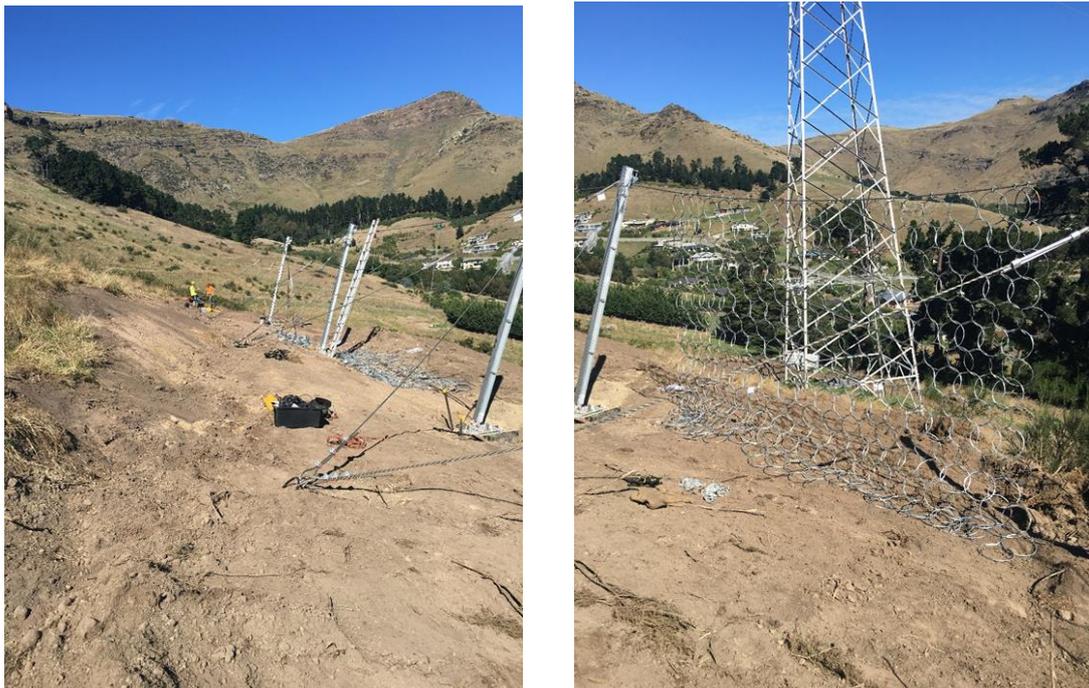
Figure 7: Construction

The rockfall protection fence was constructed by Solutions 2 Access Ltd with a rockfall protection fence provided by Geofabrics. Figure 7 shows the site during construction. Figure 8 shows the completed fence.

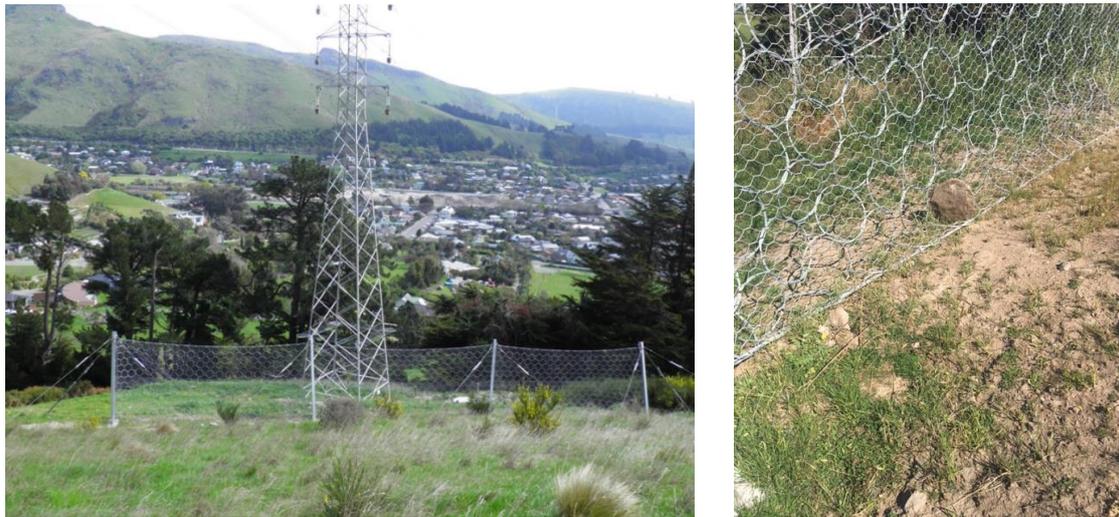
Figure 8: Completed fence

There are a variety of rockfall protection techniques that could broadly be classified into two types; source treatment and protection structures. These were considered and a combined approach using both source treatment of the larger boulders as well as construction of a rockfall protection structure. The construction of the rockfall protection fence reduces the risk of boulder strike to the pylon. To date a small amount of rock has been caught by the fence, see Figure 8.
