Good grounds for the future

24-26 March 2021 • Dunedin • New Zealand

# Application of the New South Wales RMS “Guide to Slope Risk Analysis” for Waka Kotahi, the NZ Transport Agency, projects.

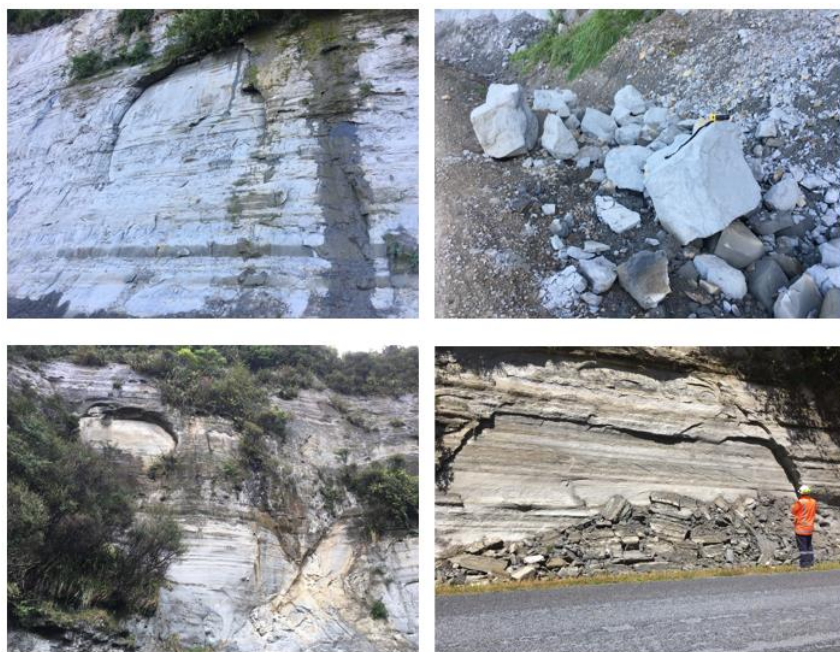
Slabbing failures, which are very common in the Tertiary-age soft rocks ubiquitous in the central North Island, are believed to result from a combination of stress relief (unloading due to cutting formation) and surface weathering (wetting-drying and heat-cool cycles); and therefore continue indefinitely. This leads to ‘slabs’ of rock which are typically 1 to 3m in length, 1 to 2m high and generally less than 0.3m deep (occasionally up to 0.5m). Some typical examples of slabbing failures within existing cuttings of the *Mim* are shown in Figure 5.

Figure 5: Slabbing failure examples from ‘papa’ rocks close to Mt Messenger.

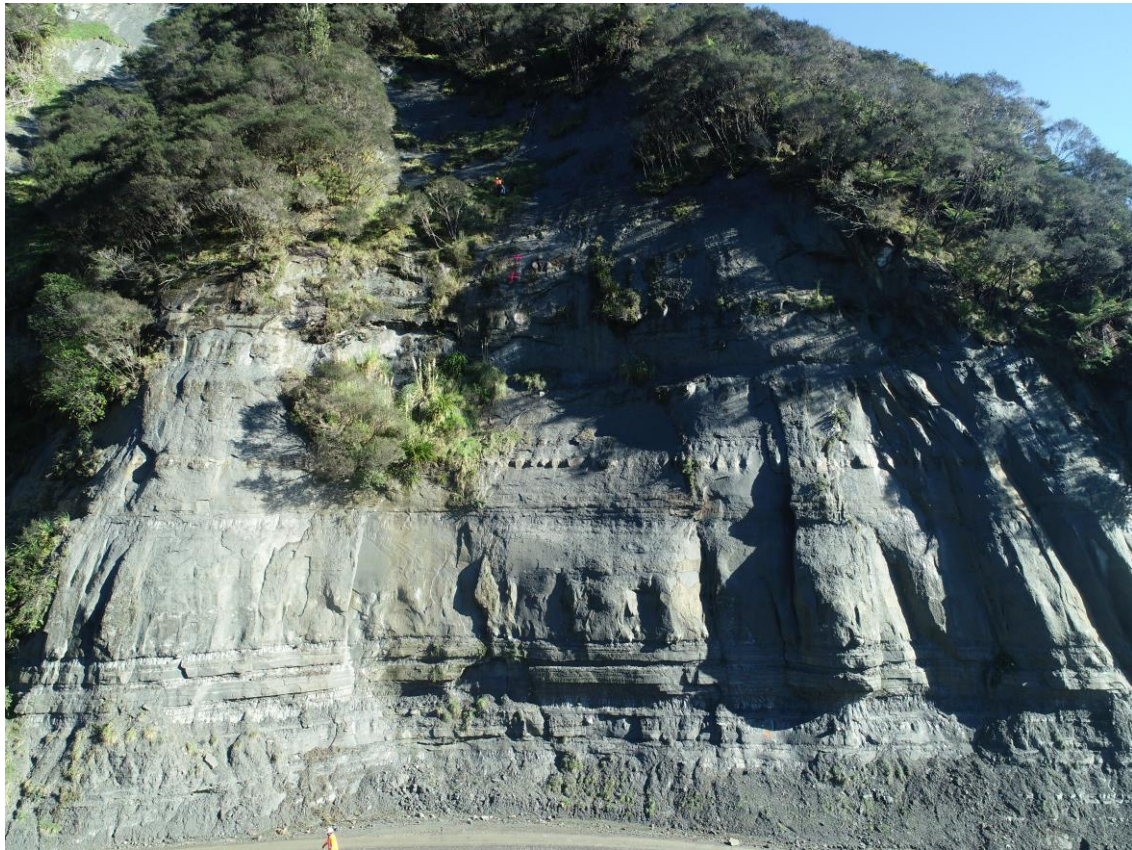
Unfortunately there were no suitable existing cuttings or natural slopes high enough and/or at a similar 2V:1H gradient, but the selected rockfall test site included an approximately 30m high cut face formed at close to 2V:1H, with a natural slope above to assist in releasing rockfalls from higher elevations to provide additional velocity required to replicate the higher cut slopes (Figure 6).

Limited details of the rockfall trial can be provided here, but the testing comprised the release of over 100 rocks ranging in size from approximately 100mm to 500mm from different heights on the cutting face and a small number from the natural slope above. Five cameras were positioned to record the route and trajectories of the falling rocks and to estimate their velocities. This included two high-definition, high-speed cameras attached to UAV's, one positioned directly above the rockfall, the other facing the cutting, with further cameras located at ground level to provide a side view of the rock trajectories.

*Figure 6: View of rockfall trial site (abseiler in orange on upper central section provides scale).*

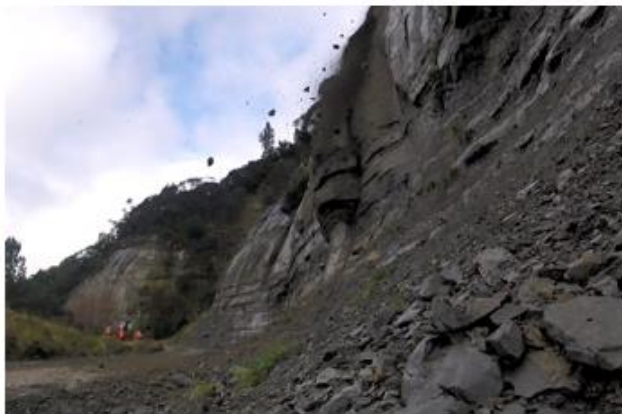
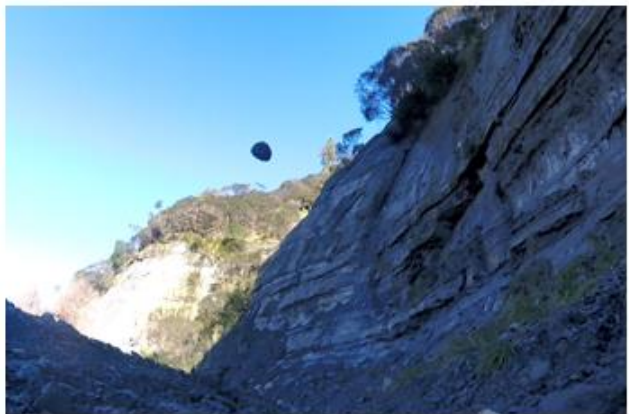
The results were, somewhat surprisingly, consistent with the rockfall modelling based on the scanned surface of the rockfall trial site. Whilst a large proportion of the rocks fell close to the toe of the cut, a small but significant proportion followed trajectories consistent with the modelled launch features, with several rocks reaching the road carriageway directly (Figure 7).

Many of the falling rocks were also observed to bounce or roll out of the catch ditch onto or across the road. It had been assumed that most blocks landing within the catch ditch would break-up on impact with little or no further travel, and had therefore been discounted from the count of potential rocks reaching the carriageway. It was also interesting to note that once released, the rock slabs very quickly broke-up into smaller rocks which then followed their own path and trajectory, rather than sliding as a single slab and breaking-up on impact at the base of the slope.

*Figure 7: Example rockfalls illustrating possible trajectories during trial.*
