SLOPE STABILITY GEOTECHNICAL GUIDANCE SERIES

UNIT 7B.1 - AUCKLAND

AN INDUSTRY REFERENCE DOCUMENT COMPILED AND PUBLISHED
BY THE NEW ZEALAND GEOTECHNICAL SOCIETY (NZGS)

NOVEMBER 2025

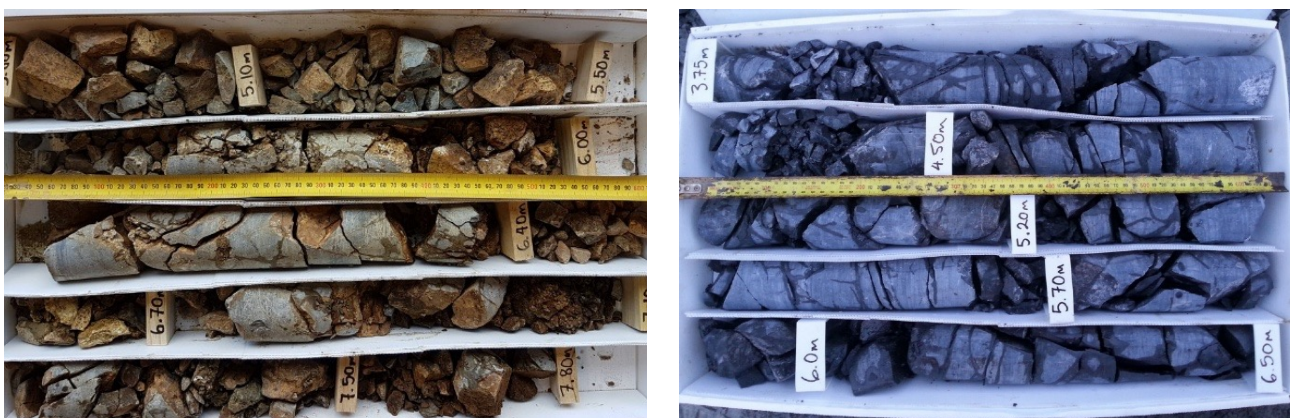
FIGURE 2: Typical closely fractured, weathered (left) and unweathered (right) rock core in Waipapa Group greywacke, Hunua Quarry

The high-stress environment of the accretionary prism and subsequent deep burial of the Waipapa Group units resulted in steeply dipping, highly deformed, tightly folded and faulted sequences. Less competent argillite beds are often highly sheared, and crushed zones within the rock mass and melange zones (highly deformed, undistinguishable 'mixed' sequences) are common. The sedimentary units (greywacke and argillite) are thinly to massively bedded and typically very closely fractured (see Figure 2).

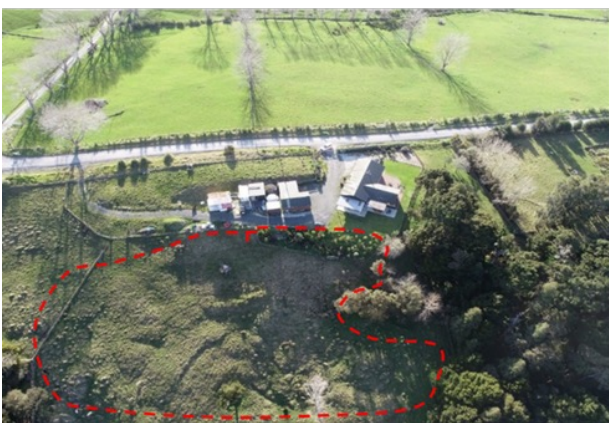
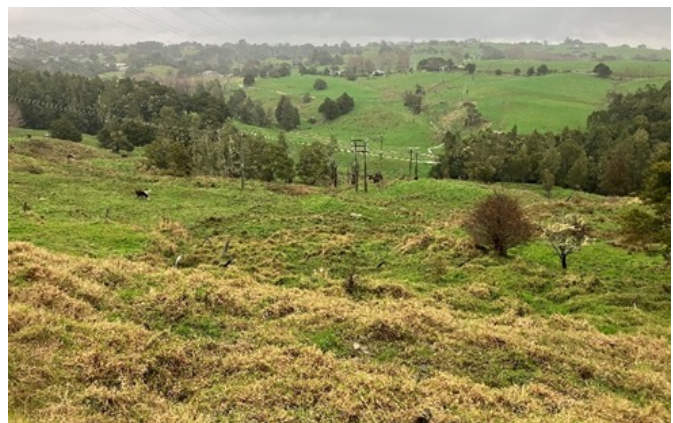
FIGURE 3: Examples of natural landsliding in Northland Allochthon terrain.

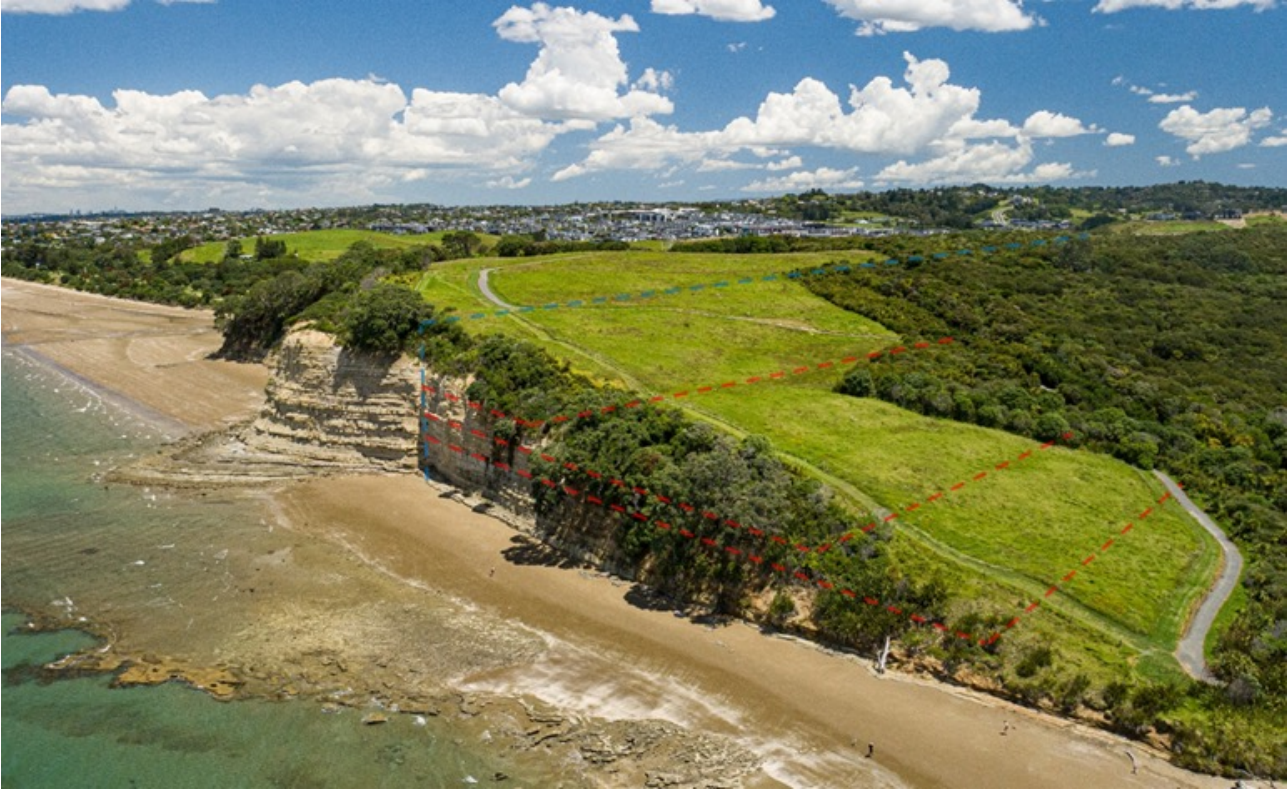
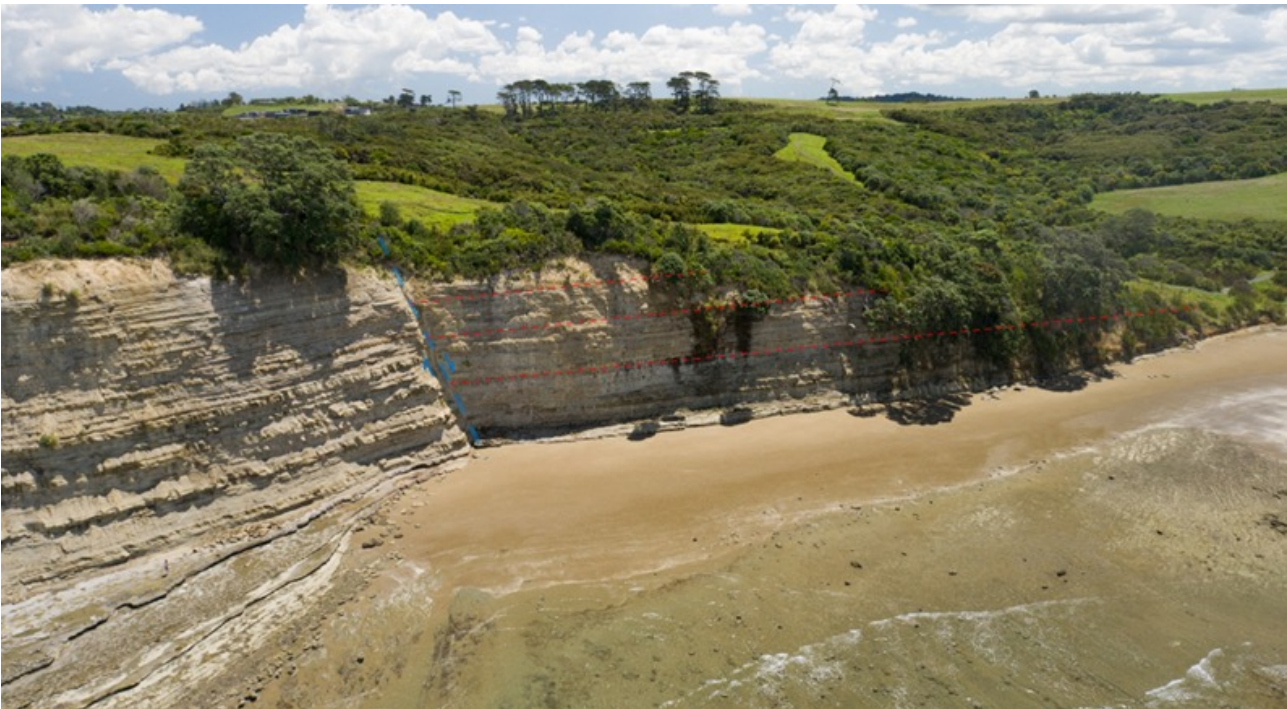
FIGURE 4: Block sliding within East Coast Bays Formation rocks at Granny's Bay, Long Bay Regional Park: The extensional crustal forces that formed the Granny's Bay Fault (Blue dashed line) also produced three distinct low-angle, bedding parallel shear zones (red dashed lines) that have strongly influenced the geomorphology of the upslope land via a series of block slides. Note groundwater seepage and vegetation growth from the shear zones in the cliff exposure.

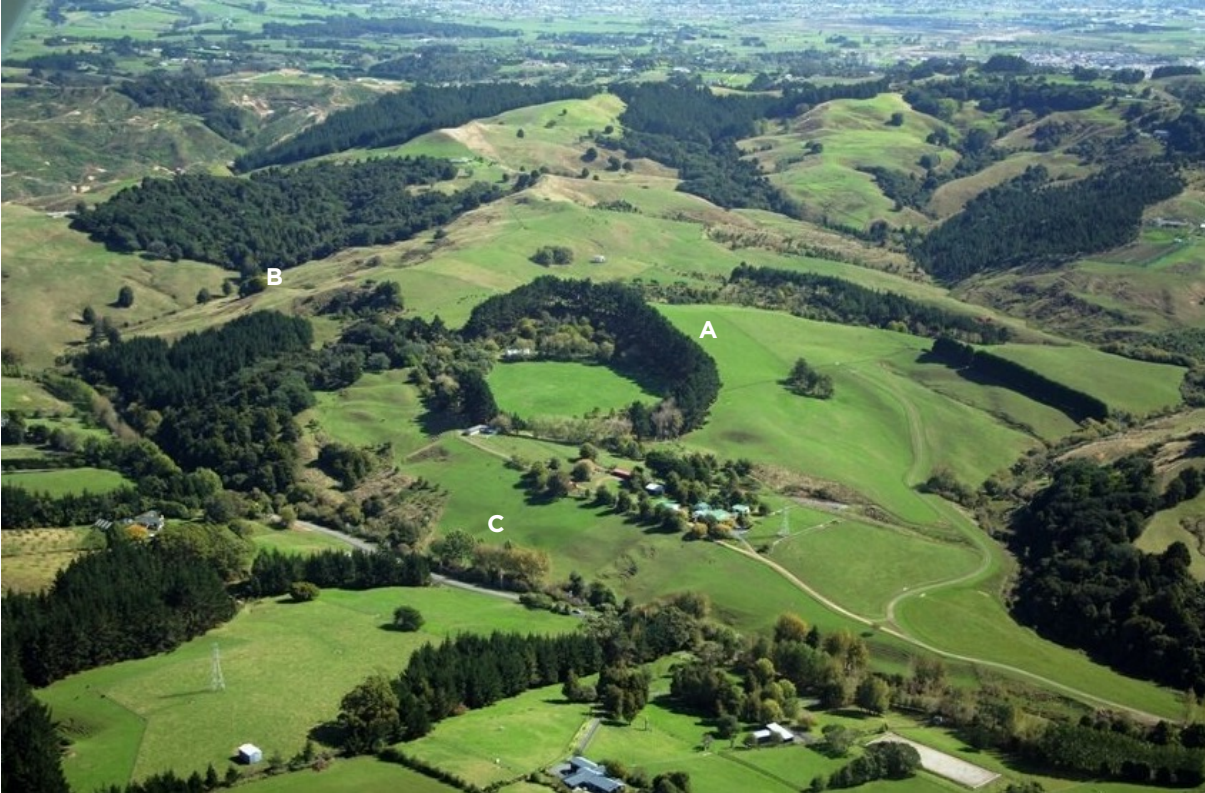
FIGURE 5: A tilted block of East Coast Bays Formation in the Southern Landslide Zone, demonstrating broad slopes parallel to bedding (A) and steep back-bedding geomorphology (B). Localised shallow-seated instability geomorphology is evident on the steeper slopes (C).

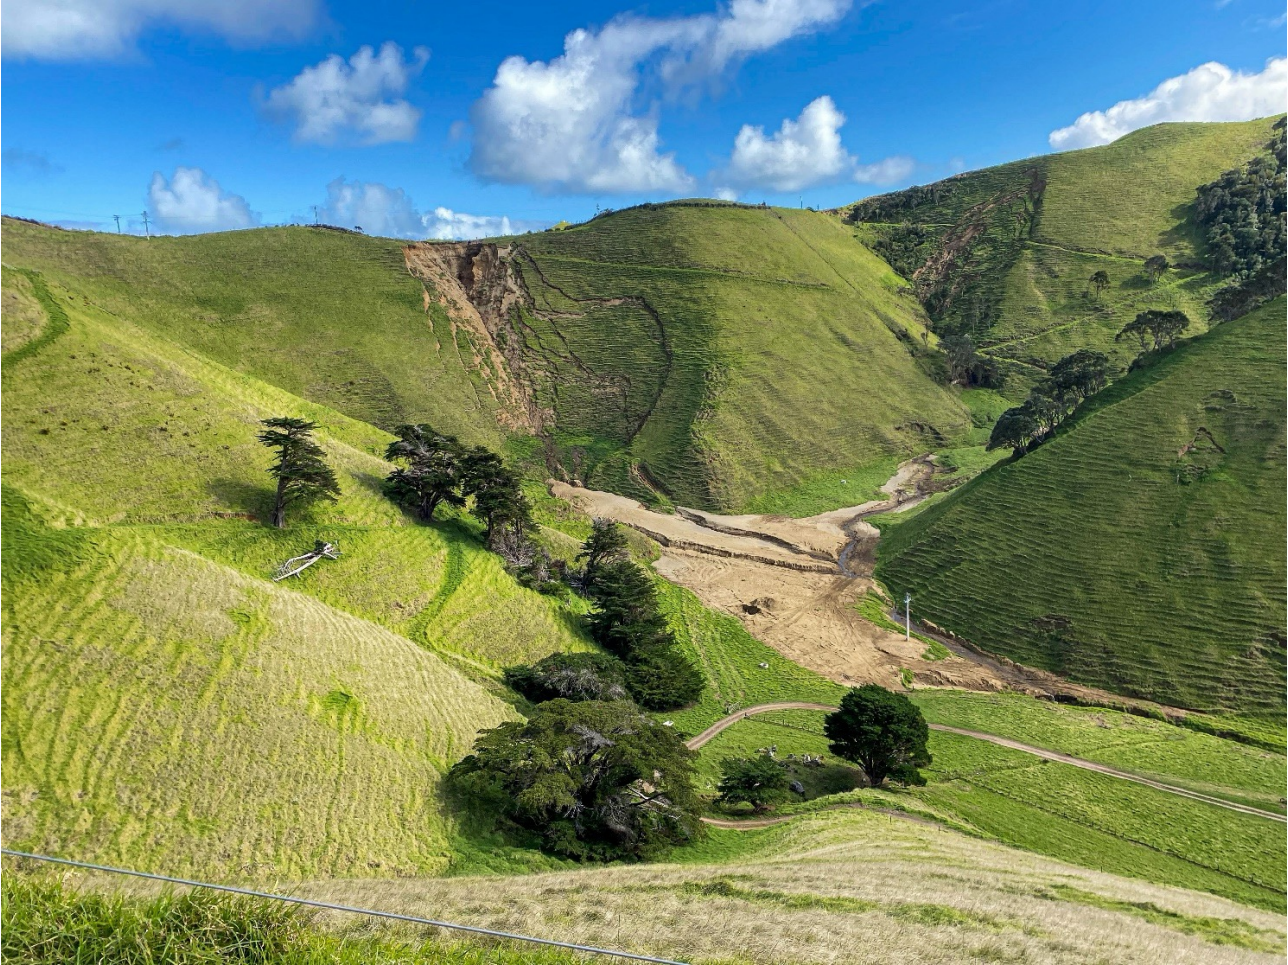
FIGURE 7: Large slope failure, colluvium deposition and terracettes in Kariotahi Group Sands, Awhitu Peninsula

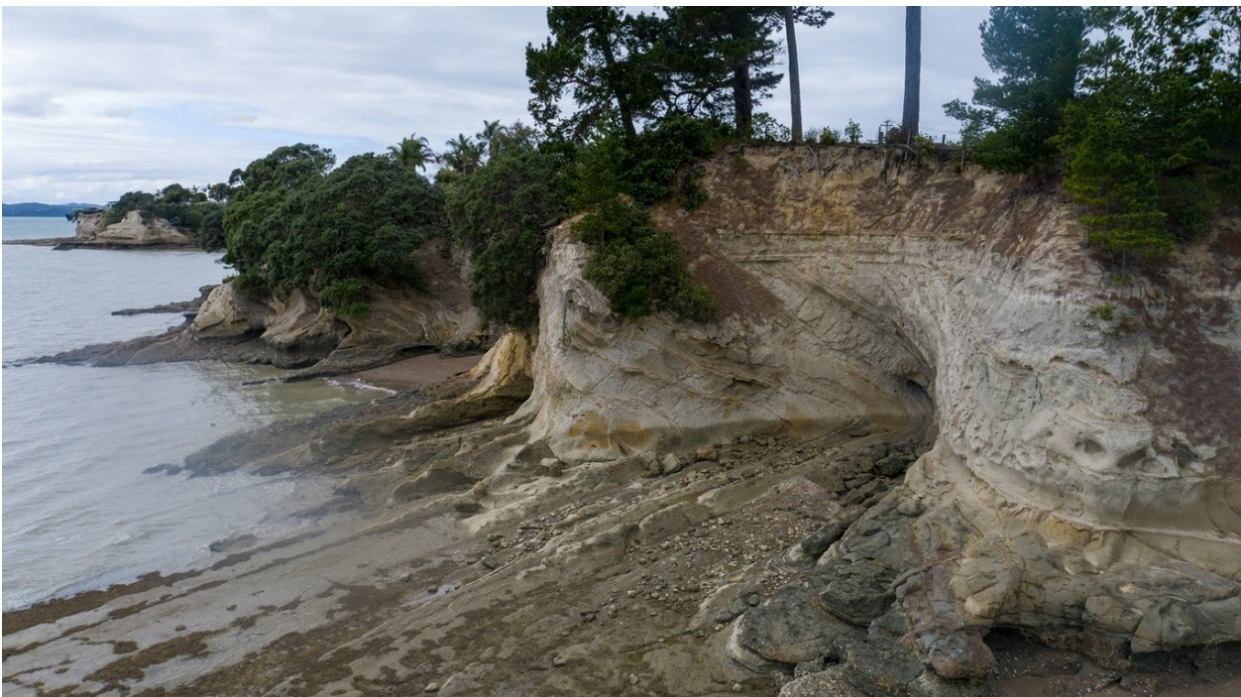
FIGURE 8: Takaanini Formation unconformably overlies tightly folded Waitematā Group at Sunkist Bay, Beachlands

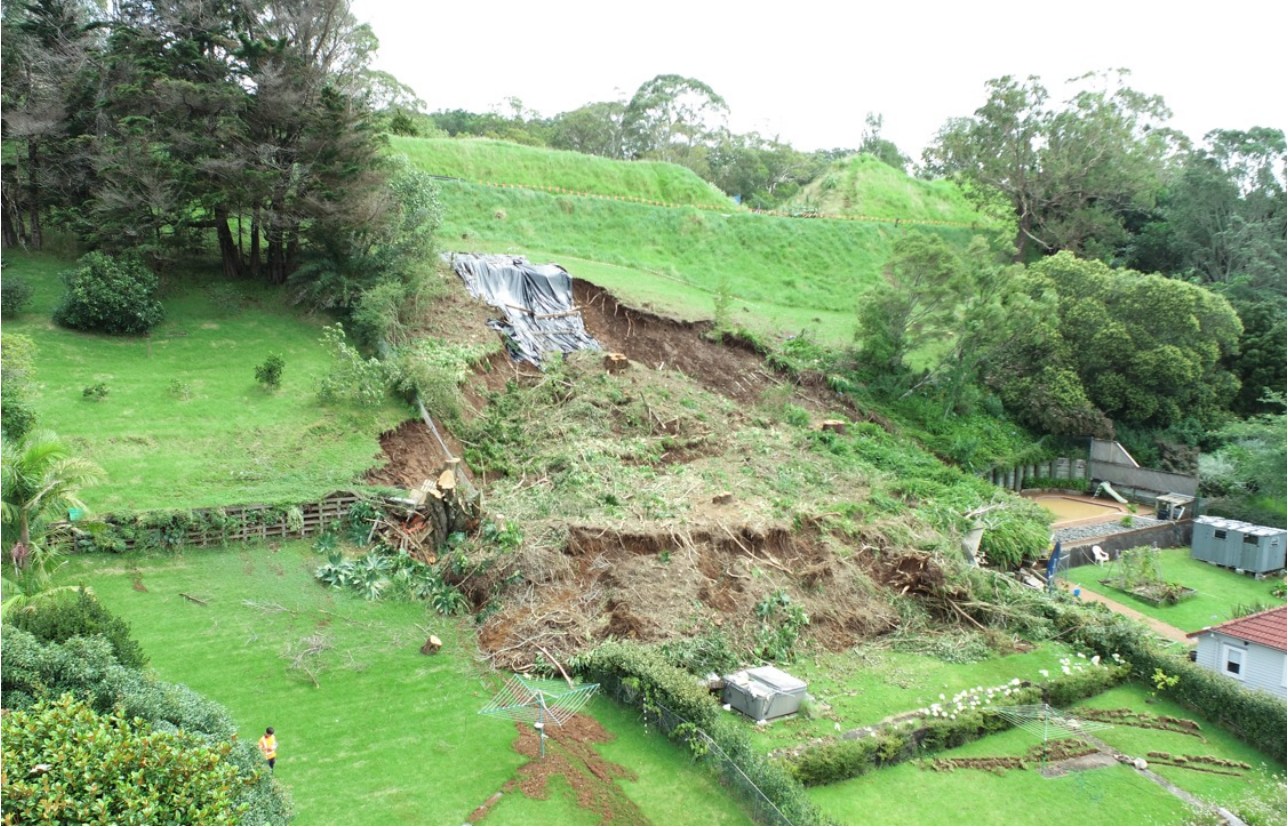
FIGURE 11: Rotational slide on the flank of Ōwairaka (Mount Albert) after heavy rainfall (2023).

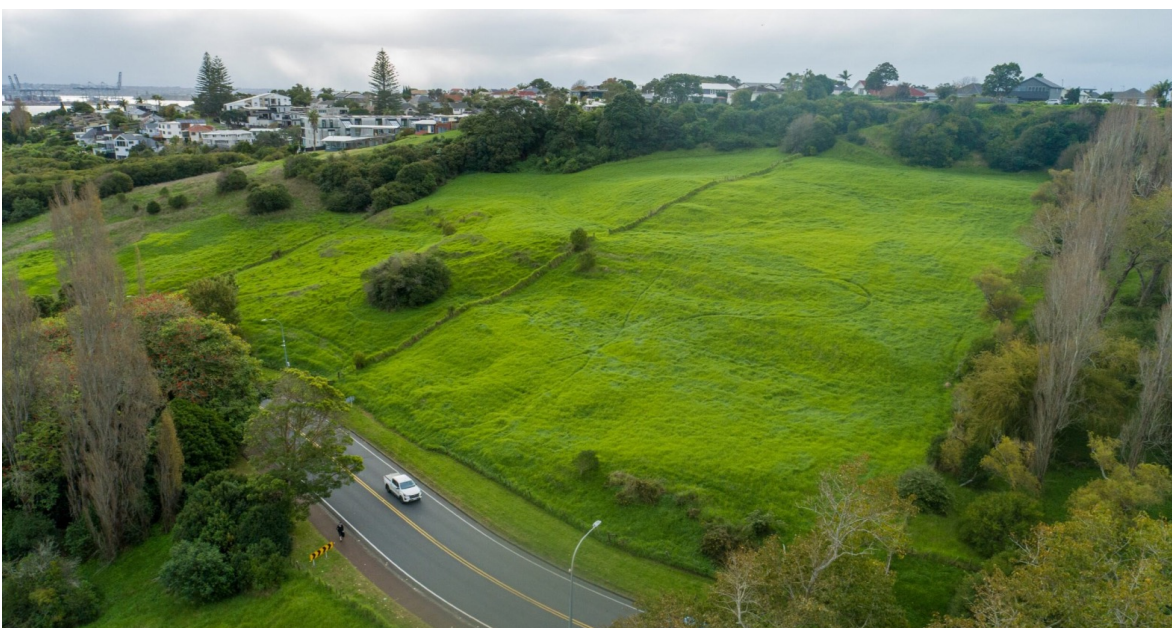
FIGURE 12: Keba Road landslide. See Section 5.1 for case study.

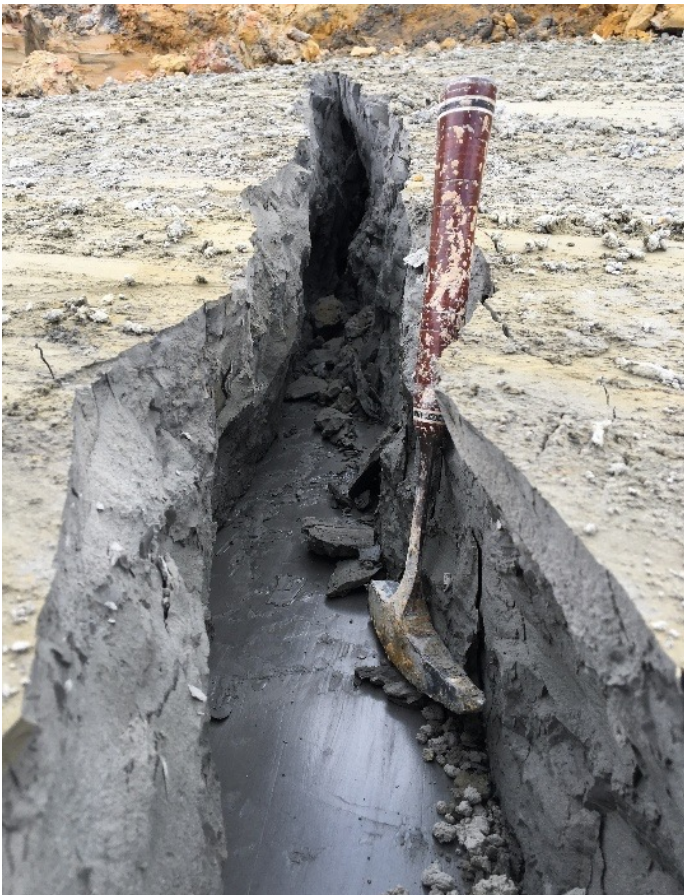
FIGURE 13: Shear plane at the contact between residual silt-dominant (upper) and clay-dominant (lower) soil layers of the East Coast Bays Formation .

Figures 13 and 14, show examples of a pre-sheared surface and features of translational landslides attributed to them.

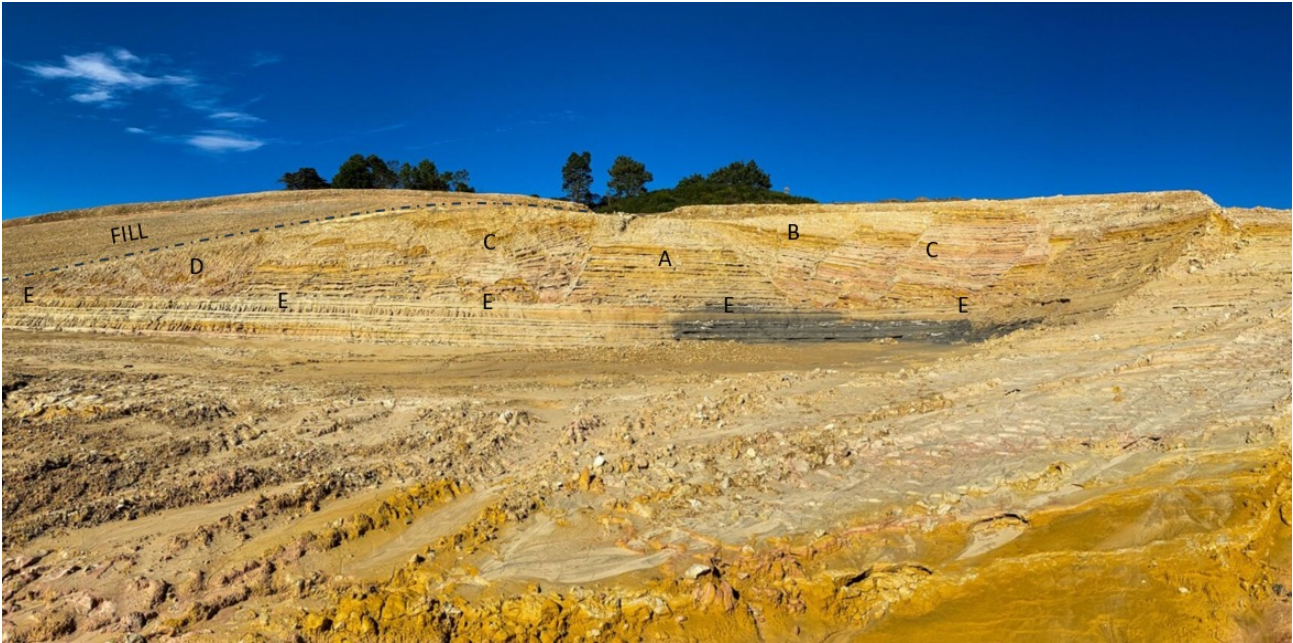
FIGURE 14: Slice through a translational relict landslide in East Coast Bays Formation Residual Soils, Orewa. Note landslide morphology features (A&B horst and graben structures, C- displaced blocks, D- increased downslope deformation and E- a basal shear surface separating lower undisturbed soil and overlying deformed, displaced soil.) The depth from ground level to the failure plane was observed to be 6 m.

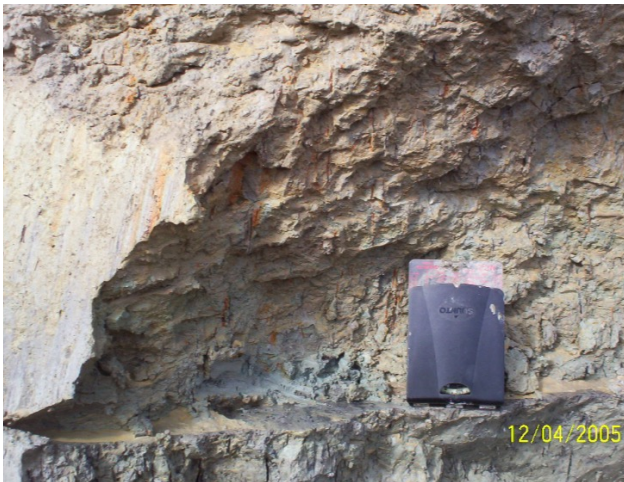
FIGURE 15: Pre-sheared surface and soil fabric in Northland Allochthon

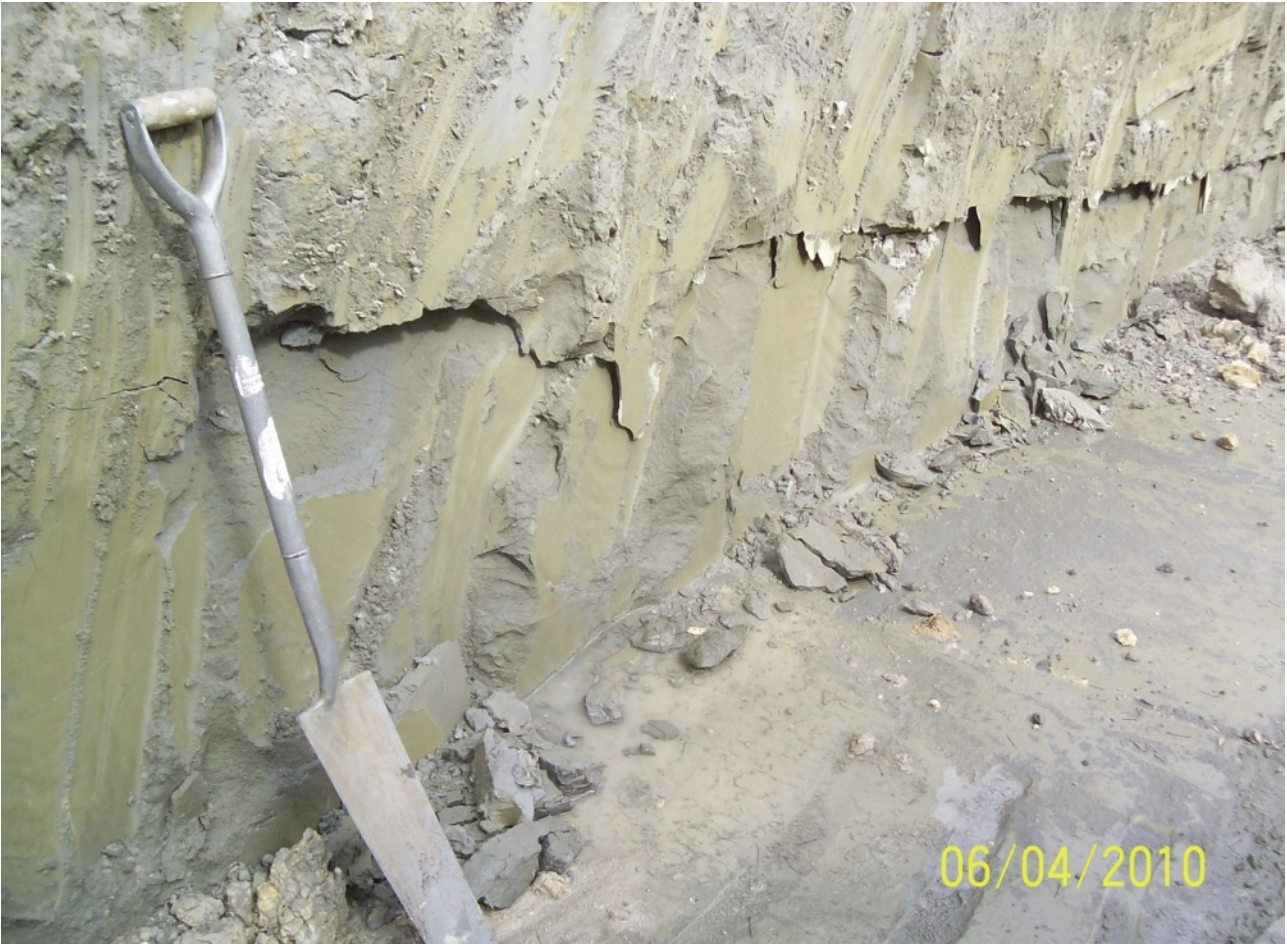
FIGURE 16: Parallel bedded clay seam in residually weathered East Coast Bays Formation sliding into a shear key excavation at a rate of approximately 20 mm/day.

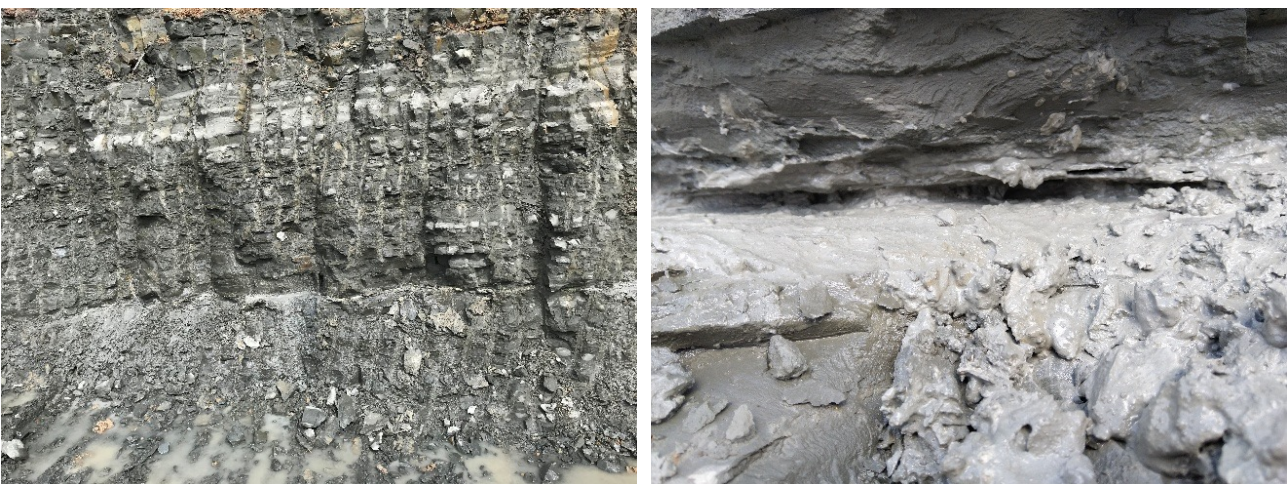
FIGURE 17: 10 mm wide parallel bedded clay seam comprising highly saturated light grey clay in East Coast Bays Formation rock excavation. Moisture content of the clay seam was measured at 62.2%. Ring shear tests carried out on the clay infill recorded effective residual friction angles, ϕ_r^* , of 10° and 19° ($c_r^* = 0$ kPa).

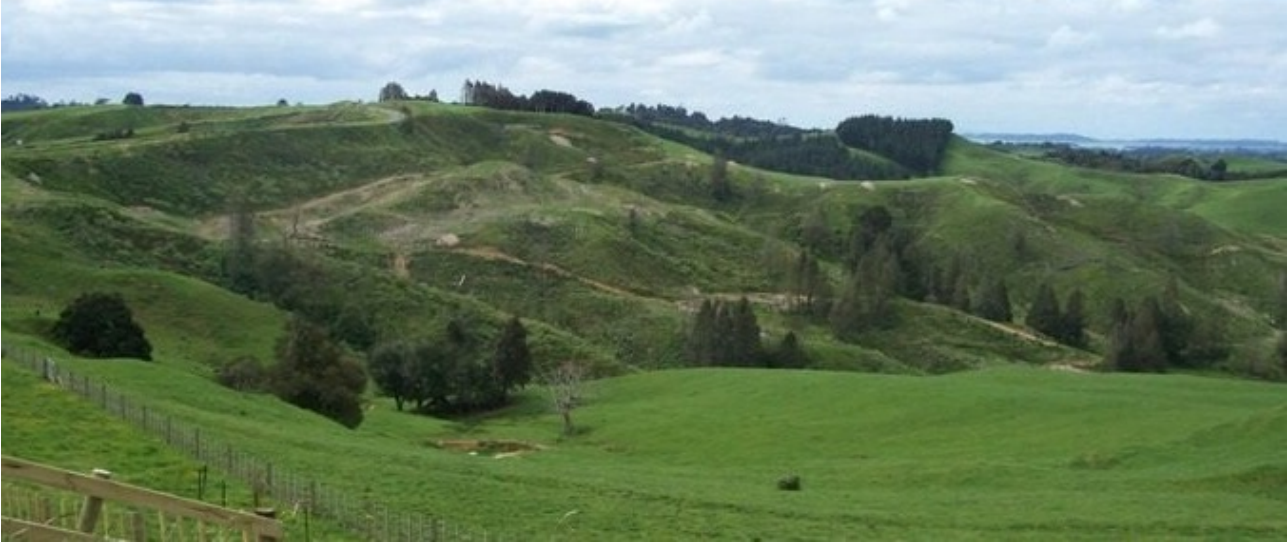
FIGURE 18: Deep seated block slide in the Southern Landslide Zone.

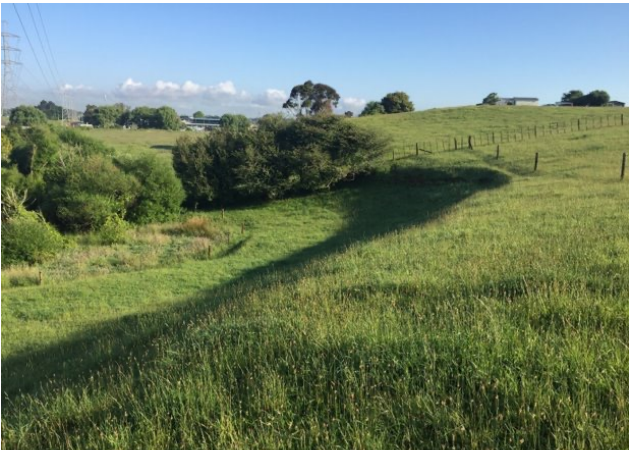
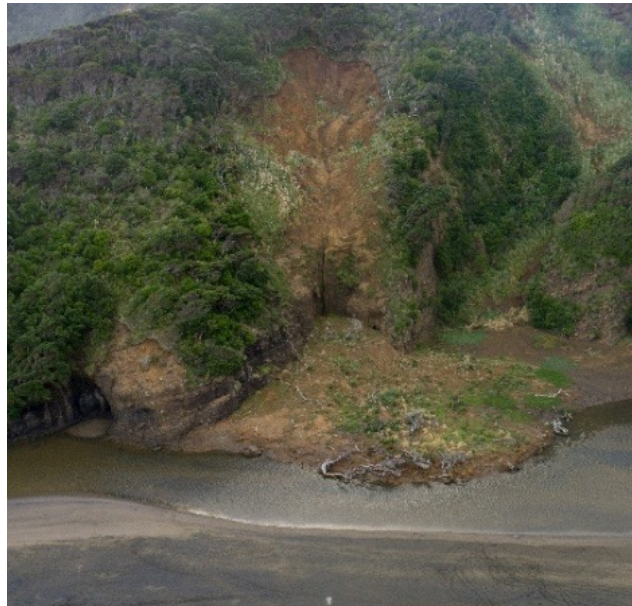
FIGURE 19: Left: Rotational slide in Holocene Undifferentiated Takaanini Formation strata adjacent to a stream (left) due to ongoing toe softening and erosion
Right: Rotational Slide in Piha Formation breccia, following intense rainfall, Bethells Beach

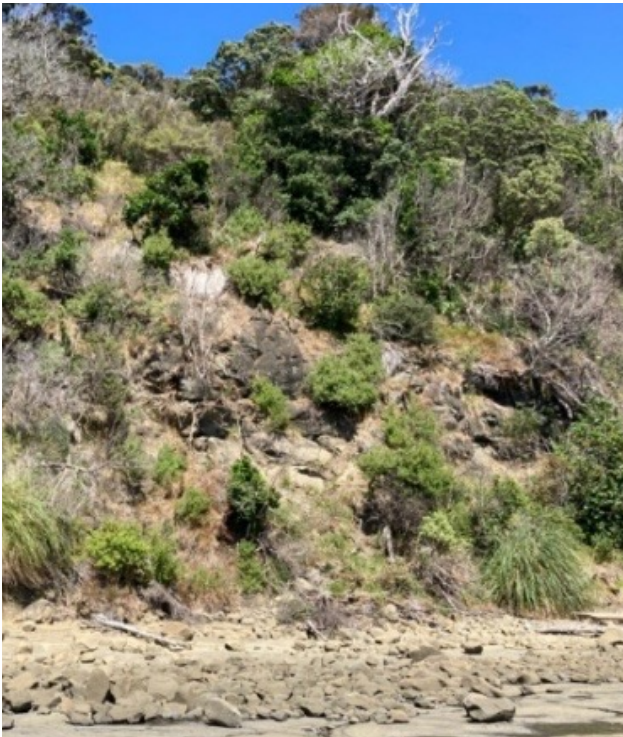
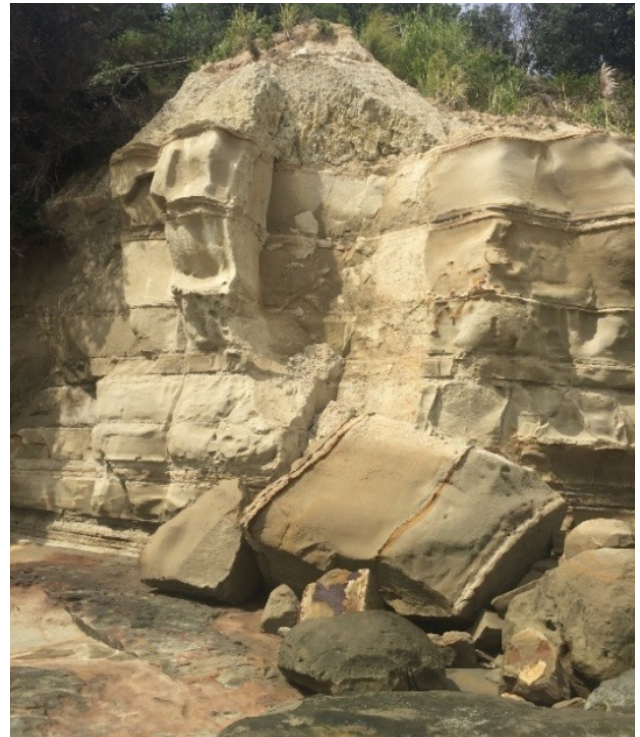
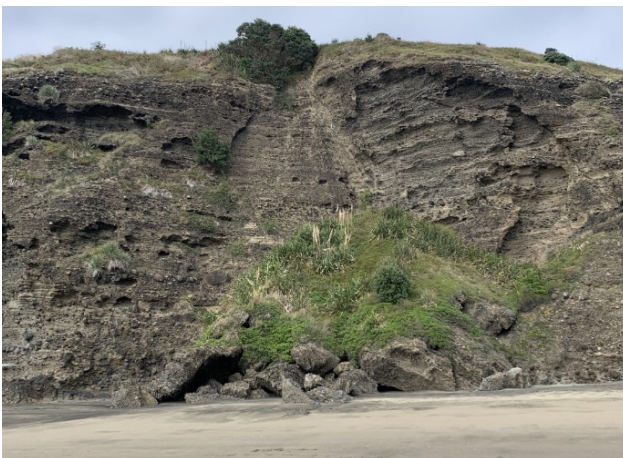
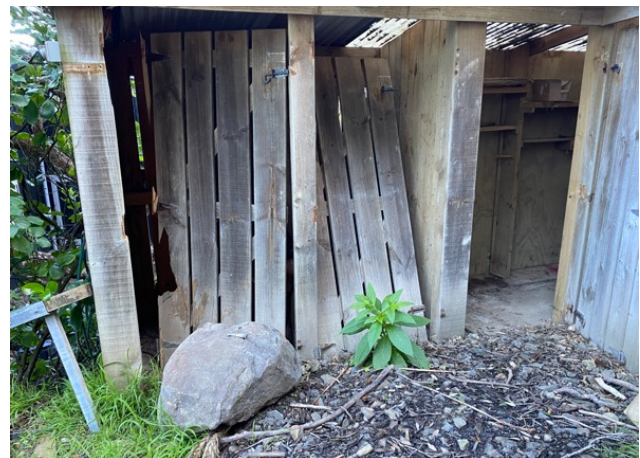
FIGURE 20:
 Top Left: Vegetated East Coast Bays Formation coastal cliff with accumulated rock fall debris at the toe on the eroded shore platform.
 Top Right: Rock topple in an East Coast Bays Formation coastal cliff, block dimensions 3 m by 1 m. Takaanini Formation alluvium forms the upper 1 to 2 m of the cliff profile.
 Bottom Left: Rock fall in Piha Formation cliffs at Piha.
 Bottom Right: 0.6 m diameter Waitarua Formation rock released from a rock outcrop above Piha.

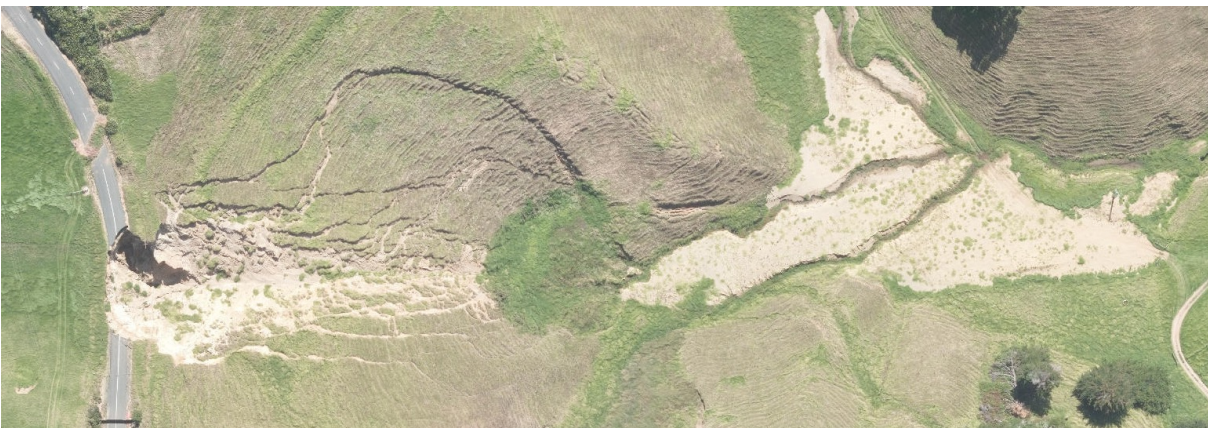
FIGURE 21: Debris flow in Kariotahi Group sand dunes (aerial view of Figure 7).

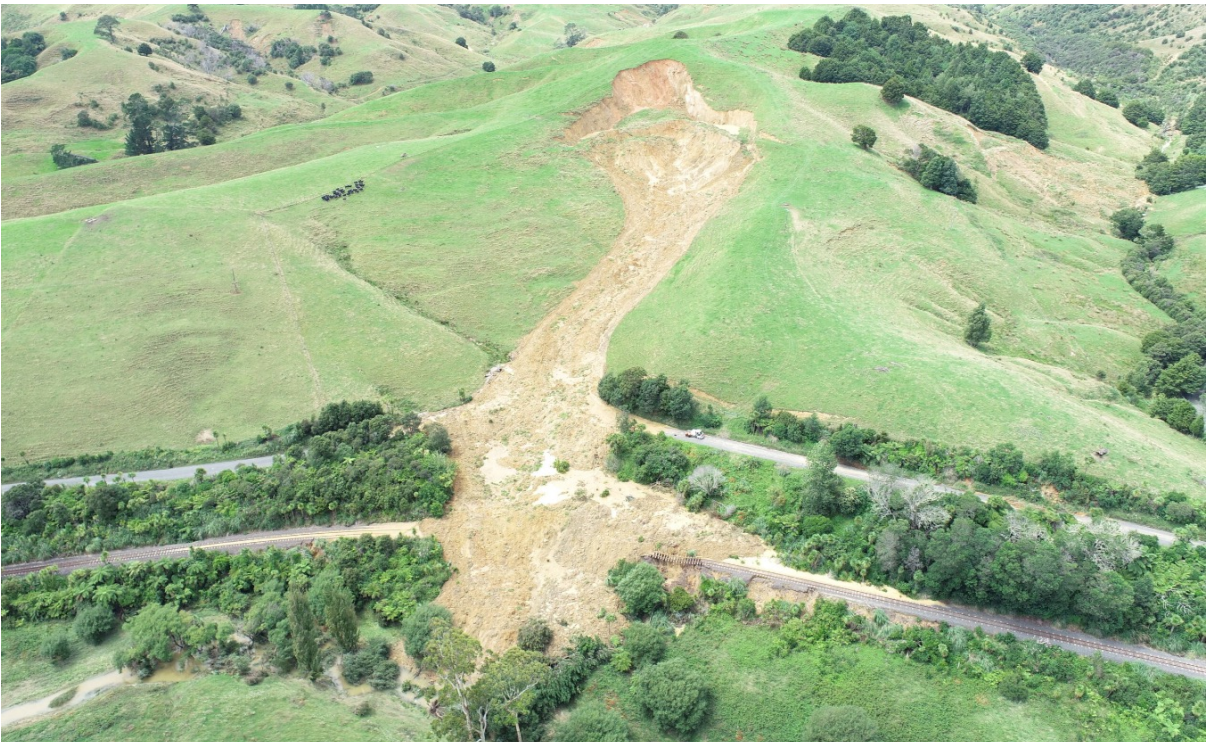
FIGURE 22: Rotational slide transitioning to debris flow in East Coast Bays Formation resulting in inundation of the road and railway line, with debris reaching the stream.

This transition from slide to flow movement also affects clay slopes, where the initial onset of failure during rainfall opens up cracks and fissures, facilitating increase in soil moisture content. More displacement leads to higher moisture contents until the soil essentially loses its shear resistance and rapid flow movement initiates. This can result in significant volume flows, like the one in Figure 22.

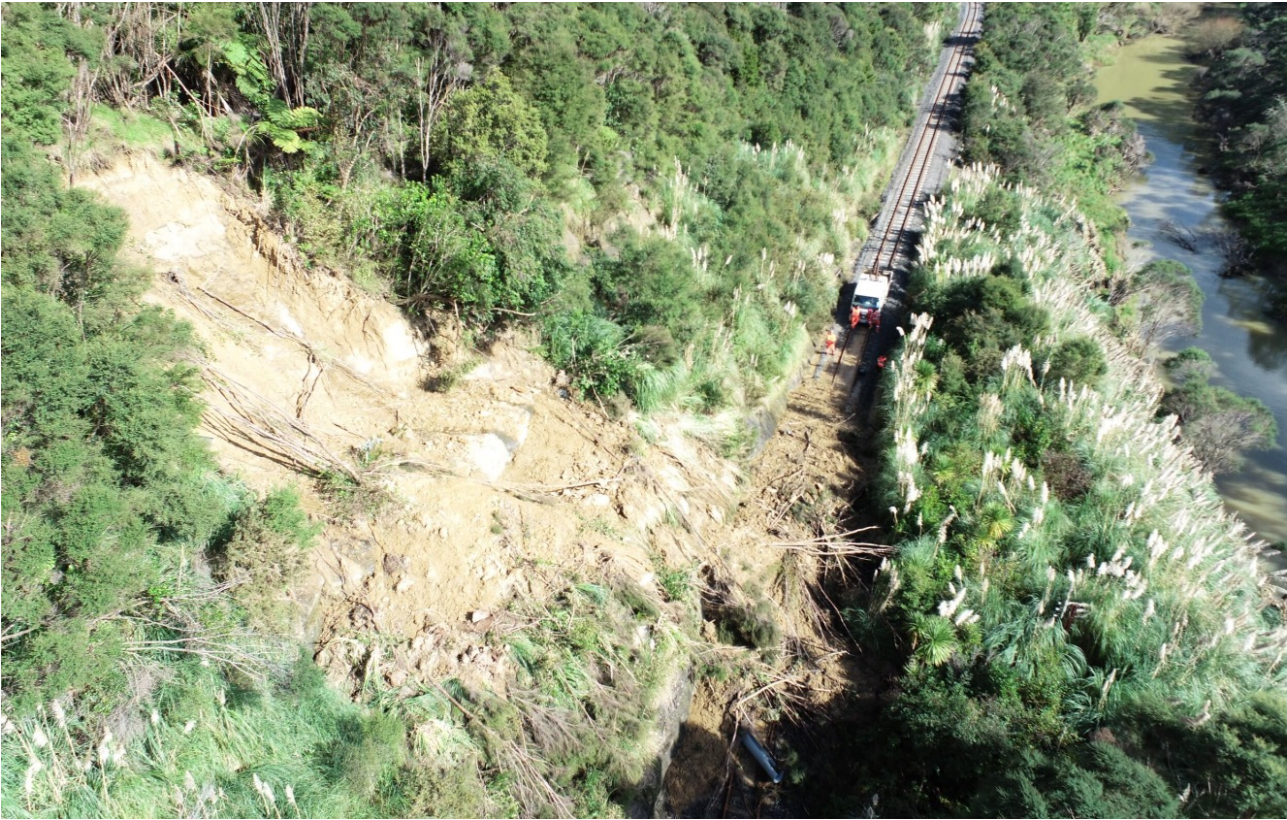
FIGURE 23: Debris avalanche in Pakiri Formation residual soil overlying rock. Saturated soil and entrained vegetation flowed over the rock shelf to inundate the railway line.

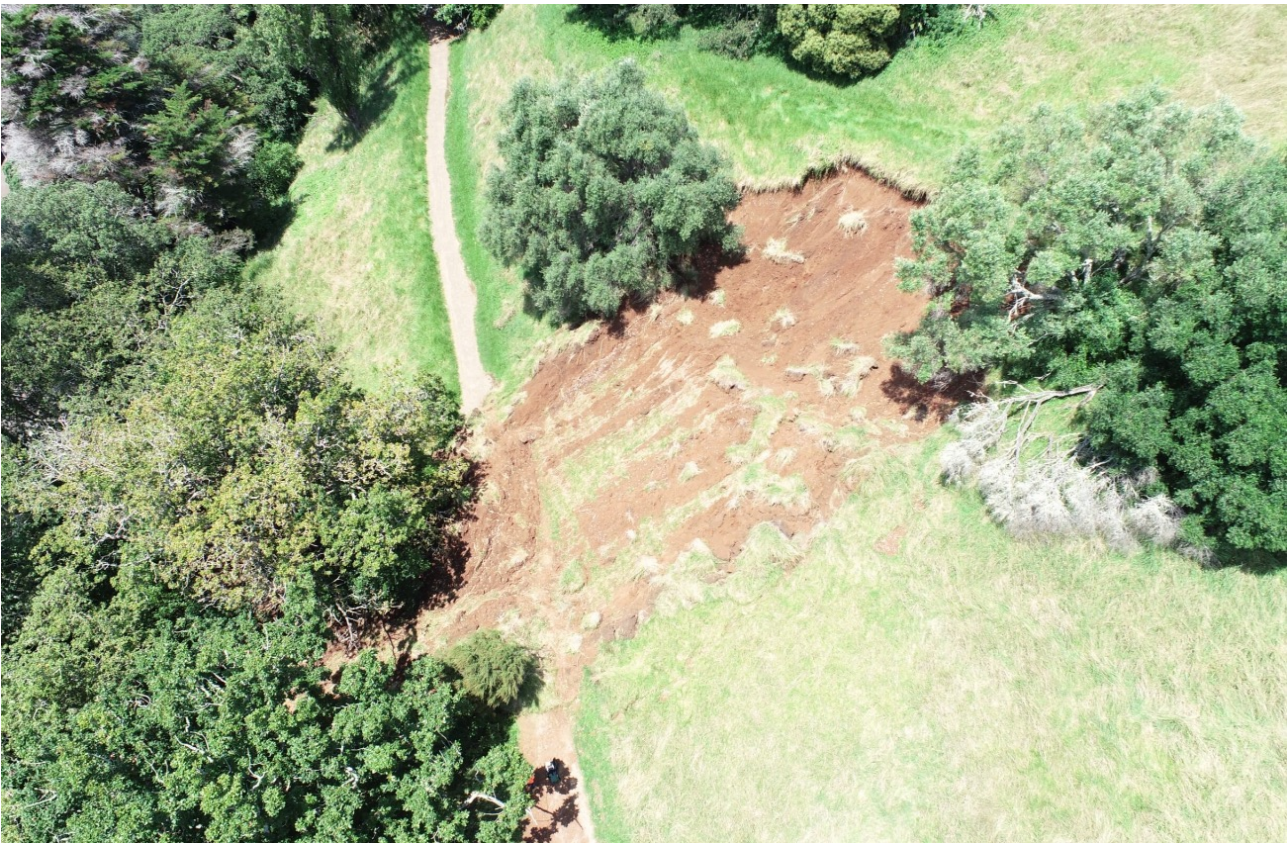
FIGURE 24: Debris avalanche in Auckland Volcanic Field sandy tuff soil.

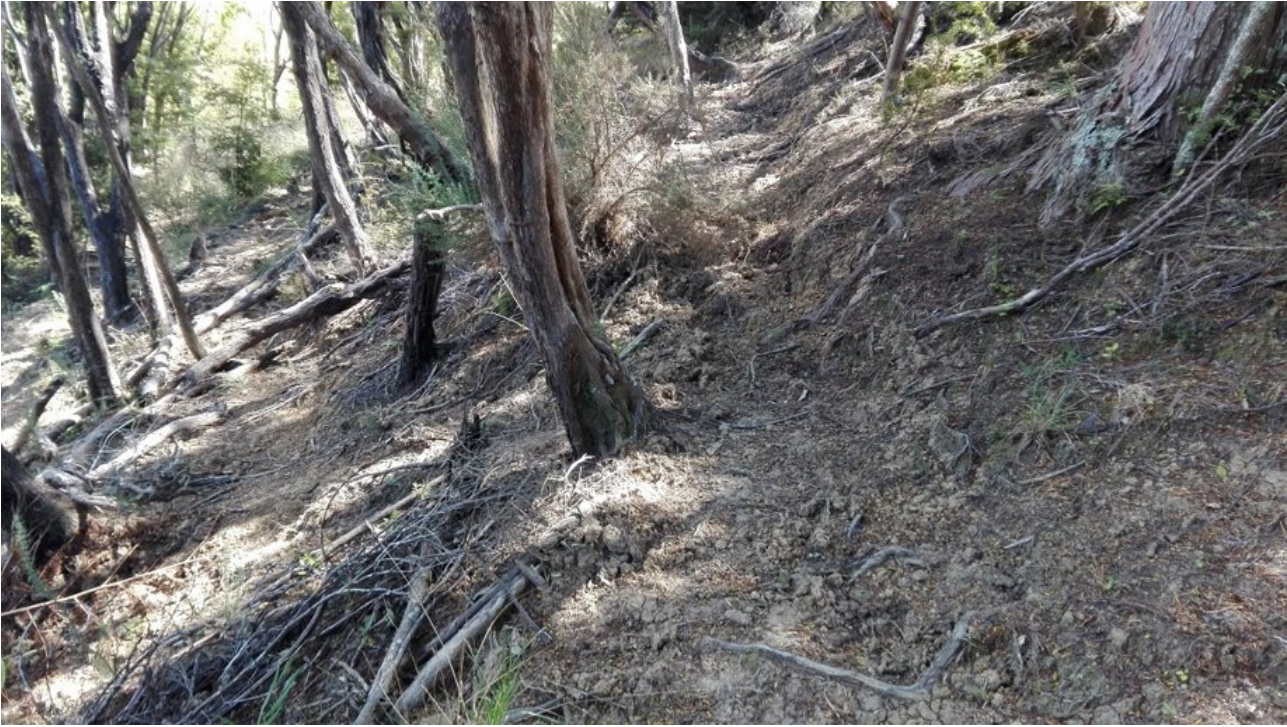
FIGURE 26: Rotation of juvenile tree trunks indicative of shallow-seated soil creep over the duration of the life of the tree.

Evidence includes deformed or leaning trees (Figure 26), fence posts or telegraph poles, and sets of slope parallel terracettes in steep hill country (Figure 27).

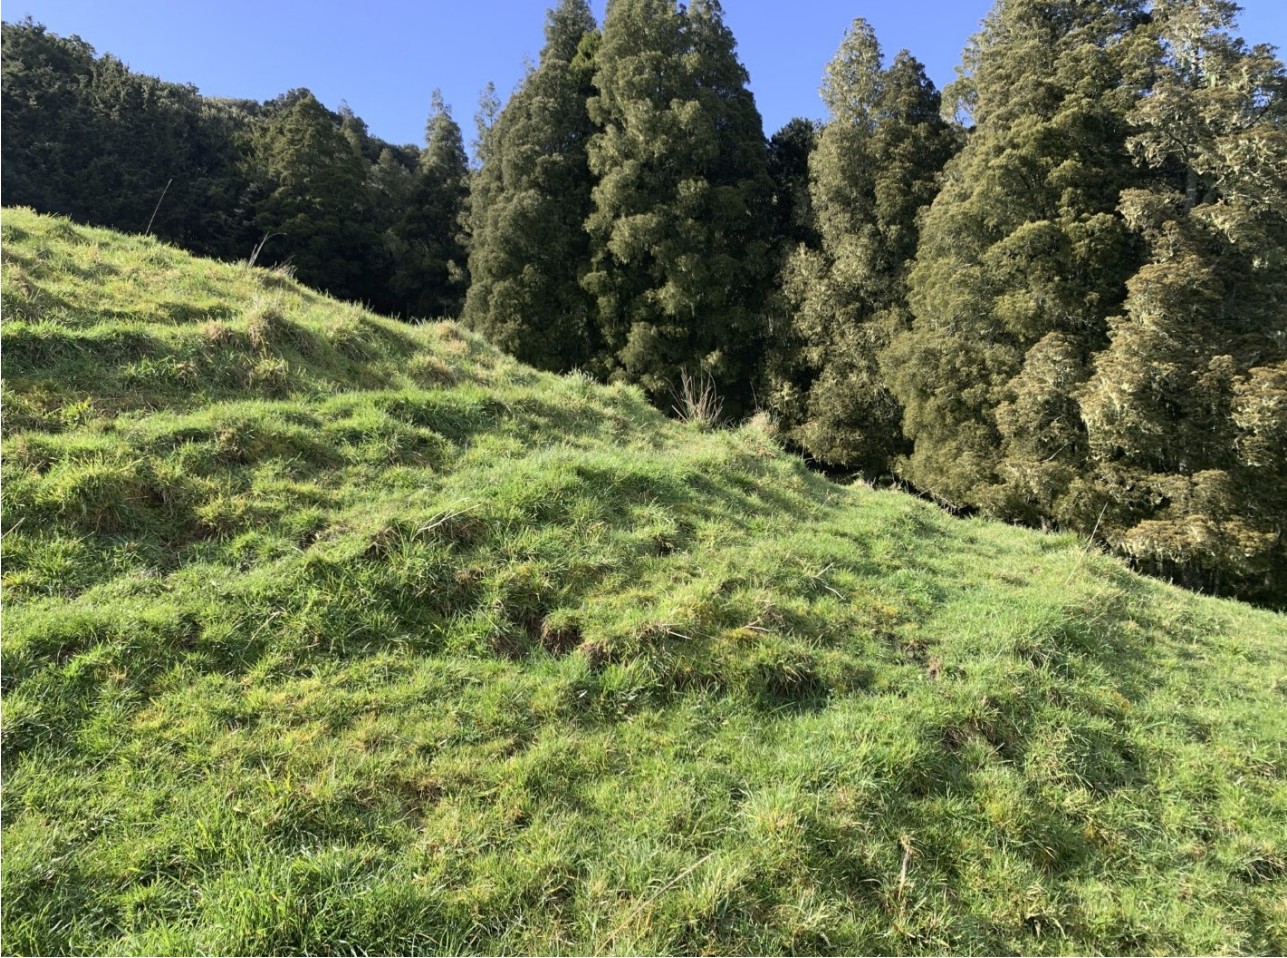
FIGURE 27: Terracettes across a soil slope indicative of soil creep.

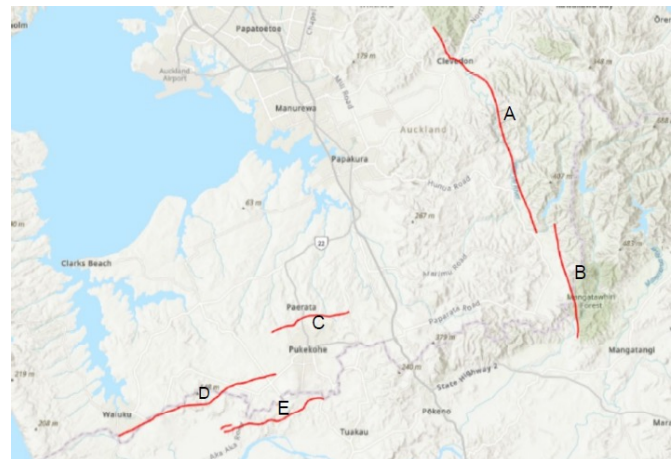
FIGURE 29: Active Faults of Auckland. A: Wairoa North Fault, B: Wairoa South Fault, C: Paerata Fault, D: Pukekohe Fault, E: Aka Aka Fault

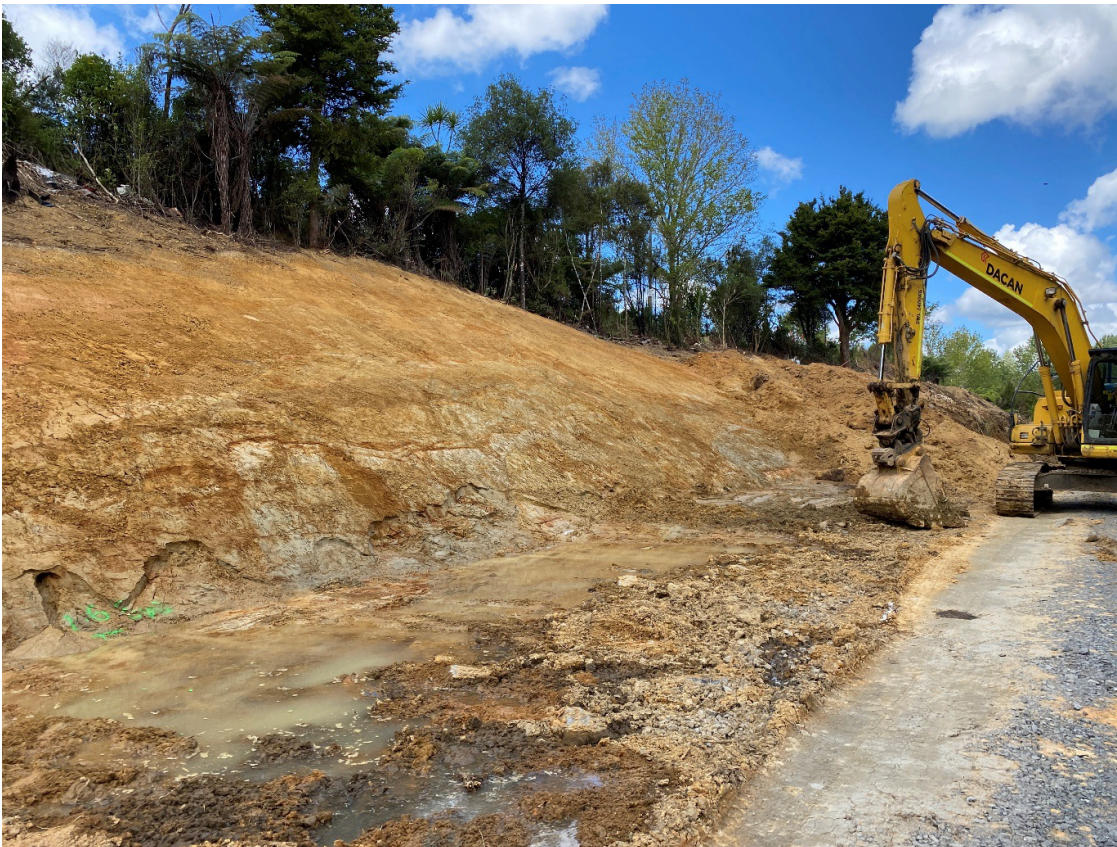
FIGURE 30: Temporary cut slope in a semi-intact block of residually weathered Pakiri Formation soil. Groundwater seepage is encountered at the toe in a silt-dominant soil layer, at or close to the basal failure surface of the block.
