SLOPE STABILITY GEOTECHNICAL GUIDANCE SERIES

UNIT 7B.1 - AUCKLAND

AN INDUSTRY REFERENCE DOCUMENT COMPILED AND PUBLISHED
BY THE NEW ZEALAND GEOTECHNICAL SOCIETY (NZGS)

NOVEMBER 2025

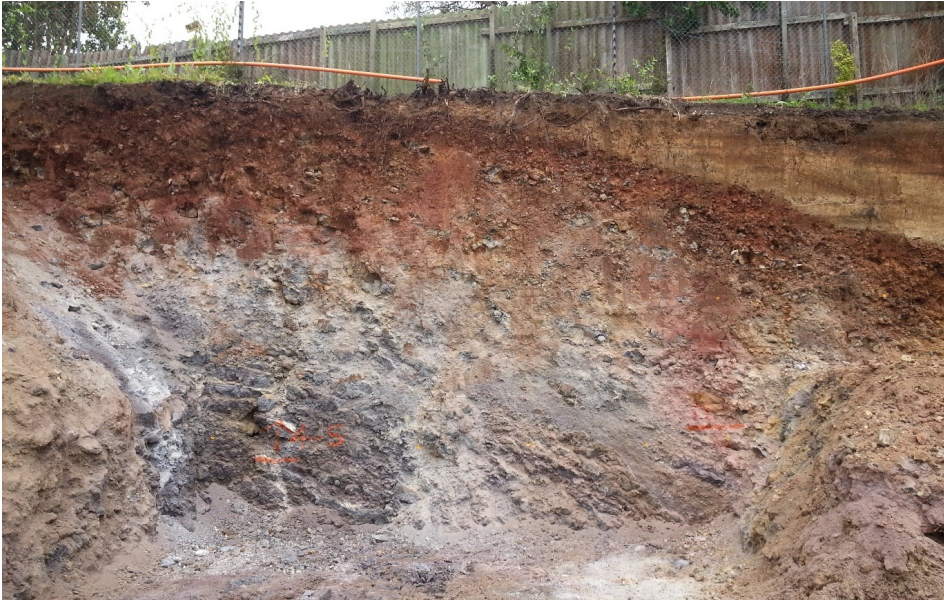
FIGURE 32: Sub-vertical temporary cut slope in partly welded scoria overlain by ash and tuff in Auckland Volcanic Field prior to anchor installation. Performance of cut slopes in this geology is governed by blockiness, soil layers of different permeability, and groundwater levels.

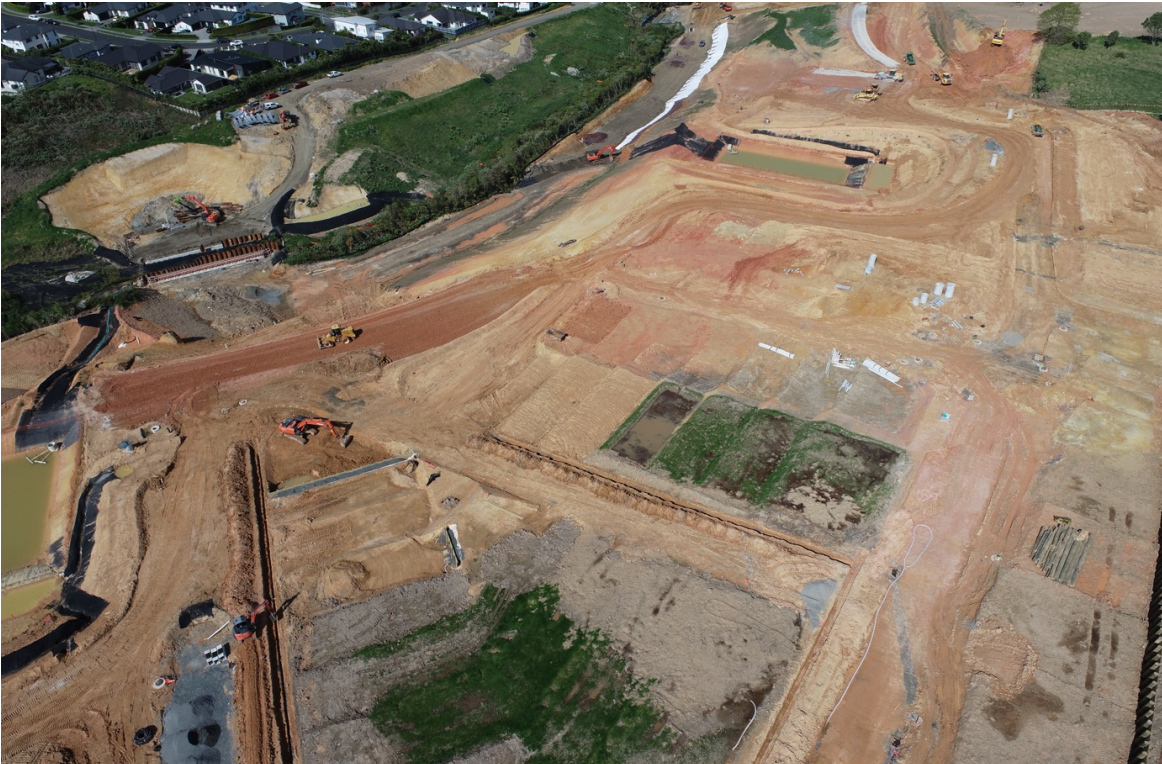
FIGURE 33: A conventional bulk earthworks site for residential subdivision in Auckland. A specialist earthworks contractor is recommended to manage a site of this nature, where installation of critical geotechnical stabilisation measures governs the civil earthworks design.

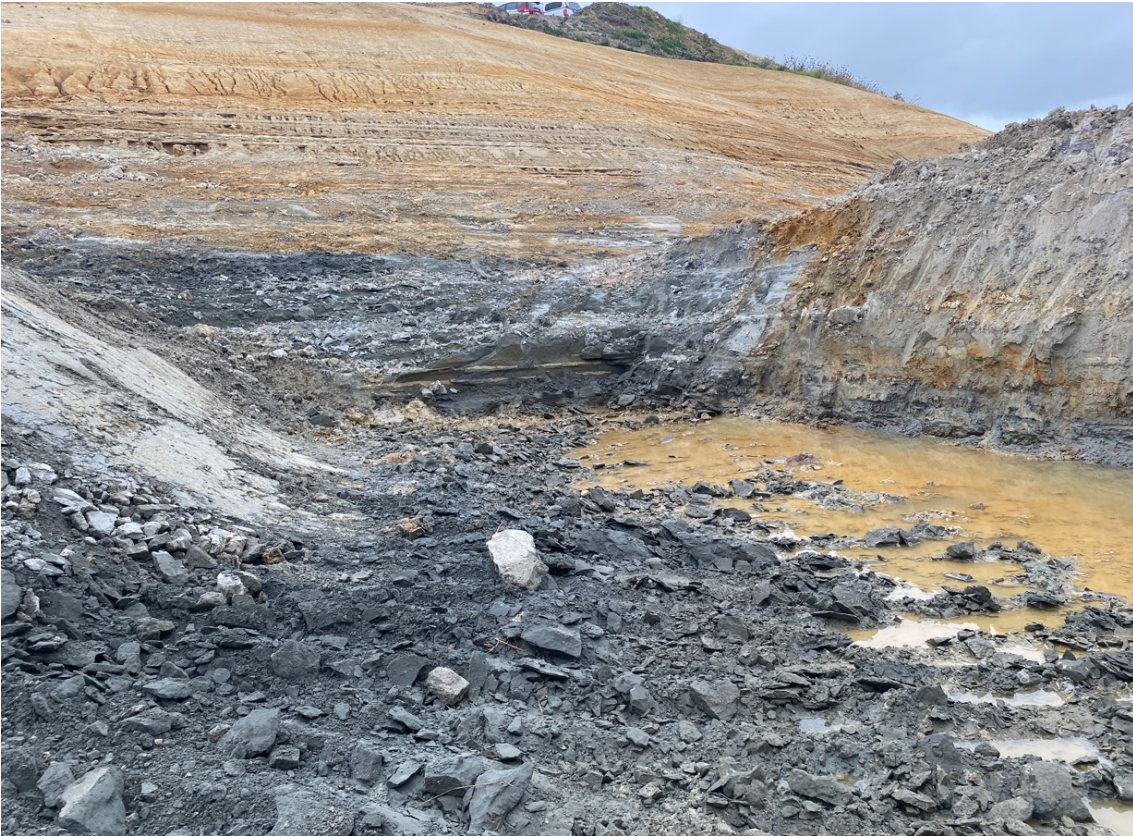
FIGURE 34: Shear key excavation in deeply weathered East Coast Bays Formation residual soil and very weak rock. Temporary stability of the excavation is managed by sequenced excavation and backfill placement over short sections. Fill wedge at left, intact ground yet to be excavated at right.

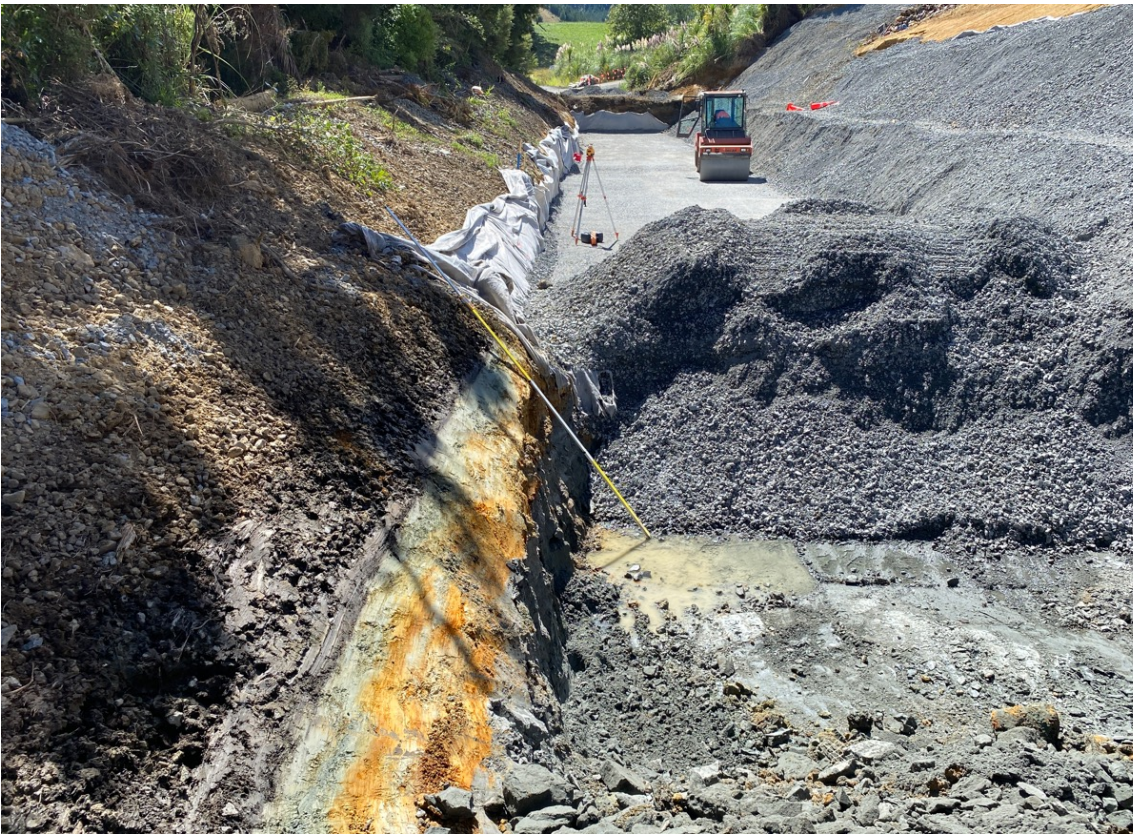
FIGURE 35: Hardfill being placed and compacted in a shear key excavation at the toe of a creeping translational block slide in Pakiri Formation.

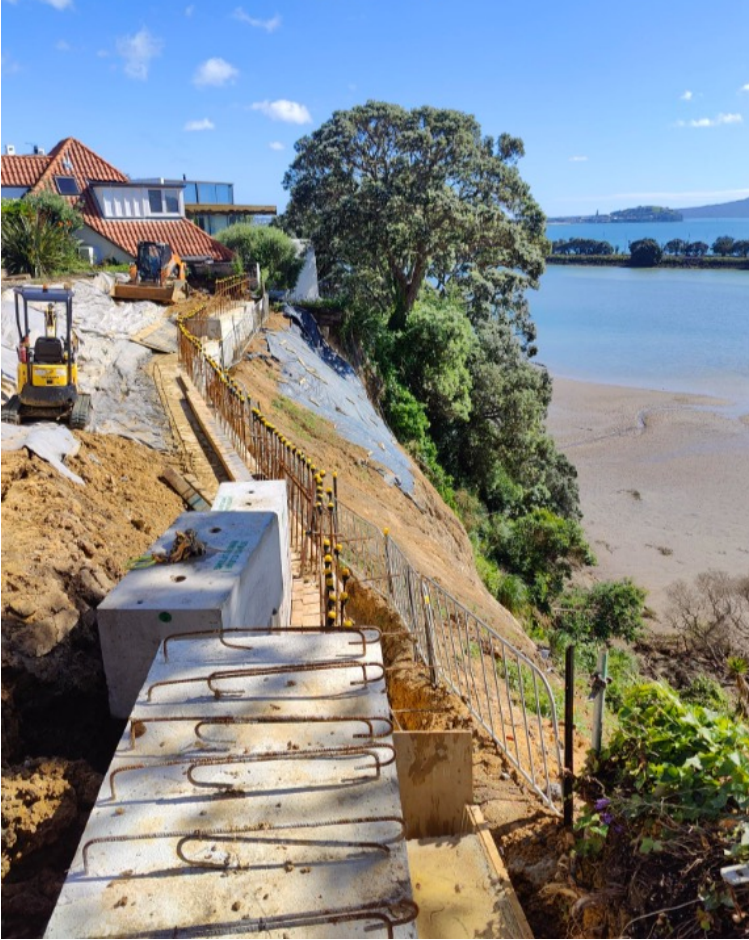
FIGURE 36: Figure 36: Construction of a palisade wall with concrete capping beam in East Coast Bays Formation in a coastal cliff setting.

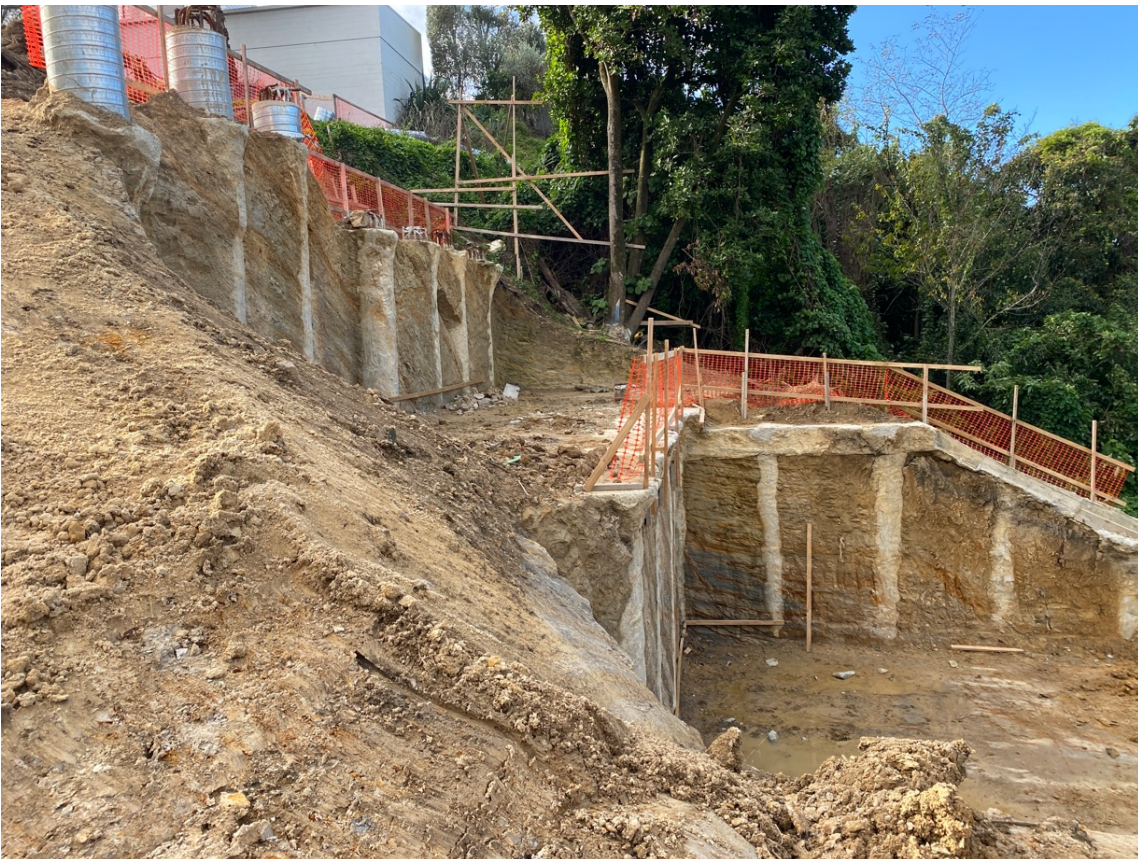
FIGURE 37: Tiered palisade walls to support building development on a steep slope in East Coast Bays Formation , with excavation after construction to support building development.

- Palisade Walls – Some examples of shear key excavations in Auckland are shown in Figures 34 and 35. These are effectively a buried pile wall designed to intercept a shear surface at depth, generally with a design allowance for loss of support downslope of the wall due to future land instability. They are routinely employed where a bulk earthworks and shear key solution is not appropriate due to space constraints or the size of the project. These typically require a smaller workforce to construct when compared to bulk earthworks, can be installed during winter, and reduce the risk of initiating instability during construction. Palisade walls require additional structural design and consenting requirements and can be expensive. If groundwater or loose or soft soil layers are intercepted during drilling, hole collapse can make construction difficult and add time and cost to projects. As palisade walls can be installed at depth, they are also regularly used to protect coastal properties, as shown in Figure 36.

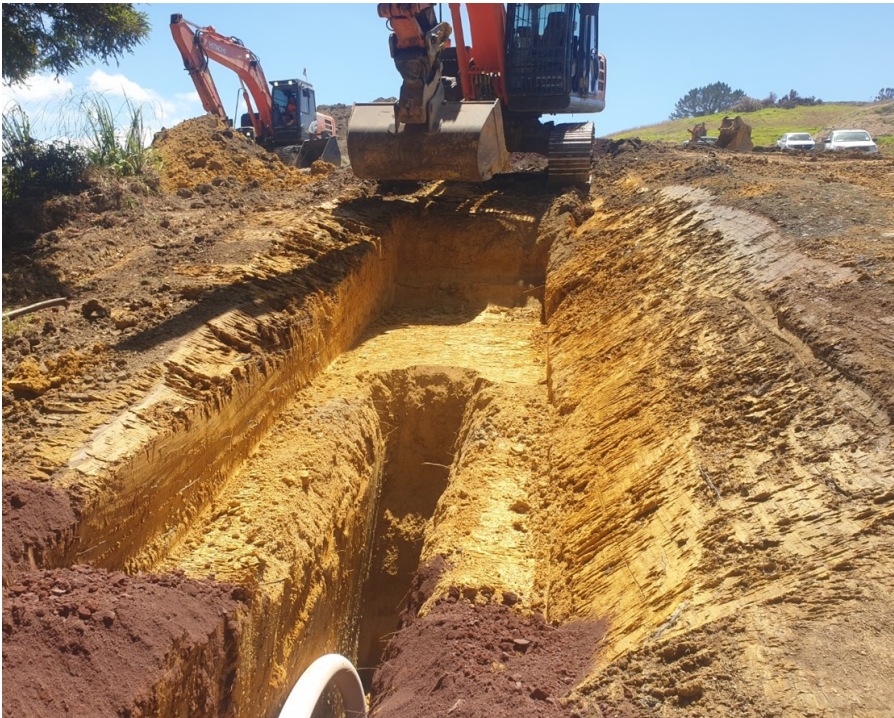
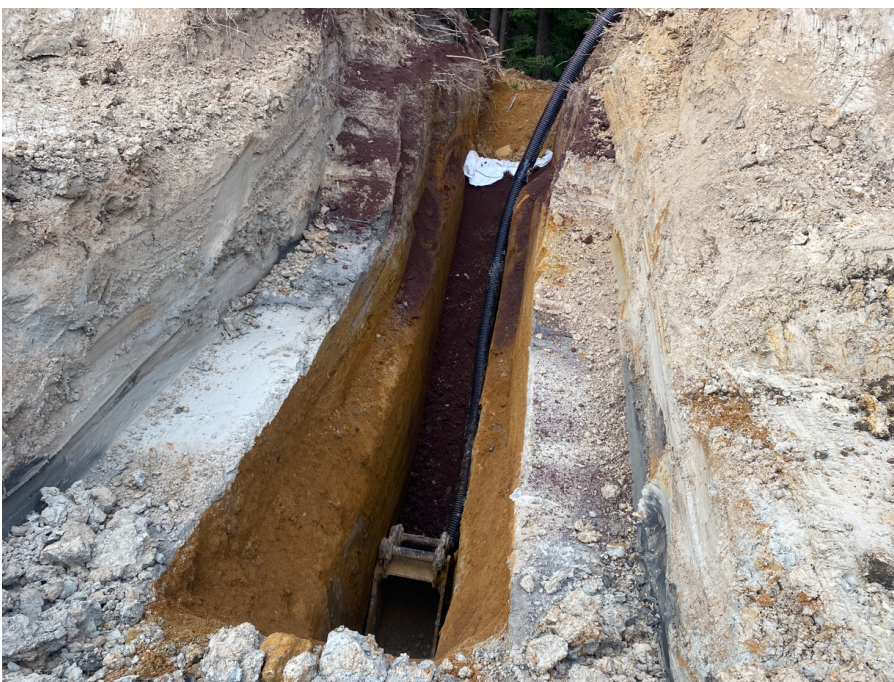
FIGURE 38: Counterfort drain installation.

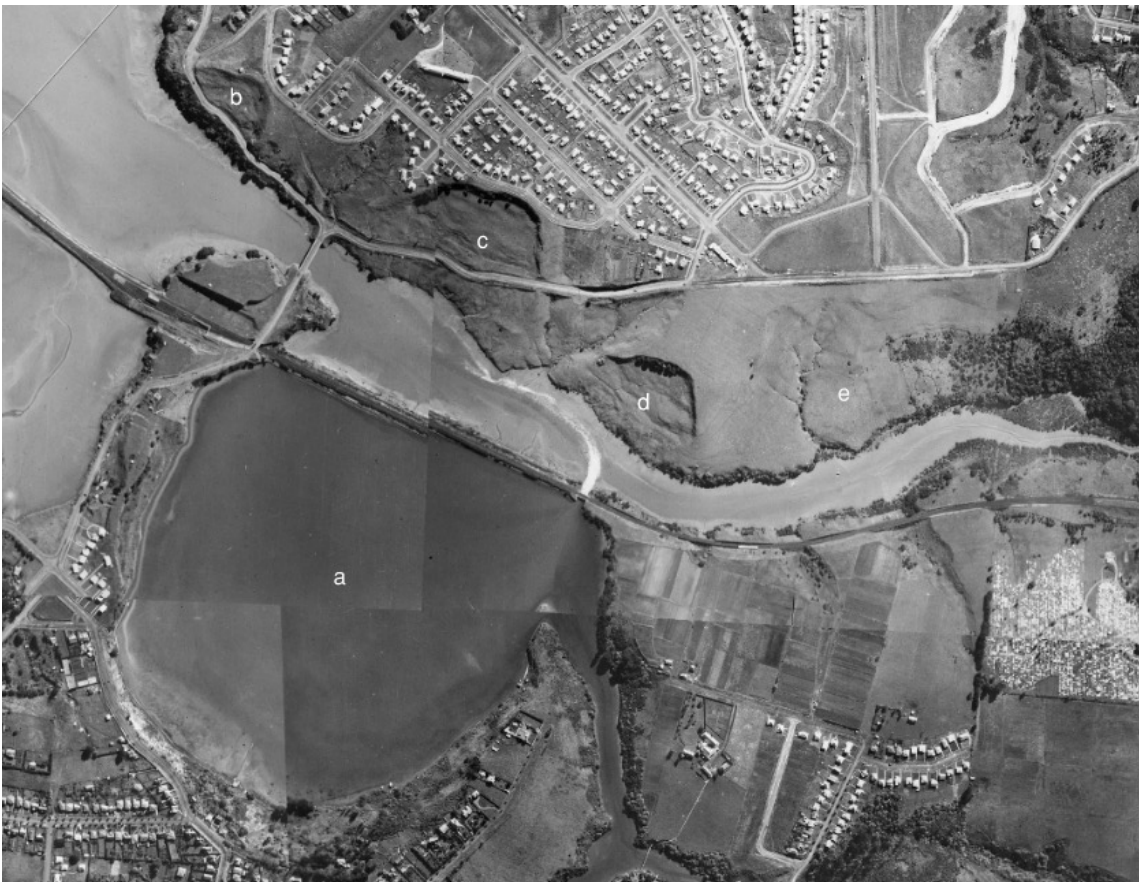
FIGURE 39: Orakei Basin and the landslides of the north-eastern flank, labelled as follows: a) Orakei Basin, b) Ngapipi Road Landslide, c) Kepa Road Landslide, d) St Josephs Landslide, e) Pourewa Landslide. Base imaged sourced from Auckland Council GeoMaps, 1940 aerial photograph layer.

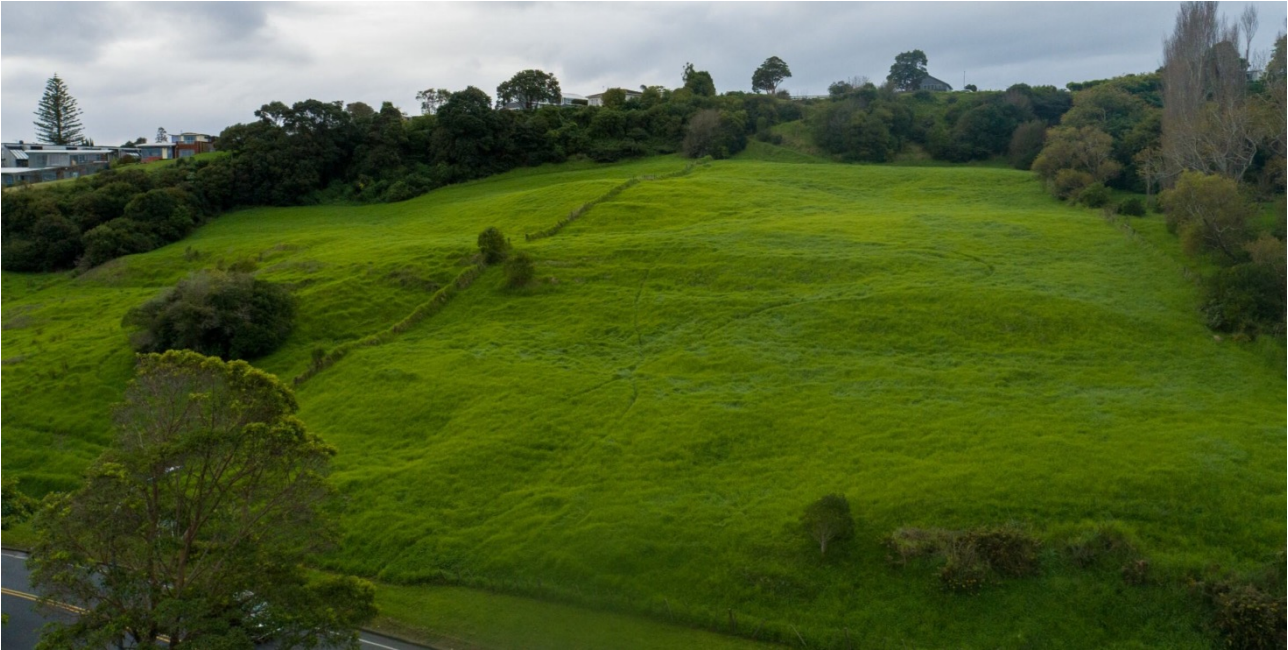
FIGURE 40: Kepa Road Landslide today.

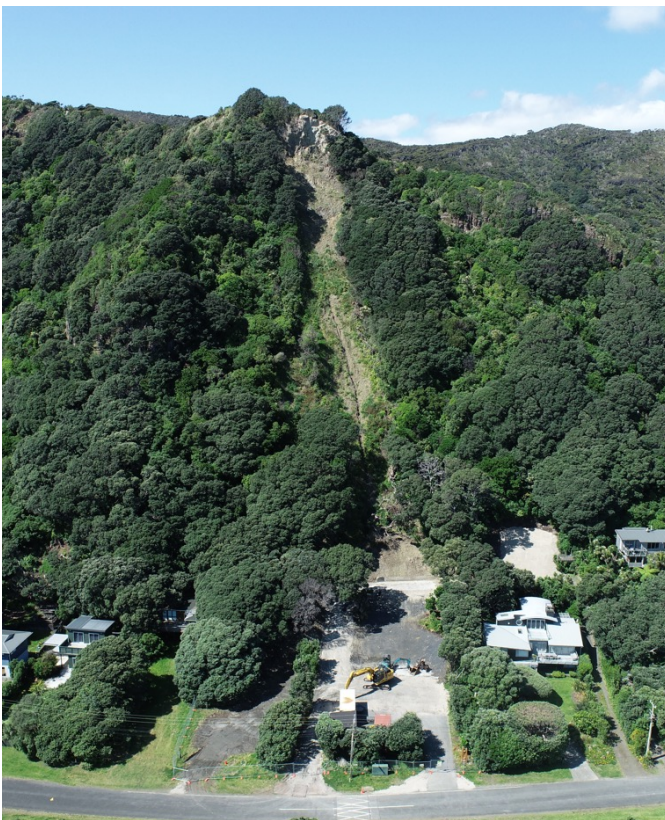
(FIGURE 43 AT LEFT) Translational slide that transitioned to rock avalanche and debris flow, head scarp and flow path (post-demolition). Head scarp at ridge crest exposes a faulted contact between Piha Formation and Waitarua Formation.

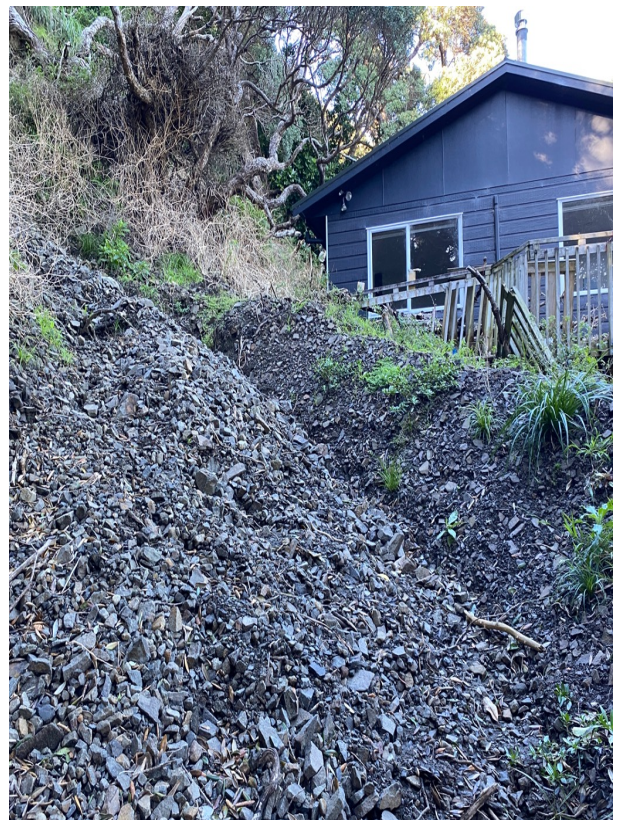
(FIGURE 44 AT RIGHT) Debris fan and impacted dwelling (pre-demolition), debris comprises tabular Waitarua Formation gravel and cobble sized fragments sourced from the highly fractured rock mass at the head scarp location.
