Good grounds for the future

24-26 March 2021 • Dunedin • New Zealand

Kaikoura Earthquake 2016: Case Study for the design and installation of a 2000kJ rockfall barrier at Ohau Point

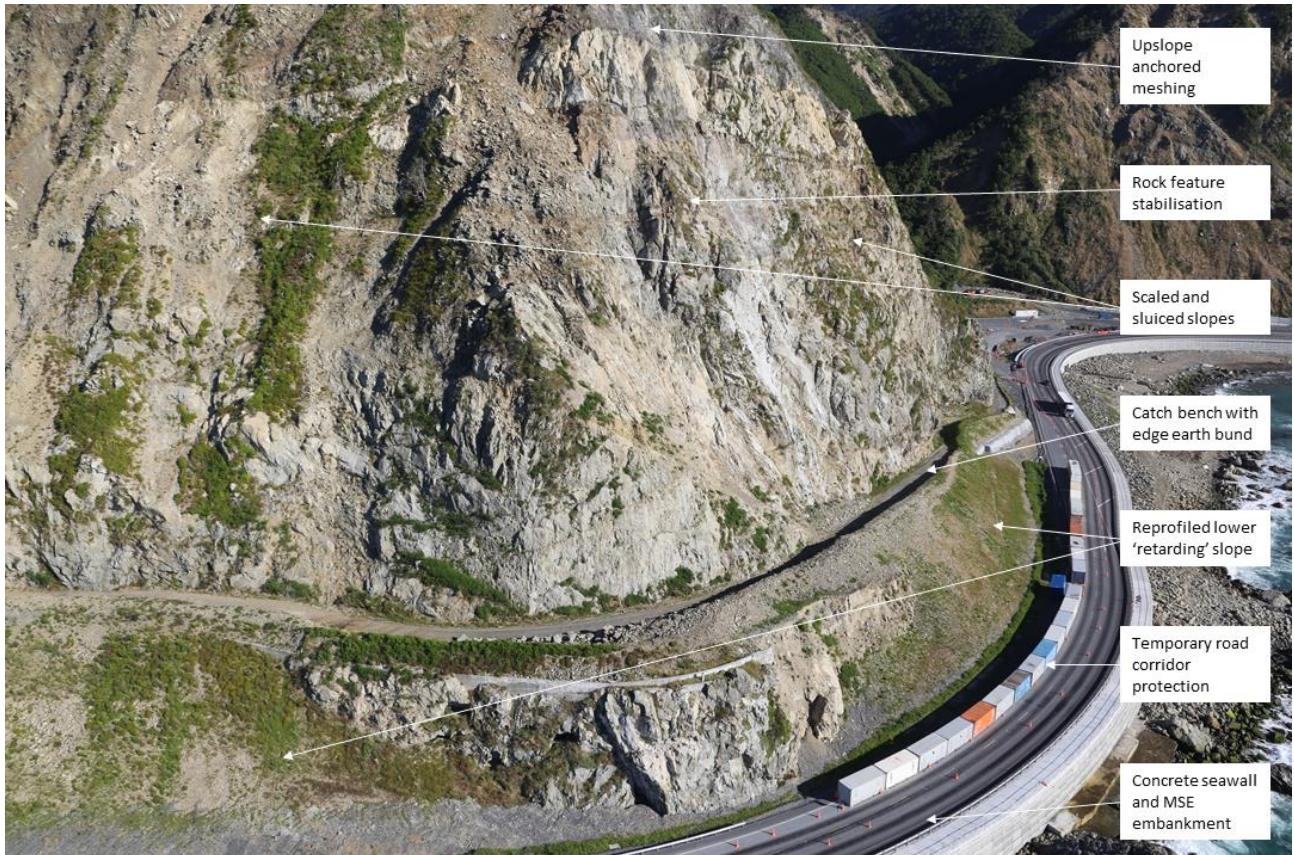
Figure 2: Works completed prior to commencement of 2000kJ barrier construction (Dec 2018)

Removal of landslide debris by armoured excavator once ALARP risk mitigation was achieved in the upper source areas. As debris removal continued, a realignment of the highway away from the slopes onto a bedrock shore platform (raised by the earthquake) was undertaken to reduce the rockfall risk to traffic. The road realignment was progressively routed over the MSE embankment and concrete seawall around the base of Ohau Point as lifts progressed. Unearthing of the old road bench and establishment of a continuous earth bund along its outer edge, effectively re-purposed the old road as a rockfall and debris catch bench. Reprofiling of remnant colluvium and landslide debris below the old road bench to provide a uniform grade, acts as a retarding zone to any material bypassing the catch bench. These works were completed by December 2018. Figure 2.

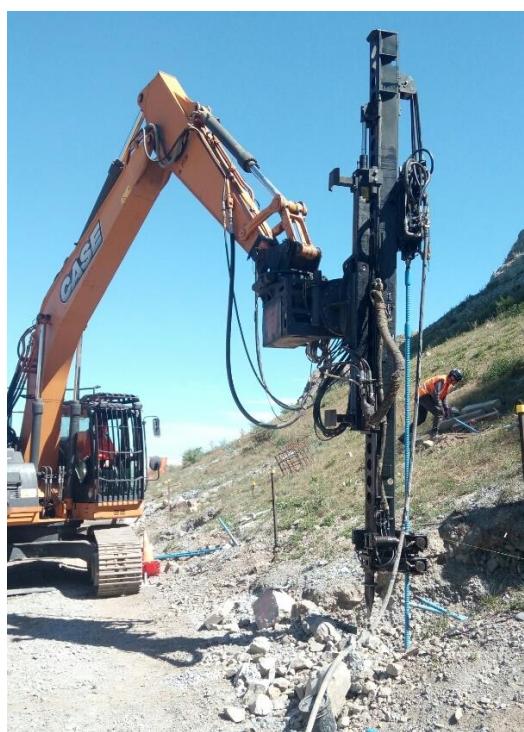
Figure 6: Excavator mounted drill rig installing self-drilling foundation micro-piles at Ohau Point

Anchor drilling was completed with two excavator mounted top hammer hydraulic rigs, which facilitated ease of positioning setup for the various anchor installation geometries required.

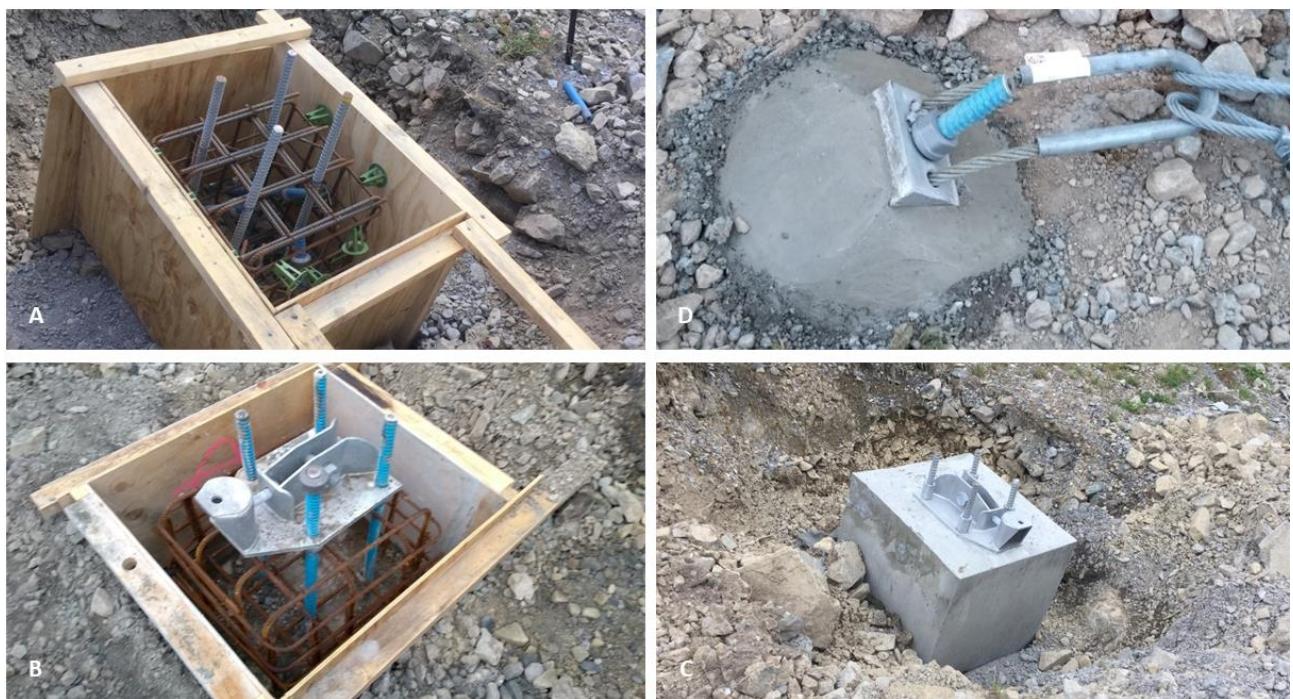
Figure 7 Plinth construction, note the variable particle sizes in the excavations. A) Landslide debris plinth detail B) Rock plinth detail C) Poured plinth awaiting backfill D) Bracing anchor flexed plinth detail.

Plinths were constructed inclined to match the slope geometry, facilitating load transfer from fence post baseplate to ground bonded anchors, typical examples of plinths under construction shown in Figure 7.

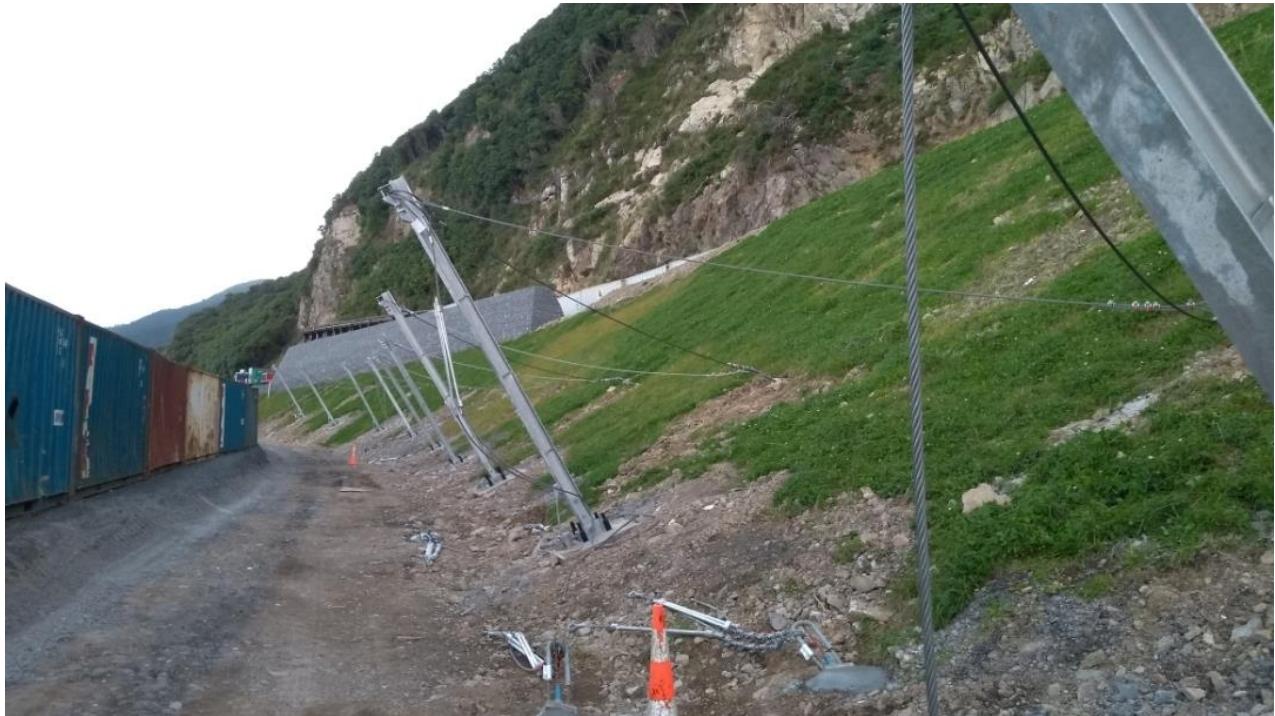
Figure 8: Partially constructed barrier, posts, foundations and bracing cables in place

As sections of bracing anchors and plinths were completed, construction of the HRRB fence could begin. This allowed construction personnel to be installing the barrier posts, associated cables, mesh and energy dissipating elements while anchor drilling continued for another section of the HRRB fence.

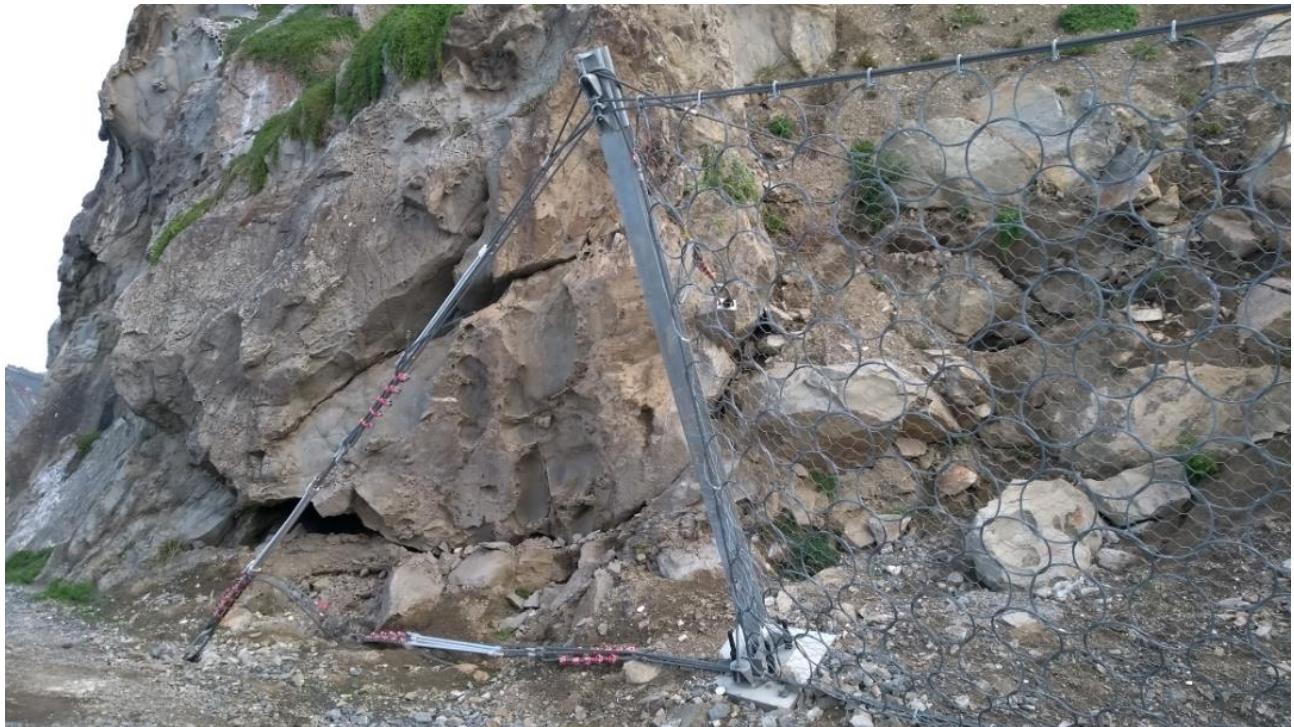
Figure 9 Southern end of 2000kJ B2 segment with modified upslope bracing cable geometry

While the 2000kJ fence alignment accommodated the prominent features outlined in 5.1, the lateral and in particular the upslope bracing cables encountered more discrete features that necessitated modified anchor set out locations. Resolution was achieved by separating the single shared upslope anchor into two independent upslope anchors located where the projection of a standard bracing cable geometry intercepts the obstruction, thereby maintaining the geometry of any applied loads. This technique was utilised nine times across the three fence segments, an example of one shown in Figure 9.

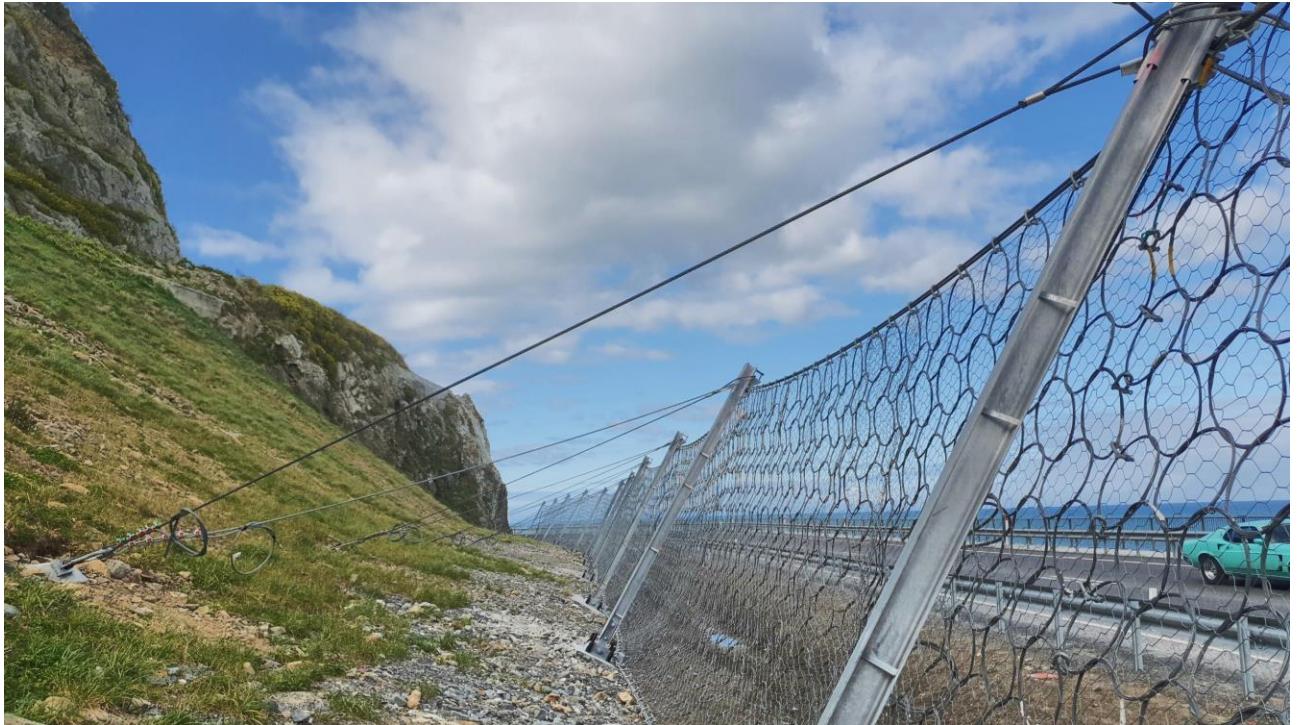
Figure 10: Looking north along an upslope portion of the completed barrier B1

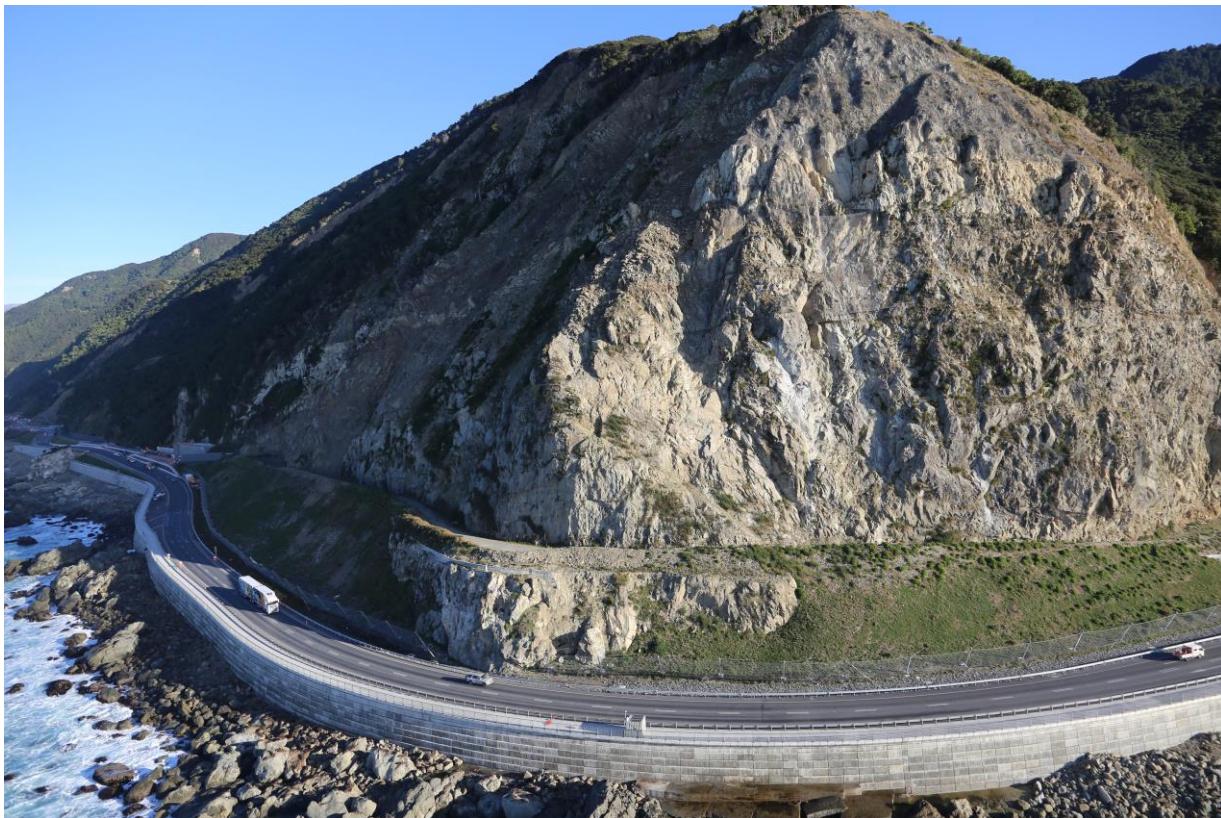
Figure 11: Ohau Point with the completed rockfall mitigation works in place.
