## Anzac Cliffs –Geotechnical aspects of cliff stabilisation works

Keywords: Anzac Cliffs, slope stabilisation, fill buttress

### ABSTRACT

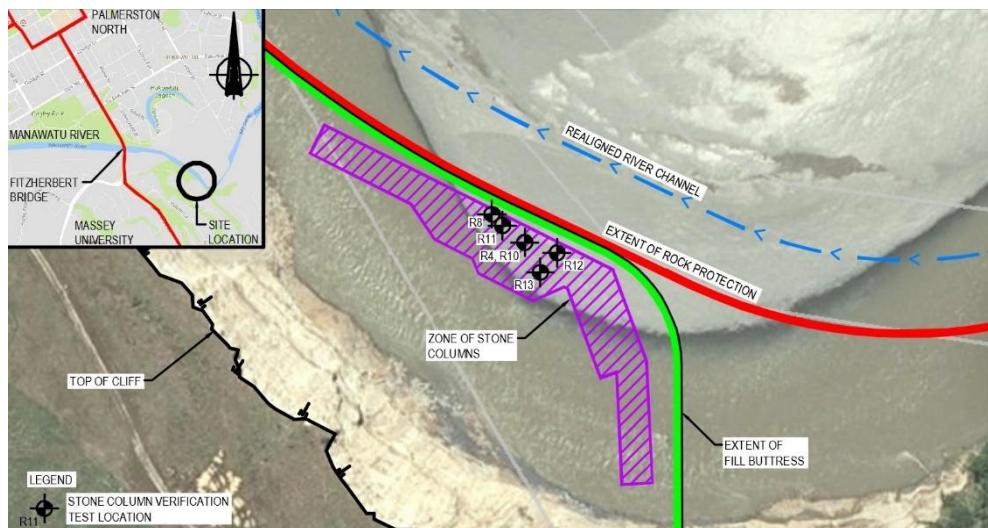
**Figure 1: Location of machine holes for stone column verification testing, extent of stone columns, erosion protection and stabilisation works (additional borehole and test pit locations omitted for clarity)**

The proposed Anzac Cliff residential subdivision is sited above the southern true left bank of the Manawatu River, some 3.5km south-east of Palmerston North City Centre (Figure 1). The north-eastern portion of the subdivision was bound by an approximately 50m high cliff that was subject to large-scale ongoing river erosion. The rapid erosion of this section of the cliff became a concern to various stakeholders with regard to the additional sediment load it added to the river, and the potential adverse effects that its altered course would have on the existing river protection works on the opposite northern bank. In April 2006 works to realign this section of the river back to its 1992 course were incorporated into the City Reach Project, a major works programme to upgrade the lower Manawatu River Scheme that protects Palmerston North from flooding.

Modelling of the required ground improvement work was carried out utilising selected parameters and the slope computer program Slide, to meet the project criteria of no more than 500mm deformation in a 0.43g maximum design earthquake (MDE). The residual shear strengths for potentially liquefiable layers were selected based on correlations with SPT testing (Idriss and Boulanger 2008). Analysis indicating an 8m to 18m width of stone column treatment for different fill buttress heights could achieve the requirements of a static post liquefaction FoS of 1.2, from a FoS of less than 1.0 without stone columns. The finalised geometry of the stone column layout is based on these calculations, with extrapolation based on judgement. The design utilised a 15% replacement value of imported crushed gravels for the columns (Figures 1 and 4).

Further validation testing consisting of boreholes with SPT testing was carried out following installation of the columns with very significant strength improvements were recorded (Figures 1 and 5). As expected, there was a variability in the strength improvements, which is considered to be related to variability in material type, with the best response noted in the clean sands and gravels, and lesser improvements in silty sands. Figure 5 shows the calculated FoS of 1 against liquefaction based on correlations between relative density and liquefaction trigger values (Boulanger & Idriss, 2014). Due to the nature of the materials and significant scatter for the SPT results, the liquefiable layer was characterised based on the 66 percentile (i.e. 66% of values are greater than the design value) (Idriss and Boulanger, 2008).

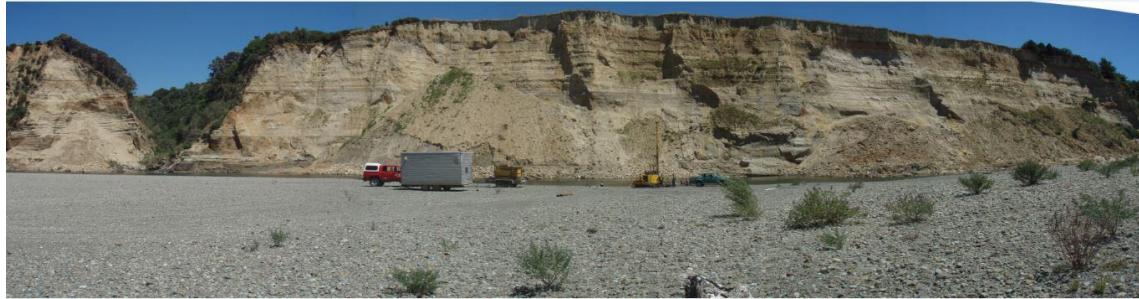
**Figure 2: Composite of photographs taken from the opposite true right northern river bank during 2008 feasibility study**

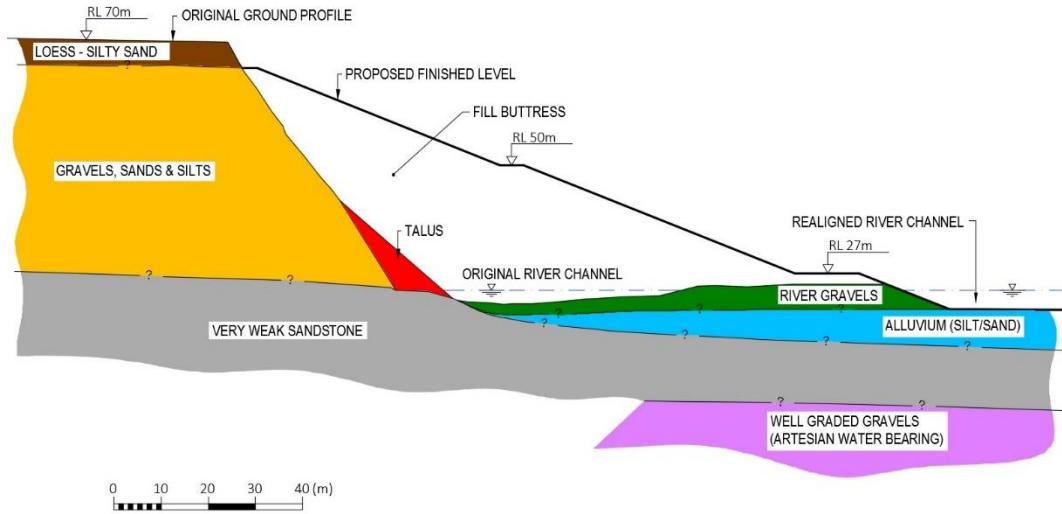
**Figure 3: Simplified geological cross section showing original and finished ground profiles**

The Anzac Cliffs, along with the adjacent Waicola and Strand Cliffs, have formed as a result of down cutting of the Manawatu River into a coastal terrace formed during the previous interglacial period around 100,000 years ago (Lee & Begg 2002). These sand, silt, and interbedded sandy gravel horizons were visible in the cliff face and capped by loess. At the base of the cliff an erosion-resistant rock platform, interpreted to be of Pliocene Age, was exposed. The sandstone horizon is very weak in engineering terms, but is considered more erosion-resistant than the cliff materials above (Figure 3).

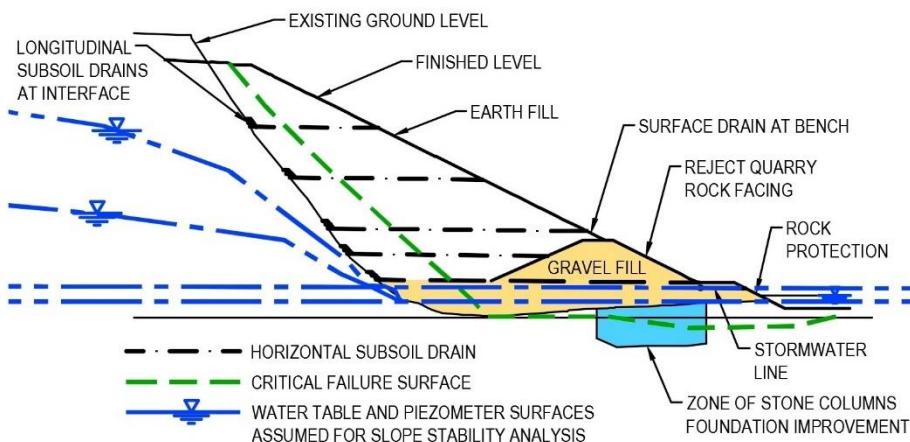
**Figure 4: Cross section showing zone of stone columns, subsurface drainage, groundwater levels assumed for analysis, and critical failure surface from slope stability analysis**

An assessment of the liquefaction risk to the project was carried out for the cliff materials, engineered fill, and foundations. Neither the in-situ cliff materials nor the engineered fill buttress were considered to be significant hazards. The cliff itself has a fundamentally low groundwater level, although minor seeps indicating perched water tables have been observed. Groundwater levels assumed for slope stability analysis purposes are shown in Figure 4. Buttress fill consists

of material compacted to engineered standards, with groundwater controlled by subsurface drainage. The more potentially hazardous location was assessed to be within the foundations of the fill buttress. Loss of support here due to widespread liquefaction could lead to large-scale lateral spreading, gross settlement and, in extreme cases, excess lateral movement of the entire cliff. Slope stability analysis was utilised for design of the fill slopes; this included an assessment and identification of where stability was assessed to be marginal below the buttress toe (Figure 4).

Shallow-seated slumps were observed to occur on these steep cliff slopes where concentrations of surface water occurred. Surface collector drains were installed at the intermediate bench with a piped outlet to the cliff base (Figures 4 and 9). The reshaped slope is proposed to be vegetated to minimise surface water infiltration in the long term and also bind the surficial soils, reducing the risk of rill erosion on the face. To monitor the performance of the fill slope, a series of survey points were set up that are subject to ongoing monitoring for horizontal and vertical movement. To date the slope's overall performance is within expectations (Figure 9).

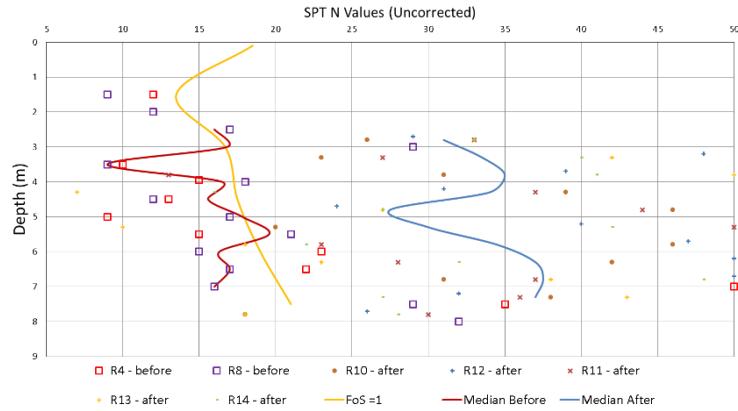
**Figure 5: SPT N tests from boreholes measured before (plotted as squares), and after installation of stone columns installation (liquefaction trigger values (FoS=1), and median before and after SPT N lines shown)**

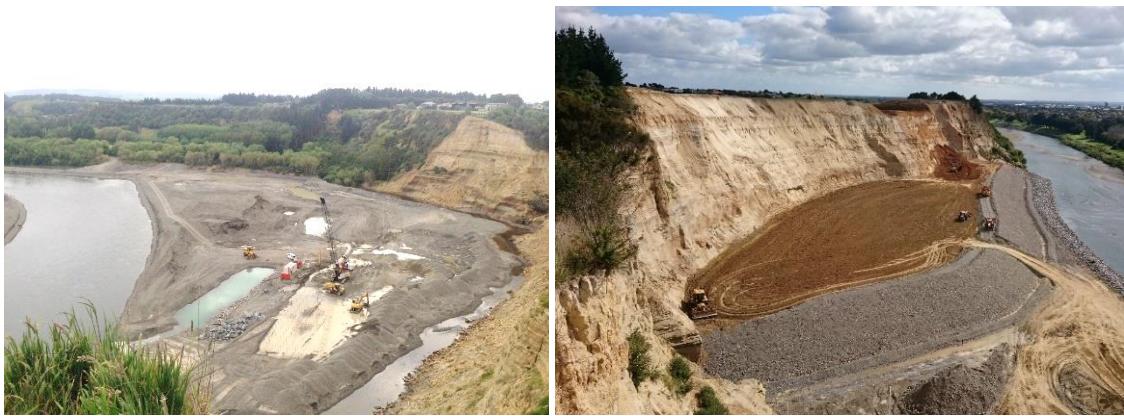
**Figures 6: Looking south towards stone column installation, (9 December 2014)**  
**Figure 7: Looking north towards later filling operations (20 April 2016)**

The second stage of stone column installation commenced in December 2014 following works to divert the river (Figure 6). This involved the installation of a 3,899m total length of stone columns, with individual columns varying between 6.3m and 7.3m depth. River levels were a constant ongoing threat to progress, with a flood on 10 December raising water level about 2m

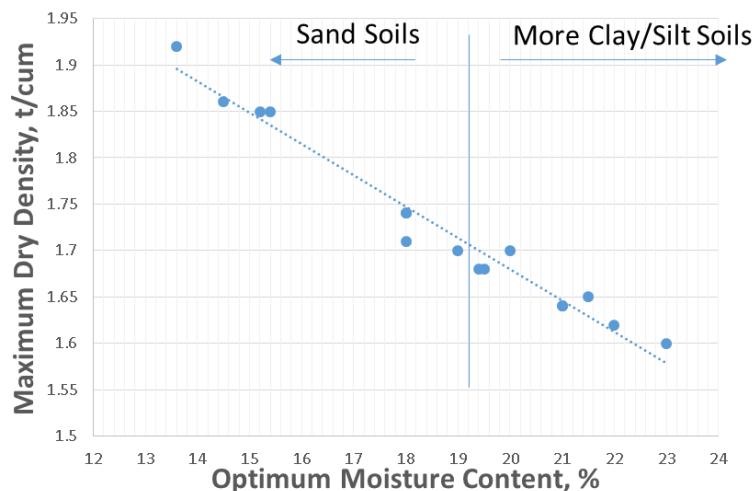
**Figure 8: Range of maximum dry density vs optimum moisture content for buttress fill from laboratory proctor tests**

The variability of material encountered in the cliff meant that compaction test results needed to be closely monitored and testing criteria adjusted to reflect the materials. To ensure fill materials achieved the design criteria, ongoing standard compaction proctor tests to determine maximum dry density, were compared to materials tested in the field. Field tests consisted of Scala penetrometer, shear vane, and nuclear density meter (NDM) with oven-measured water contents. Testing of materials on the same site ranging from clay to sand highlighted the importance of selecting the correct targets for dry density, and field tests for different materials. The more sandy soils have typically shown a higher maximum dry density with a lower optimum water content, and the opposite for more clayey soils (Figure 8). Monitoring involved an ongoing review of field and laboratory test data and regular site visits, including documentation of fill material and ground conditions. Information and feedback shared between the laboratory, consultant, and contractor was required to ensure varying materials were conditioned to an acceptable water content.

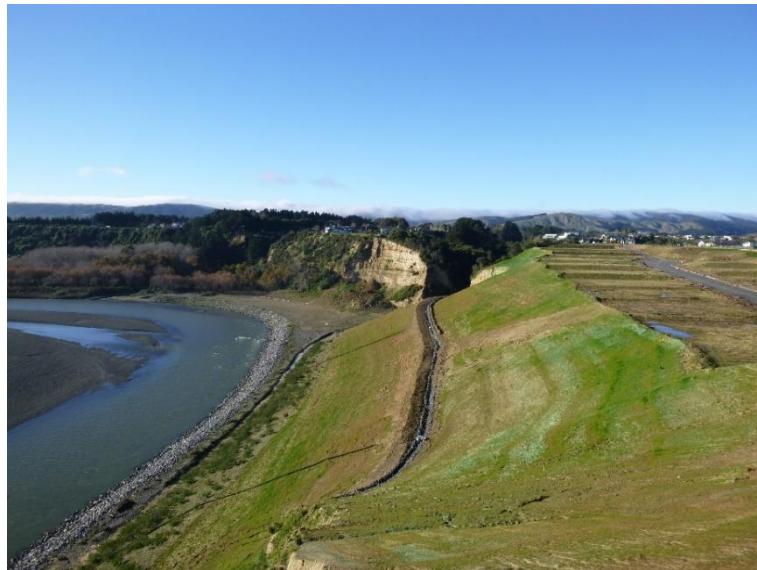
**Figure 9: Photograph of completed realignment and cliff stabilisation works**
